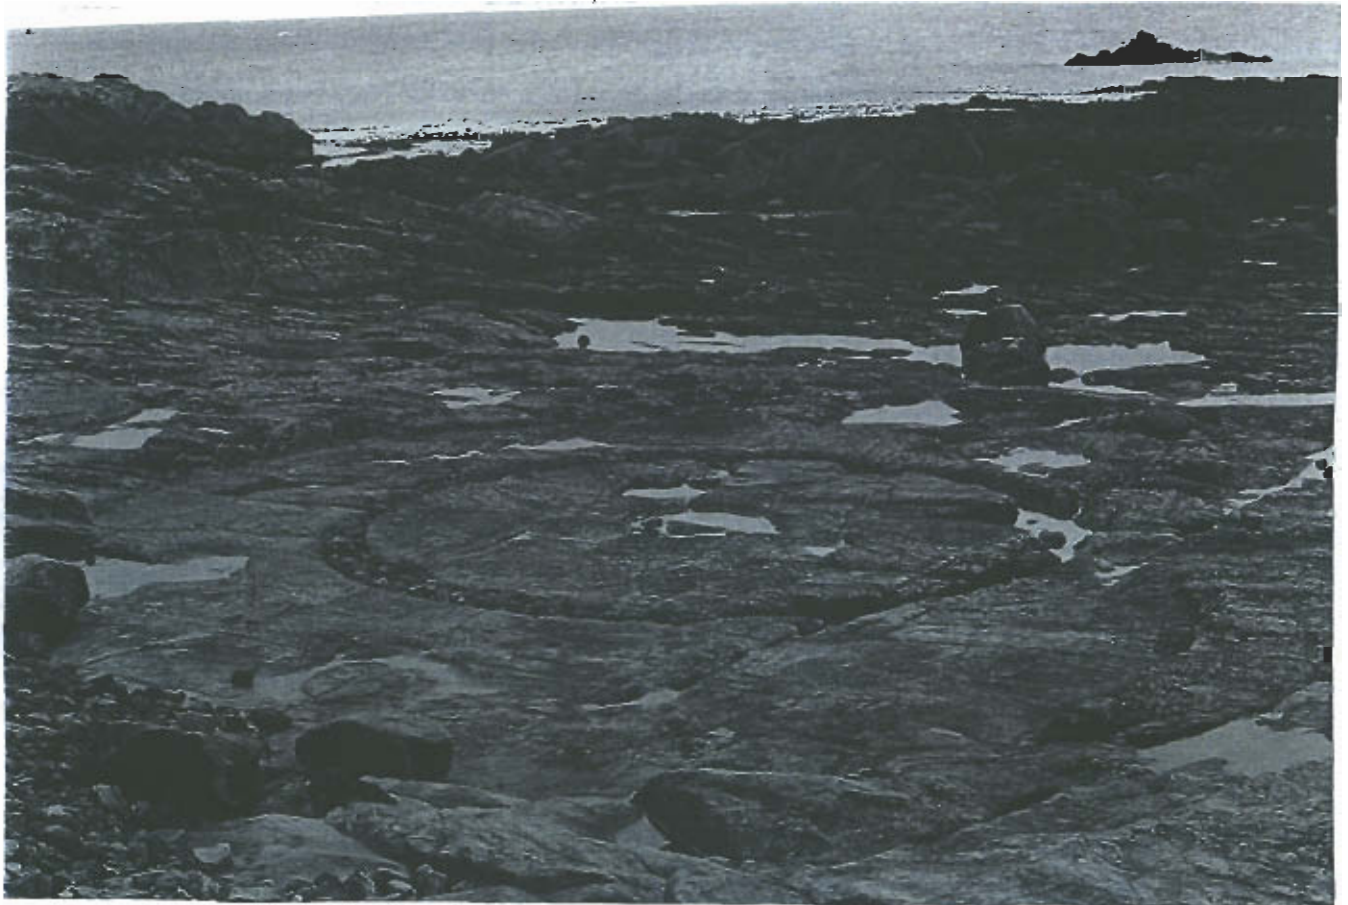
**Lighthouse Construction Site (NO60NW33.1)** The indentations marking the base of the lighthouse construction site are heavily eroded at the edges and in some places are not visible. This has been caused by shingle scouring and other marine action.

Fig 4: Fife Ness Lighthouse Construction Site (NO60NW33.1)  
 Photograph - Rudiger Bahr

Given the state of collapse of the stone quay, and the ongoing erosion to the tramway fittings and lighthouse construction site, it is recommended that the existing monuments be compared with the baseline surveys carried out by RCAHMS in 1990 to establish whether any changes have occurred in the recent past and to assess what can be done to mitigate any decline.

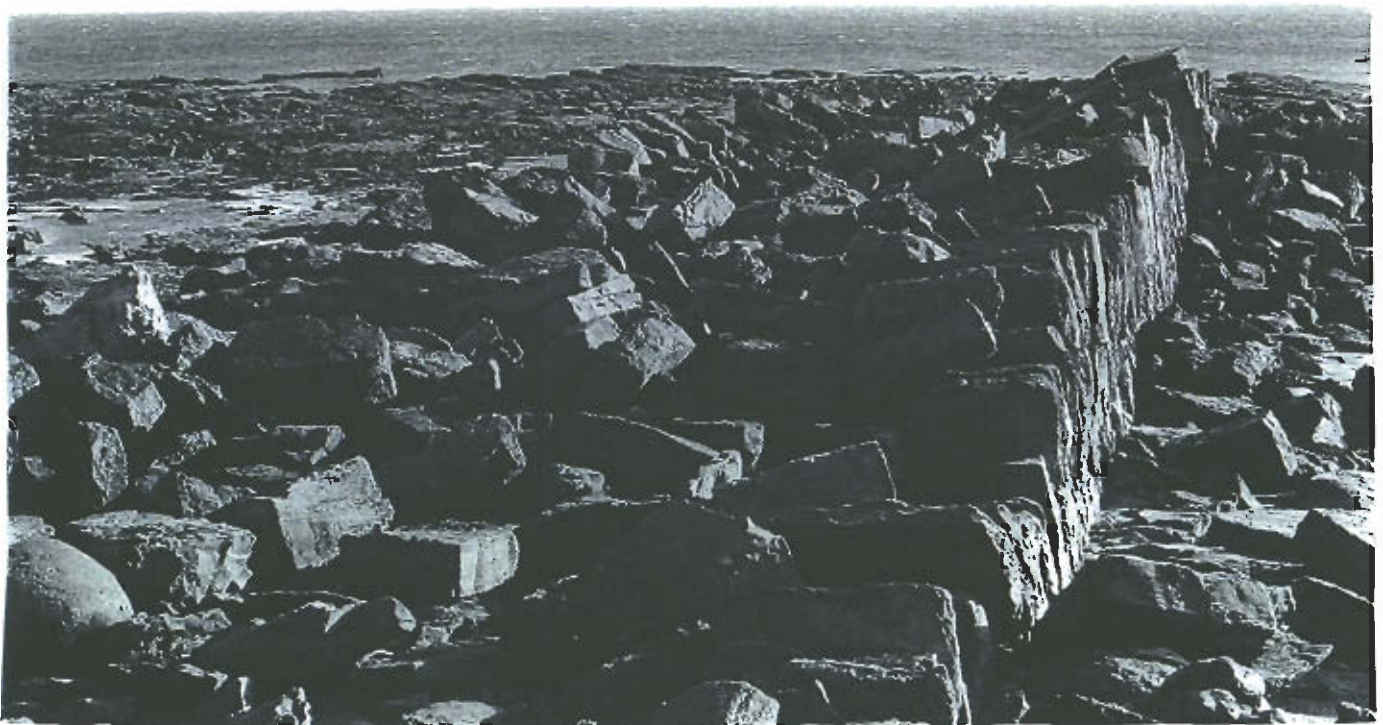
The principal threat to Kingsbarns harbour is from erosion. Throughout history, the harbour has suffered from sea damage which brought about its downfall at the end of the 19th Century. Since then, only a small part of the northern sea-wall remains intact, while the foundation courses are also intact along the length of the southern sea-wall where it appears to be protected by accreting sand deposits, and at the foundation layers of the outer wall. Sand can be seen to be breaching the northern quay at the landward side where the quay line is no longer visible. The survey team testified to substantial deterioration since a measured survey was carried out by the Scottish Institute of Maritime Studies in the 1990's. This indicates that the rate of erosion may be rapid.

Fig 6: Kingsbarns harbour wall looking east  
 Photograph - Rudiger Bahr

A further survey of this site would be desirable to confirm whether the harbour has deteriorated since the 1990's survey carried out by S.I.M.S. If there has been deterioration, then the site should be frequently monitored with additional recording work carried out in the event of imminent collapse of the harbour and its associated features, and, if required an assessment made of what can be done to mitigate the effects of erosion. In addition, monitoring of sand movement along the coastline as well as dune stabilisation work to trap sand in the vicinity of the monuments might help to protect the harbour wall structure and limekilns in the longer term.

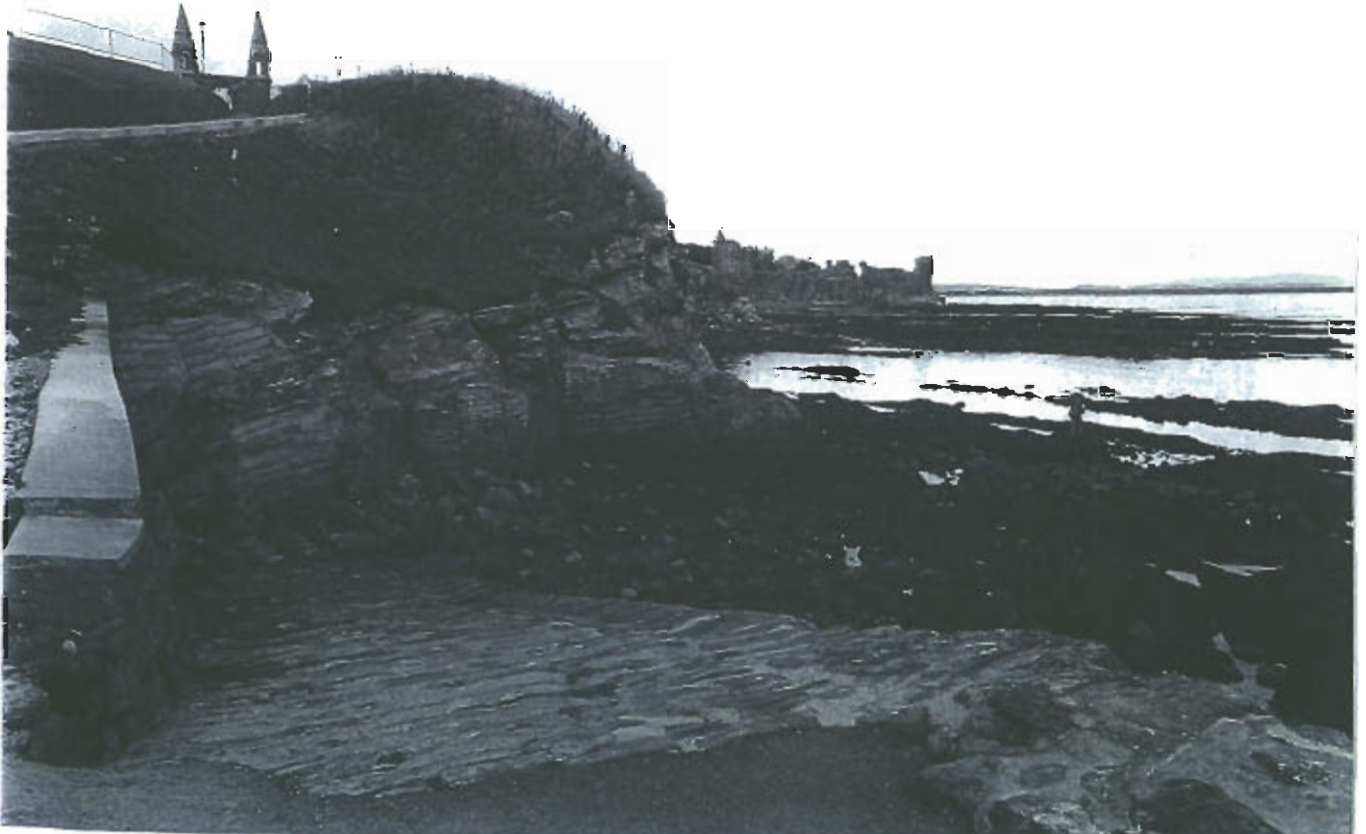
**Threat:** *These features have been inadequately recorded to date. Although the geology of the foreshore at this point will insure that the natural rock inlets remain stable for the foreseeable future, the enhanced features will soon disappear. Only a few iron fittings remain due to the corrosion of iron in sea-water and the other post footings, visible as cuts and drill holes into the littoral rocks are gradually eroding as a result of shingle scour.*

Fig 8: Looking north west from St. Andrews harbour towards St  
Andrews Castle with enhanced piers in the foreground.  
Photograph - Rudiger Bahr

**Recommendations:** A thorough survey of these features is required, including an E.D.M measured survey of the entire area including St. Andrews Castle, all identifiable inlets, post footings, steps, cart ways, and other features as far as the west sea wall of St. Andrews harbour.

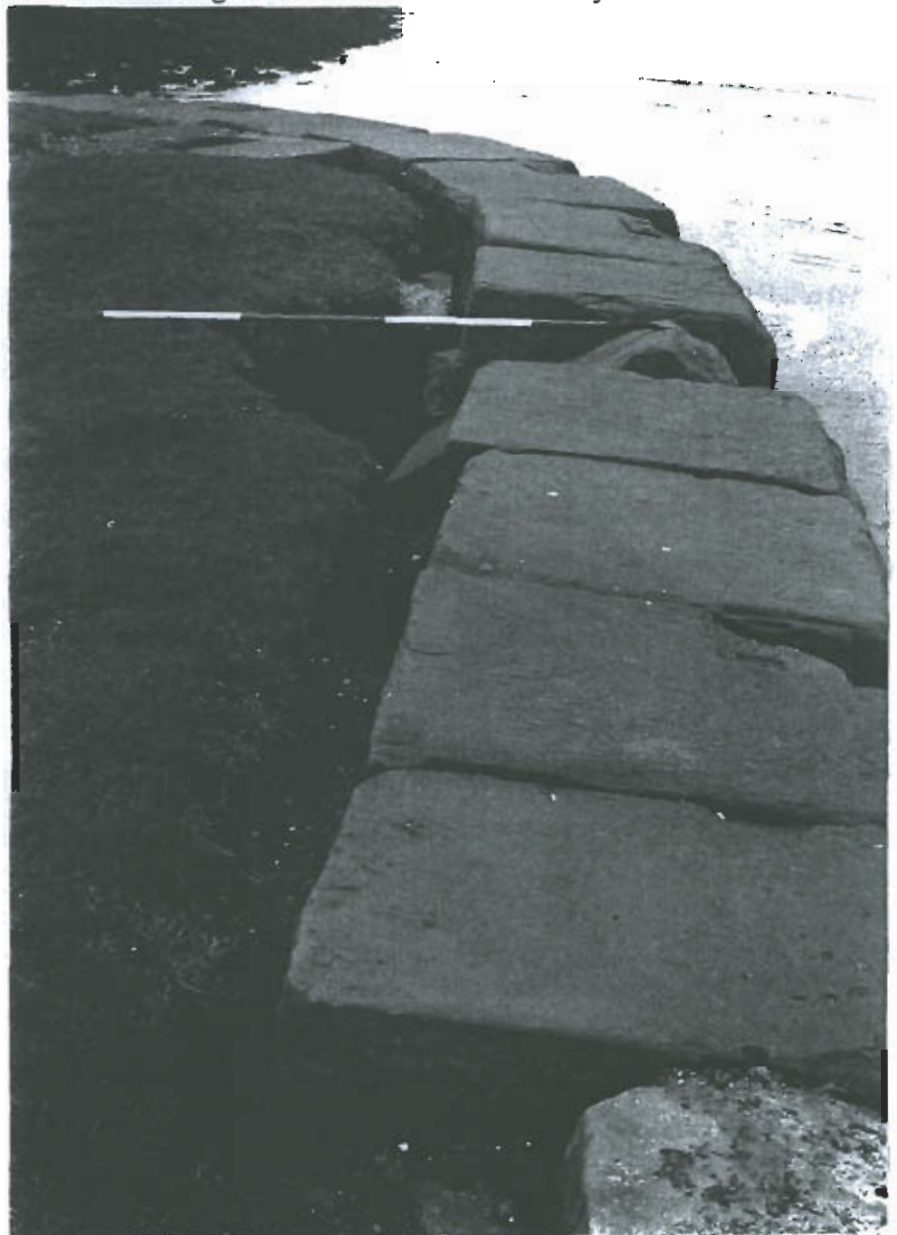
**Threat:** There is evidence of serious erosion to the harbour walls at Tayport Harbour (NO42NW58). The sloping cobble wall at the southern end of the main basin is collapsing probably because of faulty drainage causing water run-off to undermine the ground behind the wall. There has been a recent housing development in the land adjacent to this section but it was unclear whether pavement works could be connected to the deterioration of the wall. Further damage of a similar nature was evident on the topstones of the main quay of the northern harbour complex. Again drainage is probably the cause of this collapse. However, erosion to the northernmost harbour feature has probably been caused by marine action. Land-fill has been dumped at this point in an effort to mitigate the effects of erosion. Since the Pile lighthouse (NO46302930) fell into disuse, its condition has deteriorated but its structure appears to be fairly sound. However, given its exposed location, this attractive feature will quickly deteriorate. The old harbour breakwater (NO461288-461291) has almost entirely collapsed and the wide scatter of debris building material indicate the erosive effects of the sea on this feature. Although the small wreck (NO46152902) is buried in mud, it will deteriorate fairly quickly once its iron fittings have corroded and rusted away.

Fig 10: Scour erosion to Tayport Harbour wall; Photograph - Rudiger Bahr

-*Survey and monitor*

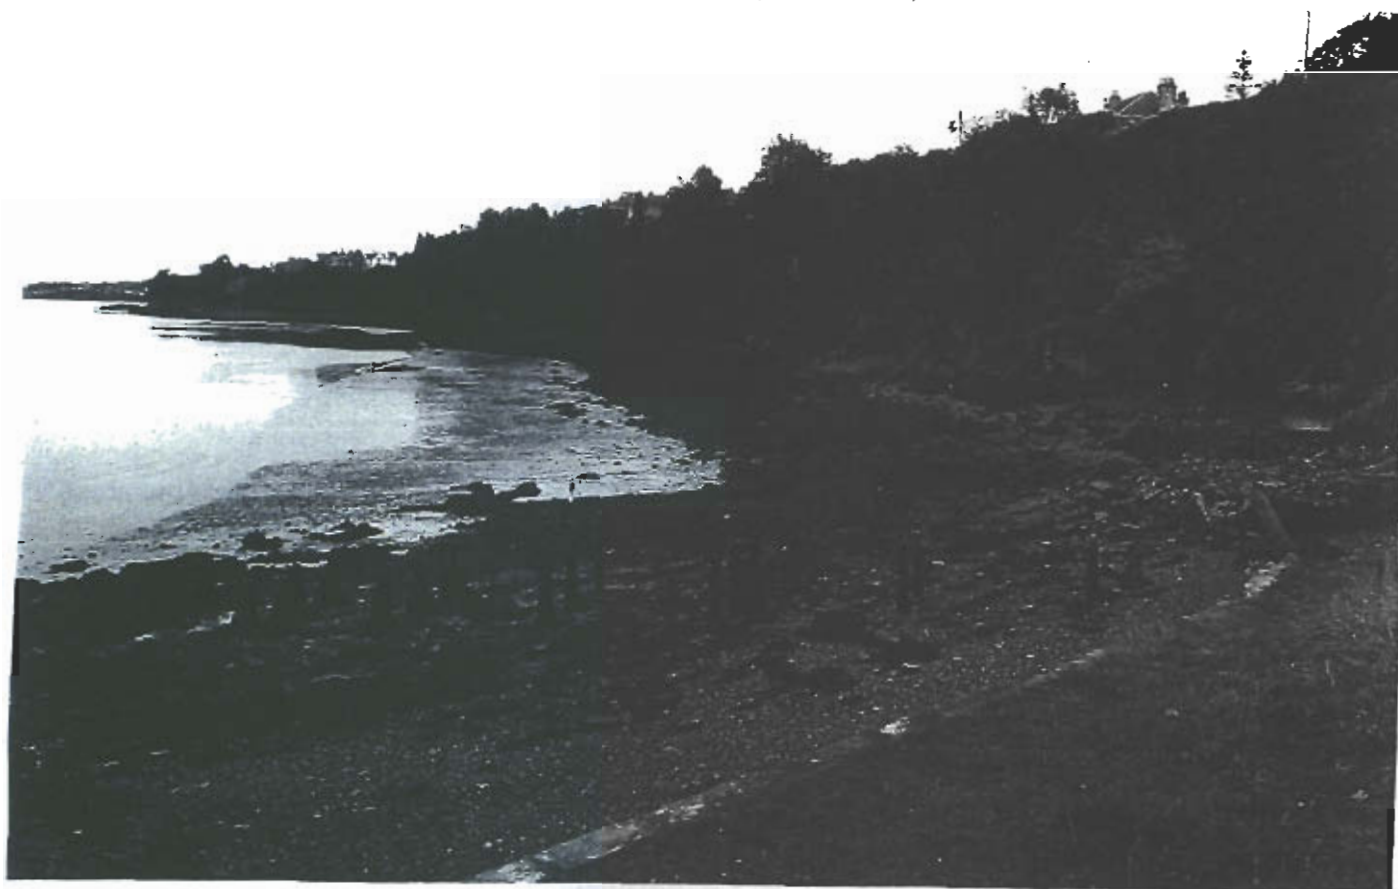
**Threat:** Heavy growth of seaweed over the wreck and wharf remains suggest that the site is stable and will if anything, be protected by the accretion of mud evident along this part of the Tay estuary. However, this interesting collection of industrial remains has been inadequately recorded to date and deserves further attention.

Fig. 12: Wharf remains in foreground; more wharfing and wreck hidden by shadow. Photograph - Rudiger Bahr

Unknown wharf and harbour remains (NO397263): *Survey*

Wreck (NO32NE8147): *Survey.*

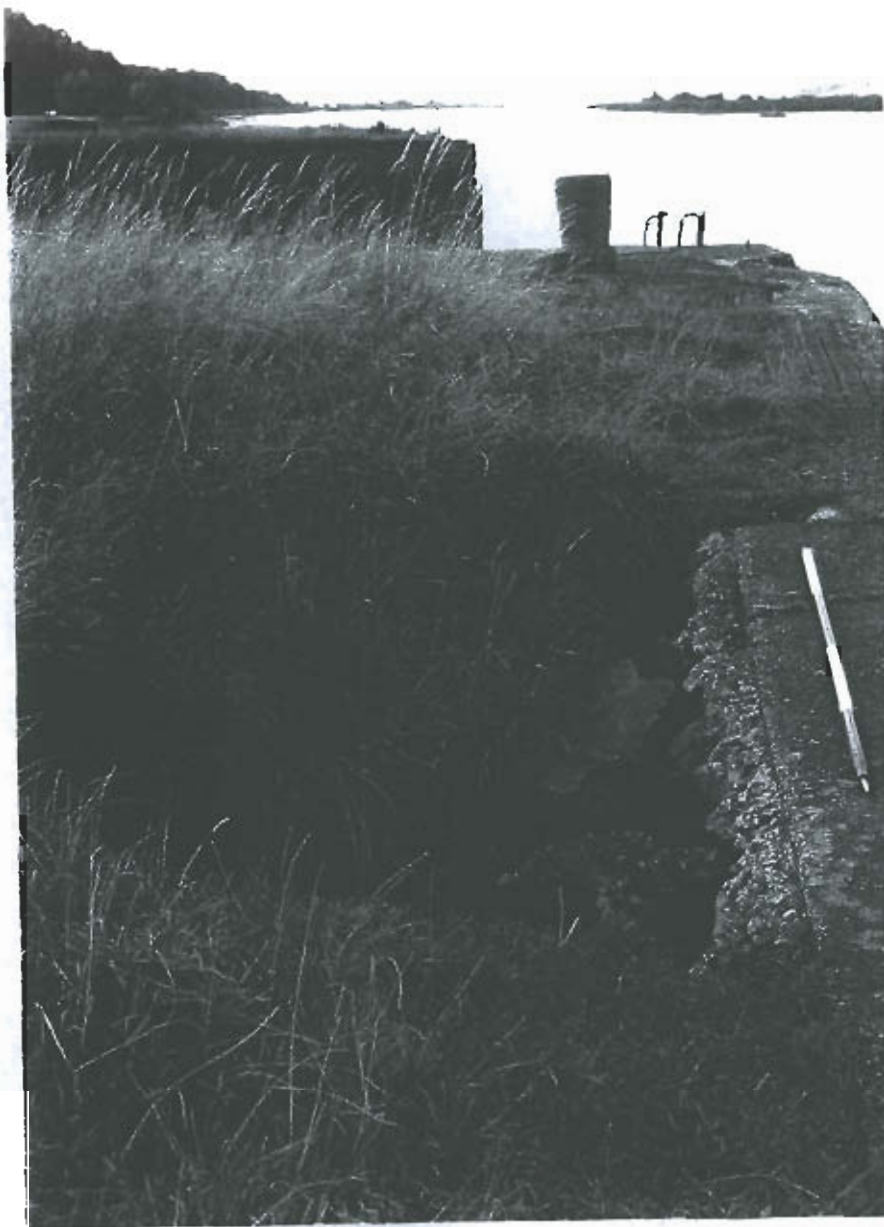
NO23741877 - 23321858 : Newburgh harbour, Wharfs, quays, slipways, bollards, wreck of fishing boat (NO23501863), salmon coble on quay. Harbour walls collapsing due to drainage problems and lack of maintenance (Poor).

Fig. 14: Scour erosion to the harbour wall at Newburgh  
Photograph - Rudiger Bahr

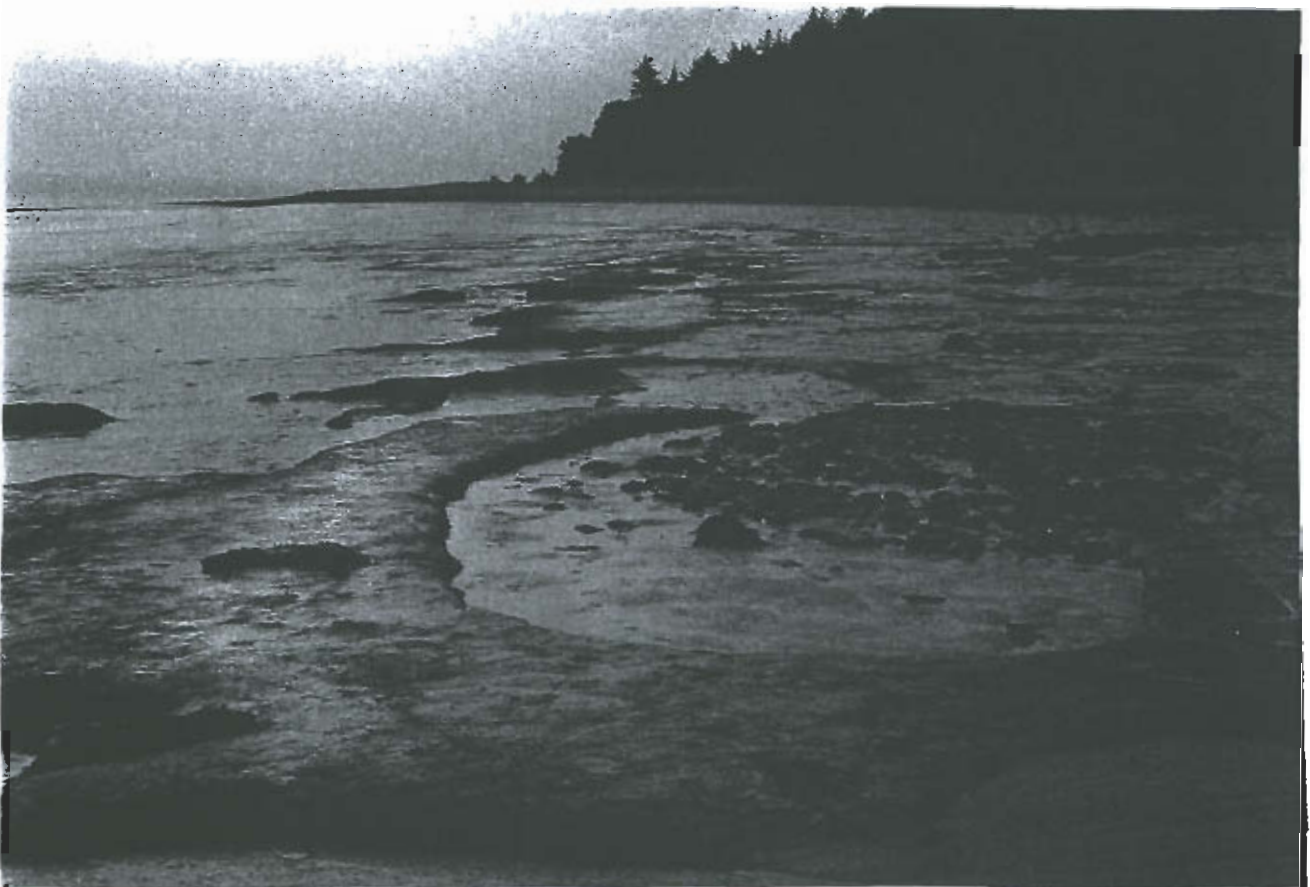
Fig. 16: Prehistoric land surface exposed on the muddy foreshore of the Tay estuary west of Balmerino (NO322231-NO312227) ; Photograph - Rudiger Bahr

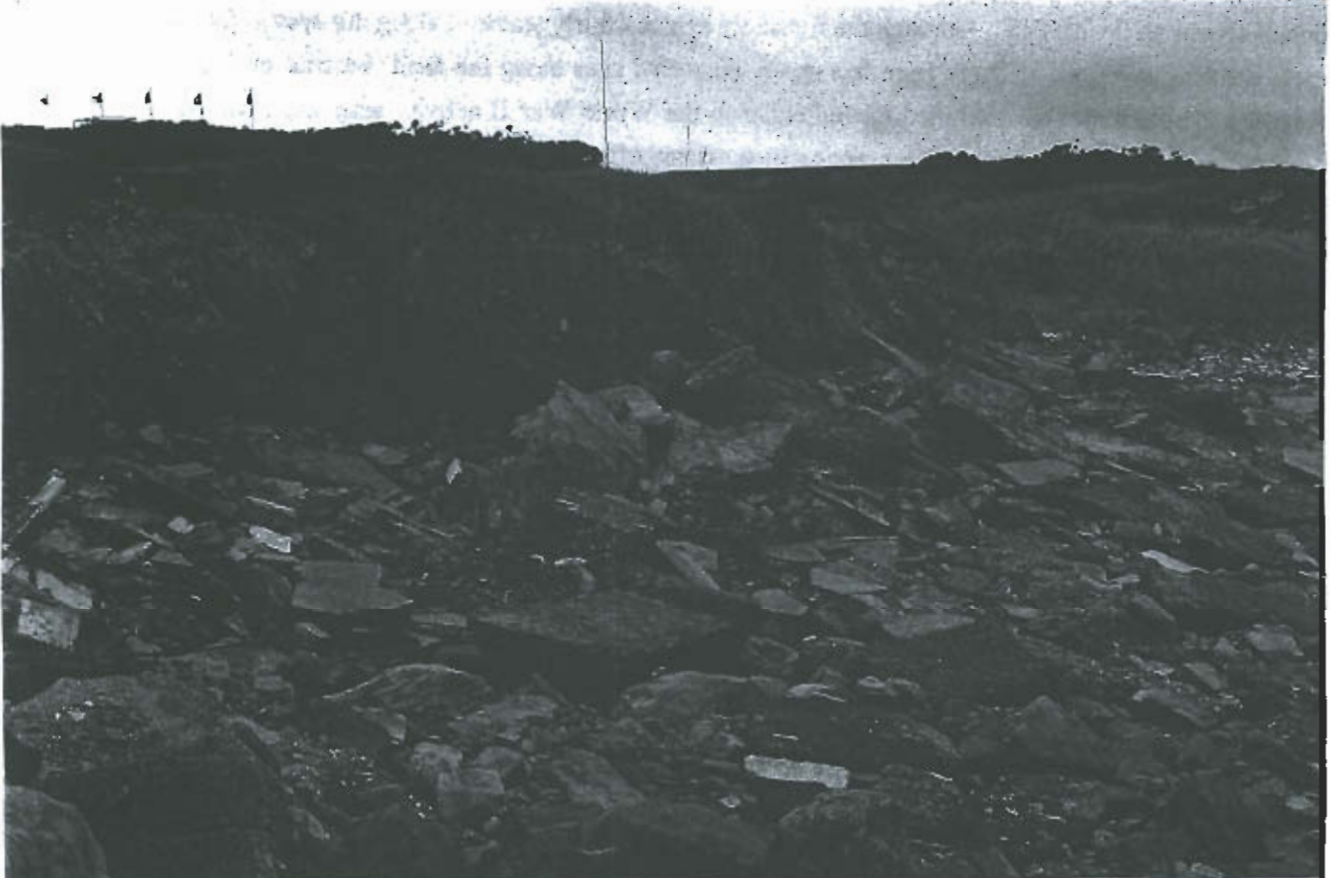
A further 114 sites have been recorded on the NMRS. This number includes 11 Protected Ancient Monuments, of which two have been adversely affected by erosion: two pillboxes situated on the coast edge near Balcomie Golf Course at Fife Ness (NO61SW16, NO61SW18: see fig. 17). Other recorded sites vary from burials (e.g. Old Haiks NO61SW2) and harbours (e.g. St Andrews NO51NW63) to castles (e.g. Randerston NO61SW4), and from caves (e.g. Constantine's NO61SW6) to shipwrecks (NO32NE8147). The character of this archaeological record broadly reflects the settlement, industrial activities and land-use of this coastline since antiquity.

Fig. 17: Coastline near Balcomie Links showing possible collapse of one of the recently scheduled pillboxes (NO61SW18). Photograph - Rudiger Bahr.

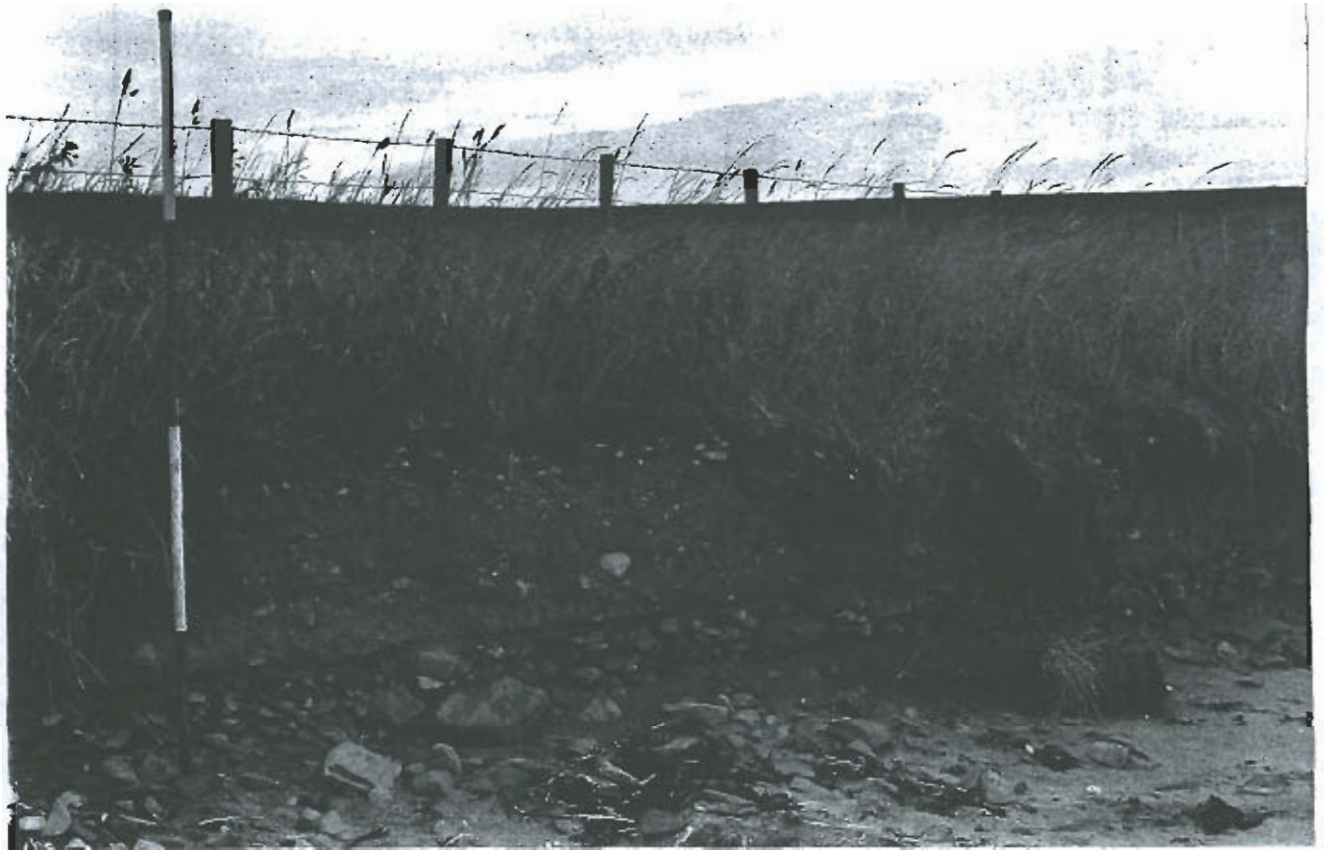
- Along the exposed coastline between Fife Ness and Kingsbarns, the sea is exploiting breaks in the rock cut platform resulting in localised undercutting of the coast edge (See fig. 18 ).

Fig. 18: Erosion of a loosely consolidated raised beach terrace near Buddo Rock. Photograph - Rudiger Bahr
