Map 1: South Gravity to Hollandstoun

Landscape, Built Heritage & Archaeology

North Ronaldsay Map 1

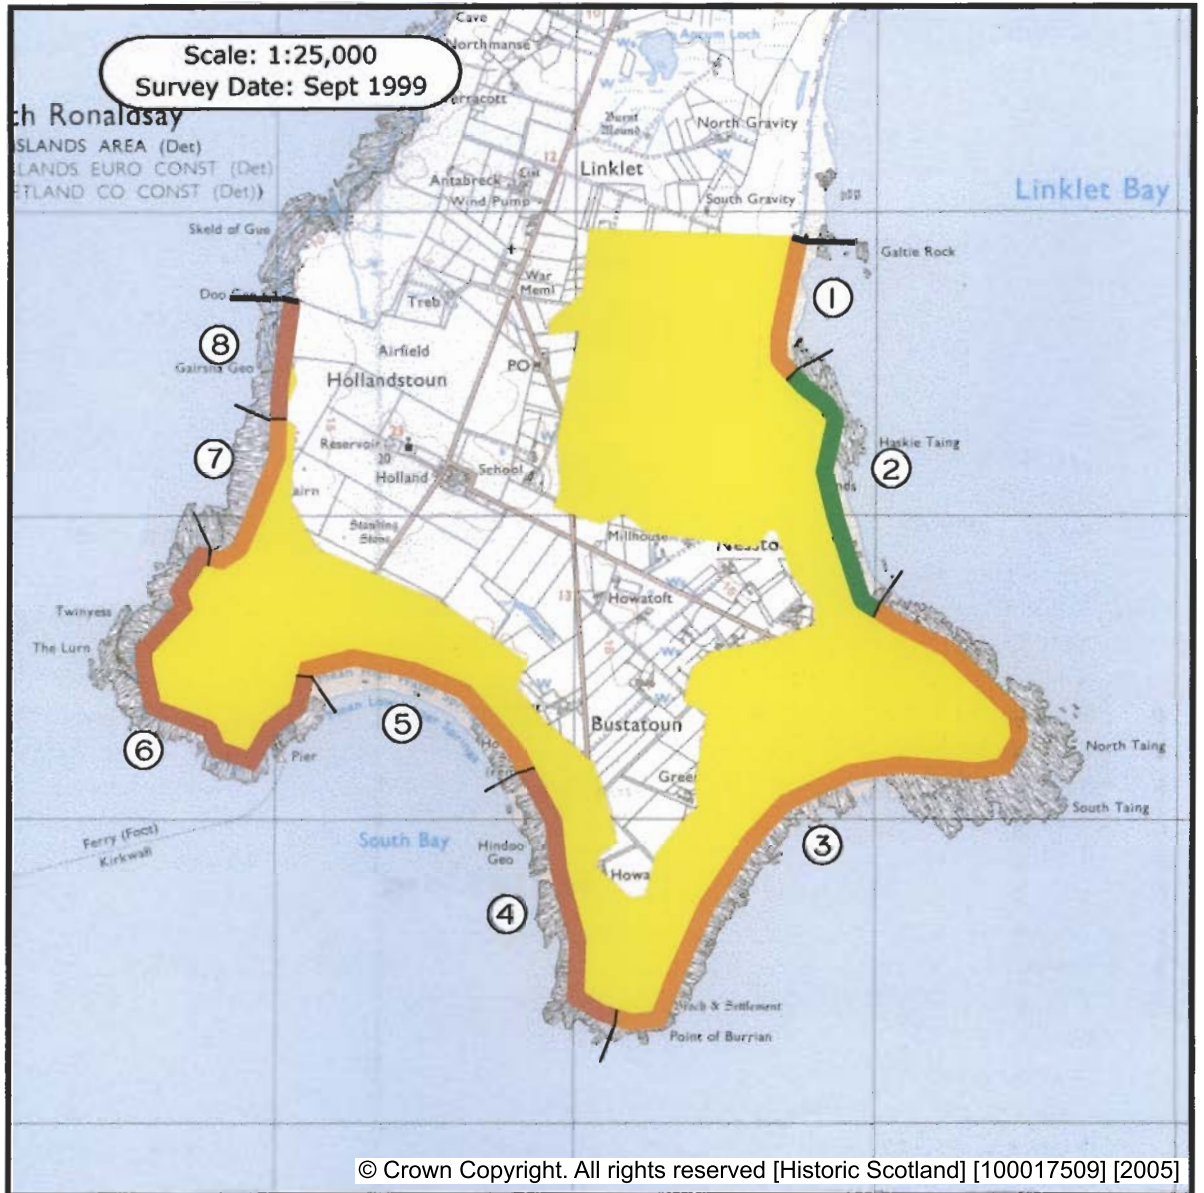
- 1. Galtie Rock**
HY 767 537
0.5 km
Eroding to Stable
A sandy beach leads to a small cliff which measures up to 1.5m high. The hinterland appears stable and well grassed. The small cliff face at the coast edge is clean and appears to be eroding. The hinterland is currently used as a golf course.

- 2. Hooking**
HY 768 529
0.9 km
Stable
This section appears mostly stable. Dunes lie in the hinterland, which are grassed over. There is some erosion at the north end of a concrete sea wall which lies in front of the farm buildings at Hooking.

- 3. Stennabreck**
HY 768 521
2.5 km
Eroding to Stable
There is a gabion wall in front of the farm buildings at Stennabreck. The coast edge to north and south of the wall is eroding in small exposures each no more than a total of 10m long. Elsewhere, the coast edge is mostly stable, with vegetation growing on top of storm beaches, but there is some damage which appears to be caused by sheep. Between South Taing and the Point of Burrian the red till has been exposed in several areas, especially towards the Point of Burrian where the sheep dyke has concentrated sheep activity within a smaller area.

- 4. Strom Ness**
HY 759 517
1 km
Eroding
The sheep dyke lies very close to the coast edge for most of this section, which has had the effect of worsening the effects of sheep erosion. There are many bare sheep trails, and most of the available vegetation has been grazed very flat or entirely eaten, leaving areas of soil with no good cover. The effects of this are most pronounced at the head of Strom Ness, to the west of the broch of Burrian, where a combination of sheep activity and aeolian erosion has rendered a large area unstable. Here, there are signs that adjacent fence lines have been moved inland in the recent past.

- 5. Bustatoun**
HY 754 524
0.9 km
Accreting and Eroding
This section comprises the inner part of South Bay. The hinterland consists of dunes, which are mostly stable and grass covered however there are areas where the grass cover has been lost, exposing the sand below. This may have been caused by apparent rabbit infestation. The land closer to the shore is eroding badly. Here, on the seaward side of the dyke which encircles the island sheep damage is apparent and is undoubtedly contributing to the erosion. The erosion is evident from the lengths of collapsed dyke and from the large 'lumps' or 'pillars' of sand left standing between hollows to either side. Fence lines have also been moved inland. Sand is accreting

- beyond the foreshore around collapsed dykes.
- 6. Nouster**
HY 746 523
1.4 km
Eroding
There are many areas of the coastline within this section which are denuded of vegetation and susceptible to salt spray. The coast edge around the pier area appears more stable, due to consolidation using dumped rubble.

- 7. Loch Gretchen**
HY 749 530
0.5 km
Eroding to Stable
The foreshore over much of this section comprises a storm beach. The coast edge is denuded of vegetation by sheep activity and vulnerable to erosion.

- 8. Holland**
HY 750 535
0.4 km
Eroding
This section is eroding; a new stone wall with concrete foundations has been built c. 2m back from the eroding old one. Sheep and rabbit activity is contributing to the erosion. There is little cobble cover here on the rock platform and this section is very exposed to the effects of the sea.
