Map 1: South Gravity to Hollandstoun

Landscape, Built Heritage & Archaeology

North Ronaldsay Map 1

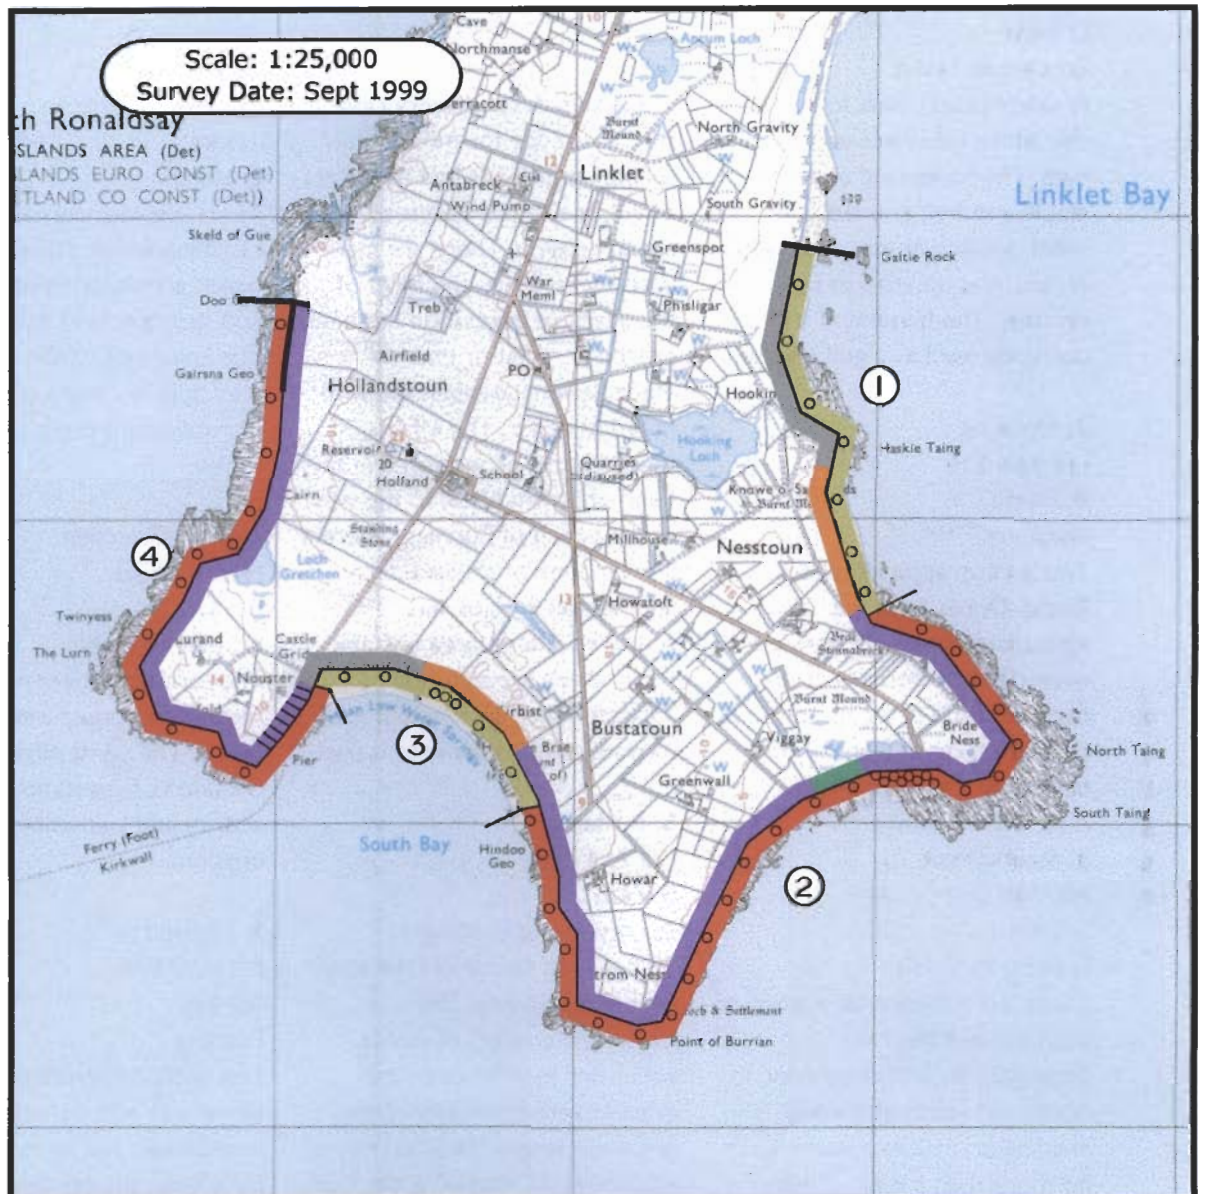
Hinterland Geology & Coastal Geomorphology

1. Galtie Rock

HY 768 532

1.3 km

Sandy foreshore

Coast edge is < 5 m

The drift/rock interface is not visible

The foreshore is sandy with a small amount of patchy cobble cover. Around Hooking/Haskie

Taing the bedrock is exposed and has some cobble cover. There is a concrete sea wall in front of Hooking farm. The hinterland is grassed, with dunes towards the southern end of the unit.

2. Stennabreck

HY 766 519

3.3 km

Rock platform, storm beach to NE

The drift/rock interface is intermittently visible

There is some cobble throw throughout this unit. A storm beach lies to the west of Brides Ness. It is large with a flat top and some vegetation. It extends c. 20 m inland. The drift/rock interface can be clearly seen around Strom Ness. The hinterland is mostly grassed and enclosed but it is marshy east of Viggay. There is a gabion wall sea defence in front of Stennabreck farm buildings.

3. South Bay

HY 755 524

1 km

This wide sandy bay has some cobble throw on the upper foreshore, especially towards the centre of the bay. The hinterland comprises dunes, which rise to c. 4 m high towards the east side of the bay.

4. Nouster

HY 748 529

2.5 km

Rock platform

Coast edge is mostly < 5 m

This unit comprises a coast edge which is well defined and has a prominent rock platform. There is some cobble cover throughout. The land around Nouster is covered in storm thrown stones. The coast edge around the eastern end of the unit has been stabilised by the pier and road, with attendant sea defences. The hinterland is grassed and fenced.

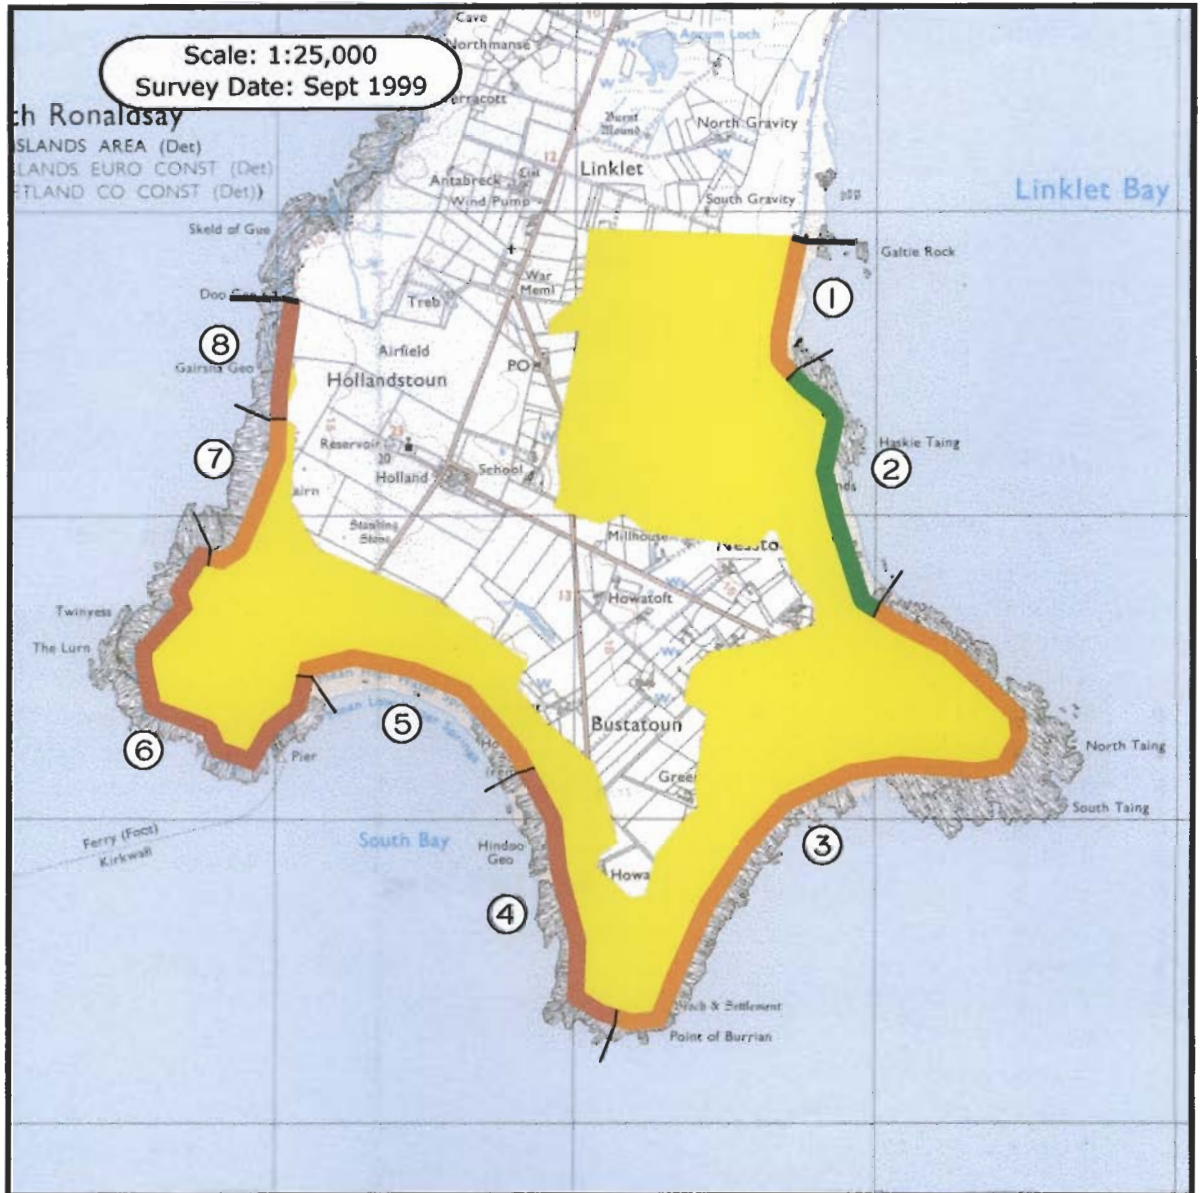
- 1. Galtie Rock**
HY 767 537
0.5 km
Eroding to Stable
A sandy beach leads to a small cliff which measures up to 1.5m high. The hinterland appears stable and well grassed. The small cliff face at the coast edge is clean and appears to be eroding. The hinterland is currently used as a golf course.

- 2. Hooking**
HY 768 529
0.9 km
Stable
This section appears mostly stable. Dunes lie in the hinterland, which are grassed over. There is some erosion at the north end of a concrete sea wall which lies in front of the farm buildings at Hooking.

- 3. Stennabreck**
HY 768 521
2.5 km
Eroding to Stable
There is a gabion wall in front of the farm buildings at Stennabreck. The coast edge to north and south of the wall is eroding in small exposures each no more than a total of 10m long. Elsewhere, the coast edge is mostly stable, with vegetation growing on top of storm beaches, but there is some damage which appears to be caused by sheep. Between South Taing and the Point of Burrian the red till has been exposed in several areas, especially towards the Point of Burrian where the sheep dyke has concentrated sheep activity within a smaller area.

- 4. Strom Ness**
HY 759 517
1 km
Eroding
The sheep dyke lies very close to the coast edge for most of this section, which has had the effect of worsening the effects of sheep erosion. There are many bare sheep trails, and most of the available vegetation has been grazed very flat or entirely eaten, leaving areas of soil with no good cover. The effects of this are most pronounced at the head of Strom Ness, to the west of the broch of Burrian, where a combination of sheep activity and aeolian erosion has rendered a large area unstable. Here, there are signs that adjacent fence lines have been moved inland in the recent past.

- 5. Bustatoun**
HY 754 524
0.9 km
Accreting and Eroding
This section comprises the inner part of South Bay. The hinterland consists of dunes, which are mostly stable and grass covered however there are areas where the grass cover has been lost, exposing the sand below. This may have been caused by apparent rabbit infestation. The land closer to the shore is eroding badly. Here, on the seaward side of the dyke which encircles the island sheep damage is apparent and is undoubtedly contributing to the erosion. The erosion is evident from the lengths of collapsed dyke and from the large 'lumps' or 'pillars' of sand left standing between hollows to either side. Fence lines have also been moved inland. Sand is accreting

- beyond the foreshore around collapsed dykes.
- 6. Nouster**
HY 746 523
1.4 km
Eroding
There are many areas of the coastline within this section which are denuded of vegetation and susceptible to salt spray. The coast edge around the pier area appears more stable, due to consolidation using dumped rubble.

- 7. Loch Gretchen**
HY 749 530
0.5 km
Eroding to Stable
The foreshore over much of this section comprises a storm beach. The coast edge is denuded of vegetation by sheep activity and vulnerable to erosion.

- 8. Holland**
HY 750 535
0.4 km
Eroding
This section is eroding; a new stone wall with concrete foundations has been built c. 2m back from the eroding old one. Sheep and rabbit activity is contributing to the erosion. There is little cobble cover here on the rock platform and this section is very exposed to the effects of the sea.
