## MAP 8: KILFILLAN POINT TO CRAIG LODGE

**KILFILLAN POINT TO CRAIG LODGE**

NGR: NX 20-24/51-55

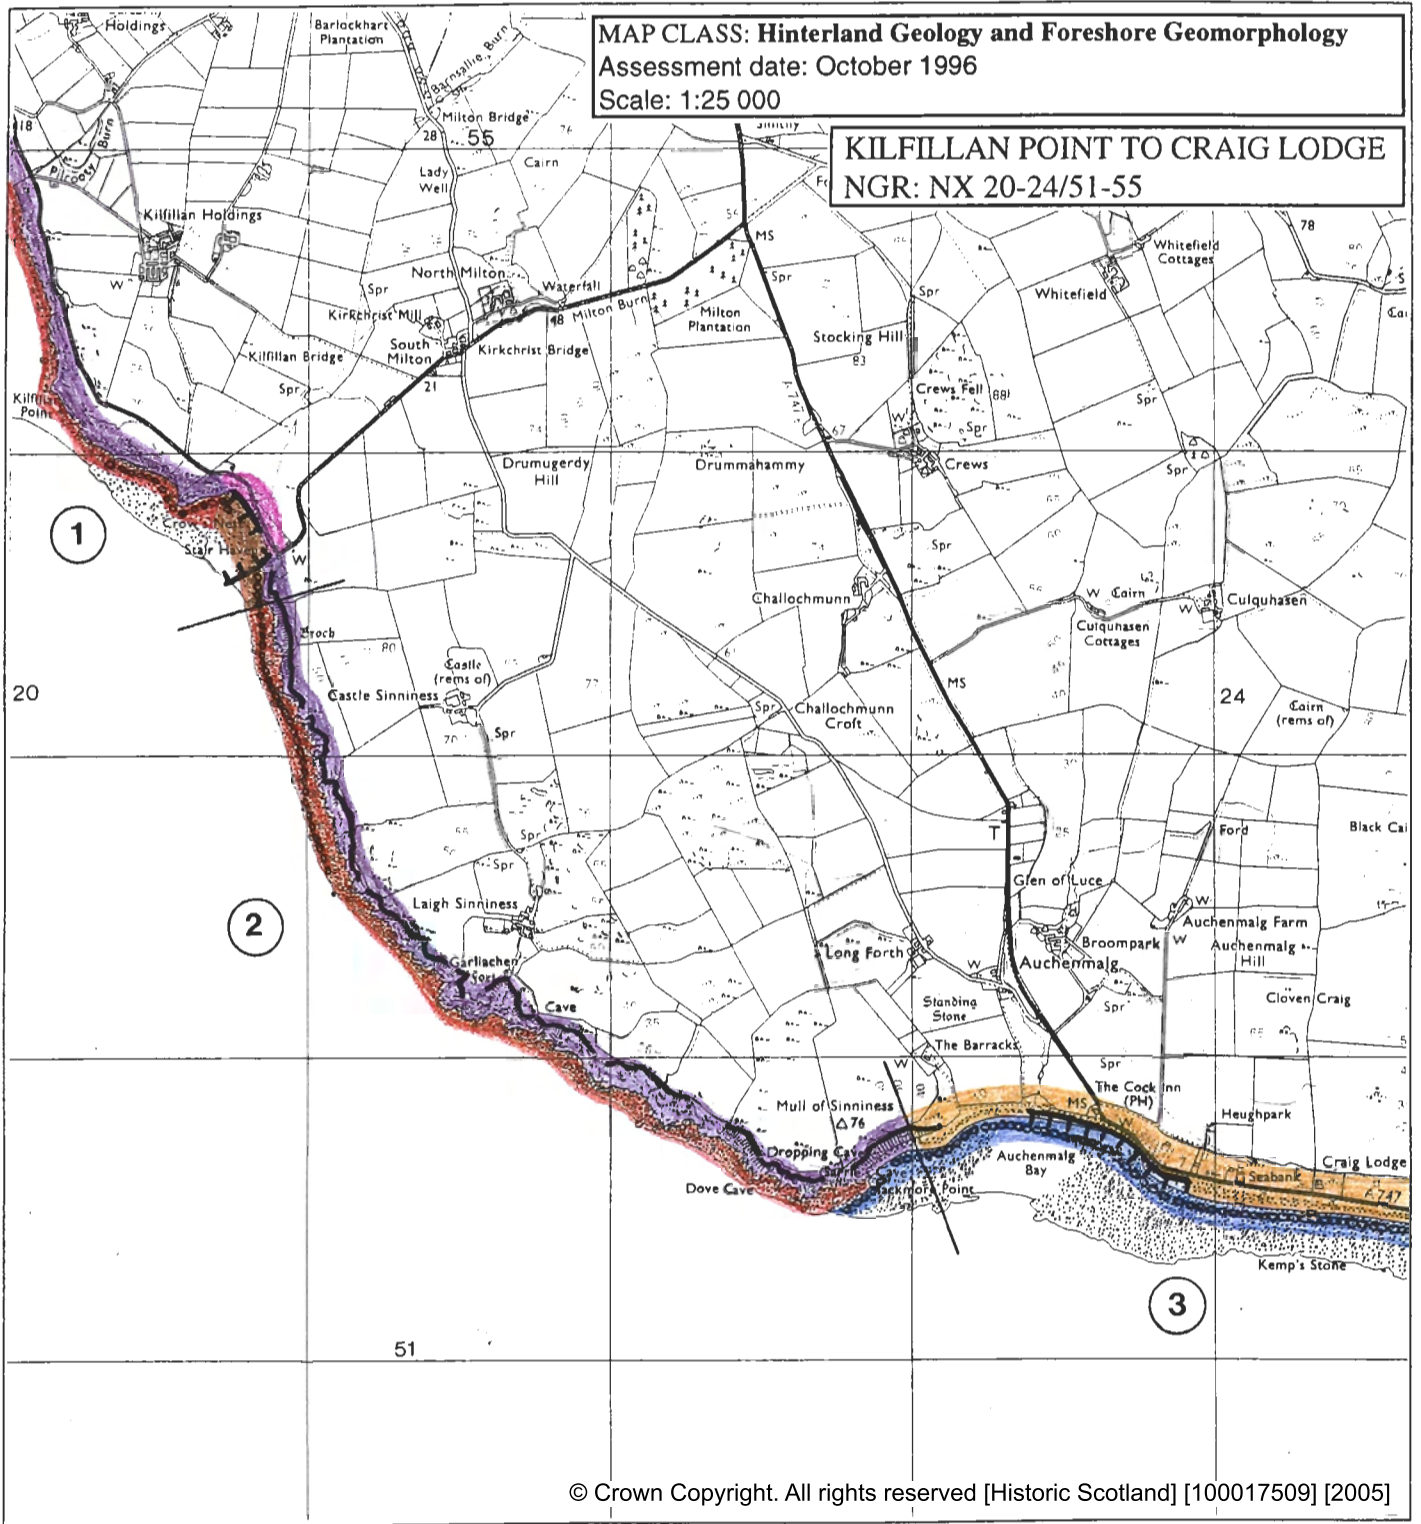
## Map 8: Hinterland Geology and Coastal Geomorphology

Broken rocky coastal edge overlain by *till* and drift deposits. Glacial sands and gravels outcrop at Stairhaven Bay. The intertidal area is wide (c.80m) and consists on boulder and shingle beds intermixed with sand bars.

The hinterland consists of precipitous greywackee cliffs with a shallow *till* cover. The foreshore is outcropping rock platform.

The exposed hinterland consists of marine sands and gravels. The foreshore is wide with an admixture of poorly sorted boulders and sandy spits.

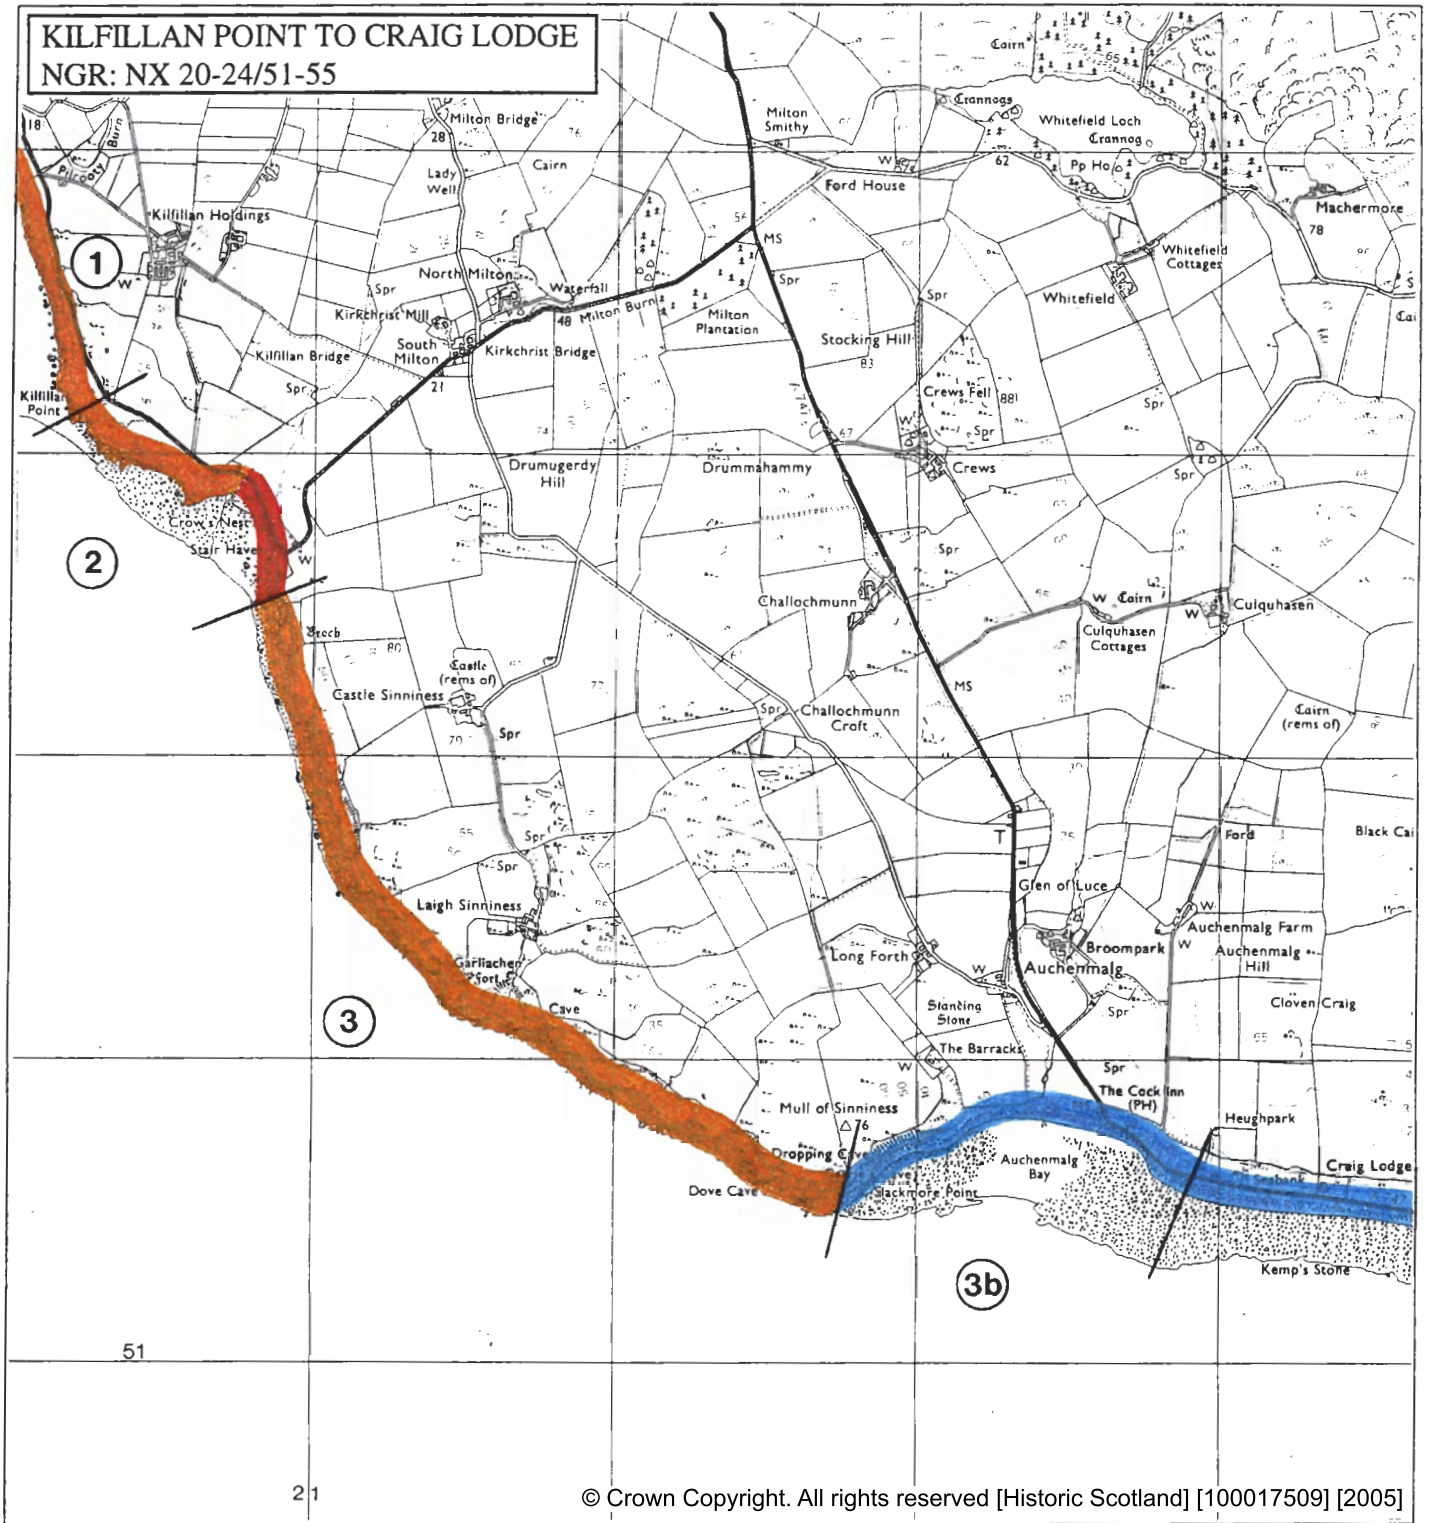
## MAP 8: EROSION

This unit has an exposed south westerly aspect and contains an indented rocky shoreline with shingle at the HWM. This region appears to be eroding only slowly.

This unit has an irregular cliff edge and an intertidal zone that is extremely wide (current SLWM is c.0.2km) consisting of boulders and sandy bars. Some sand accretion is occurring at the mouth of a small burn that enters the bay. Armour stone and Rip-Rap wall has been used with limited success as erosion is occurring either side of these works. More serious erosion is occurring to the east of a ruined pier. The 1946 vertical aerial photograph shows that the pier was extant. It has since collapsed and wave attack is accelerating erosion immediately east of the pier. Cliff edge retreat now stands in excess of 3m.

This region of coastline consist of irregular indented greywackee cliffs. Erosion is occurring along the deep gullies and especially along faults and fractures. It is difficult to estimate cliff-edge retreat but it is estimated to be slow.

This bay has a wide intertidal zone consisting of outcropping cleaved greywackee and wide areas of sand and shingle. The exposed promontory headland at Stackmore Point is precipitous and wave abraded rock fall is evident at its base.

Poorly sorted shingle is banking up at the current HWM in the centre of the bay which is defended by a concrete sea wall. The shingle is being deposited by longshore drift on a predominately easterly fetch.

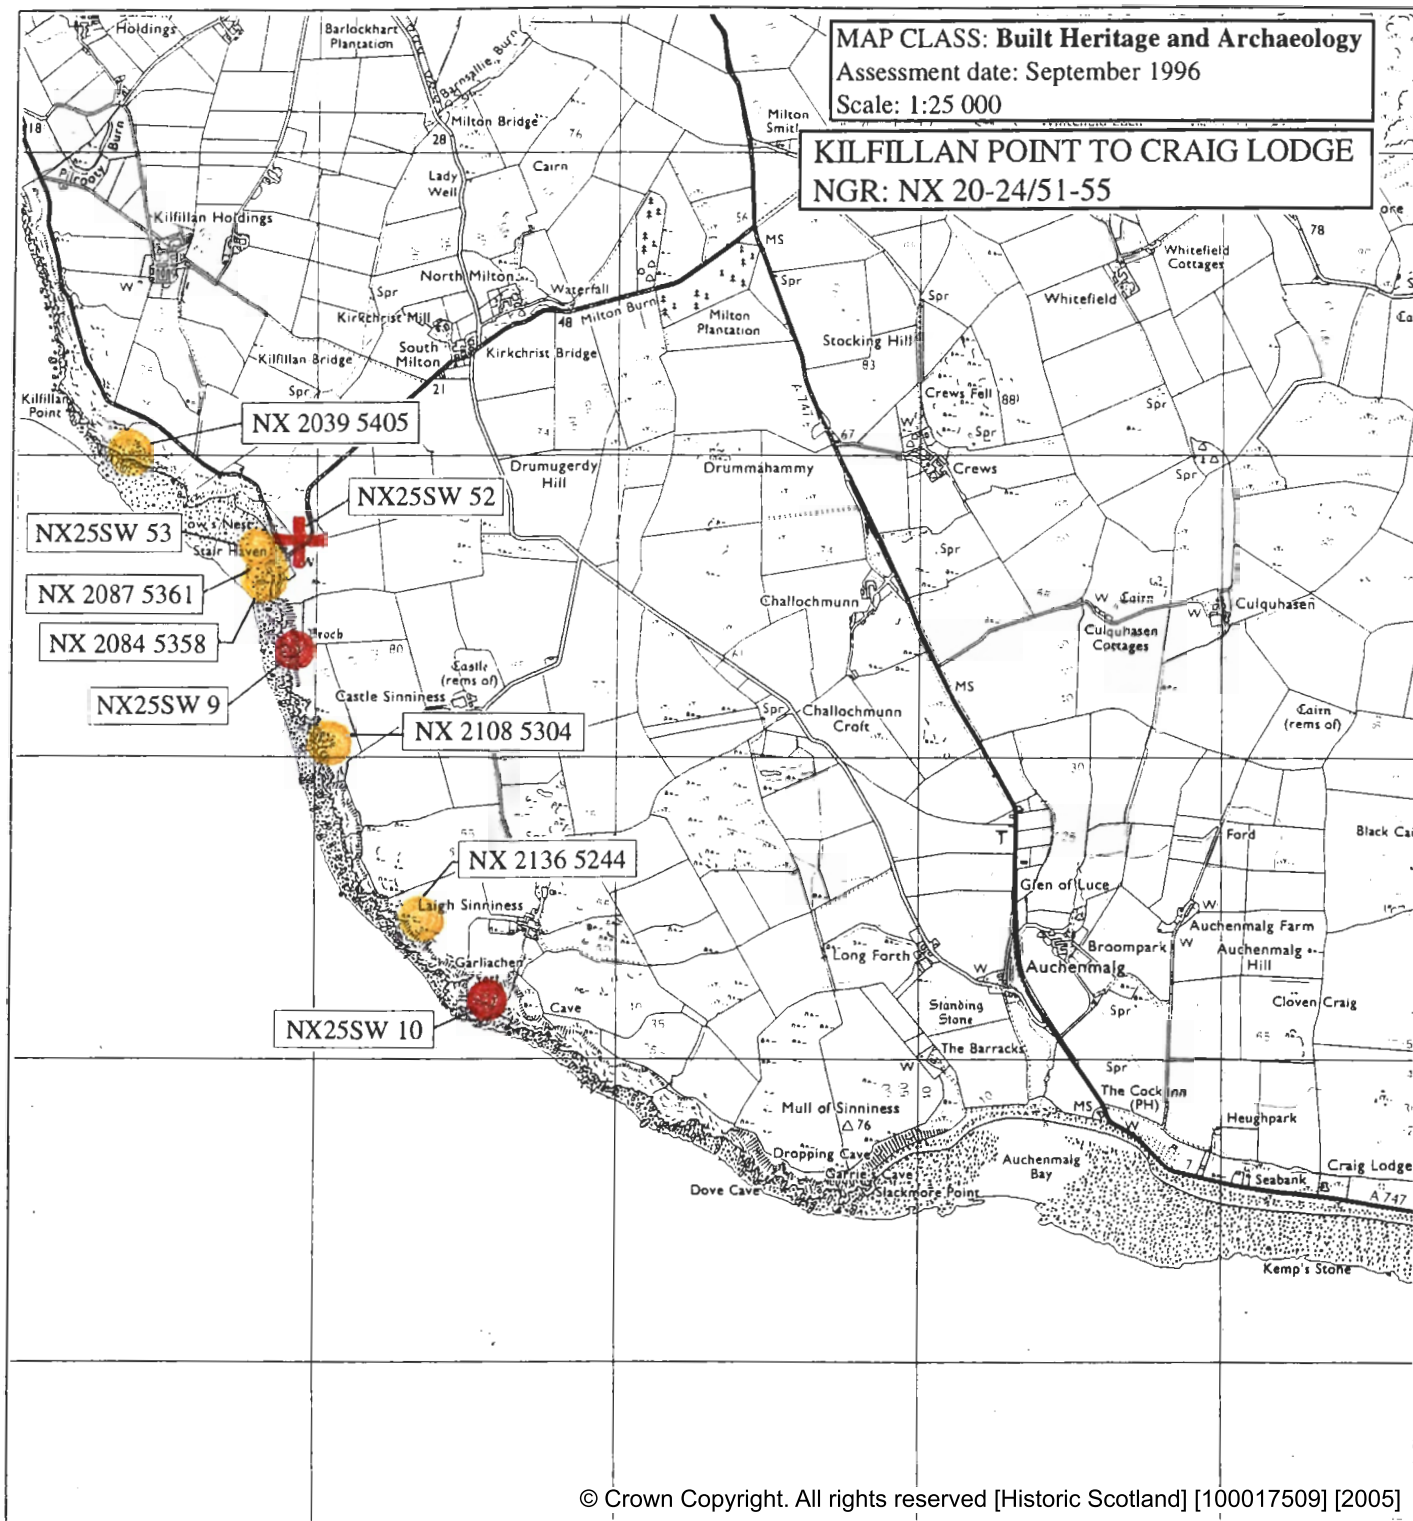
## MAP 8: BUILT HERITAGE AND ARCHAEOLOGY

**NX 2084 5358**  
STAIR HAVEN BAY  
Possible Wooden Pier/Fish Rack  
Uncertain  
Poor  
Survey & Monitor

**NX25SW 53**  
NX 2083 5365  
STAIR HAVEN BAY  
Stone & Rubble Pier  
19th century  
Poor  
Survey & Monitor

**NX 2087 5361**  
STAIR HAVEN BAY  
Ruined Harbour House  
19th century  
Fair  
Survey & Monitor

**NX25SW 9**  
NX 2091 5335  
STAIR HAVEN  
Broch  
Scheduled Ancient Monument  
2nd century BC - 2nd century AD  
Fair  
Survey & Monitor

**NX25SW 10**  
NX 2157 5219  
LAIGH SINNINESS  
Promontory Fort  
Scheduled Ancient Monument  
1st Mill. BC/AD  
Fair  
Monitor
