MAPS AND GAZETTEERS: COLL

Map 1: Traigh Bhound to Rubha Bagh na Coille

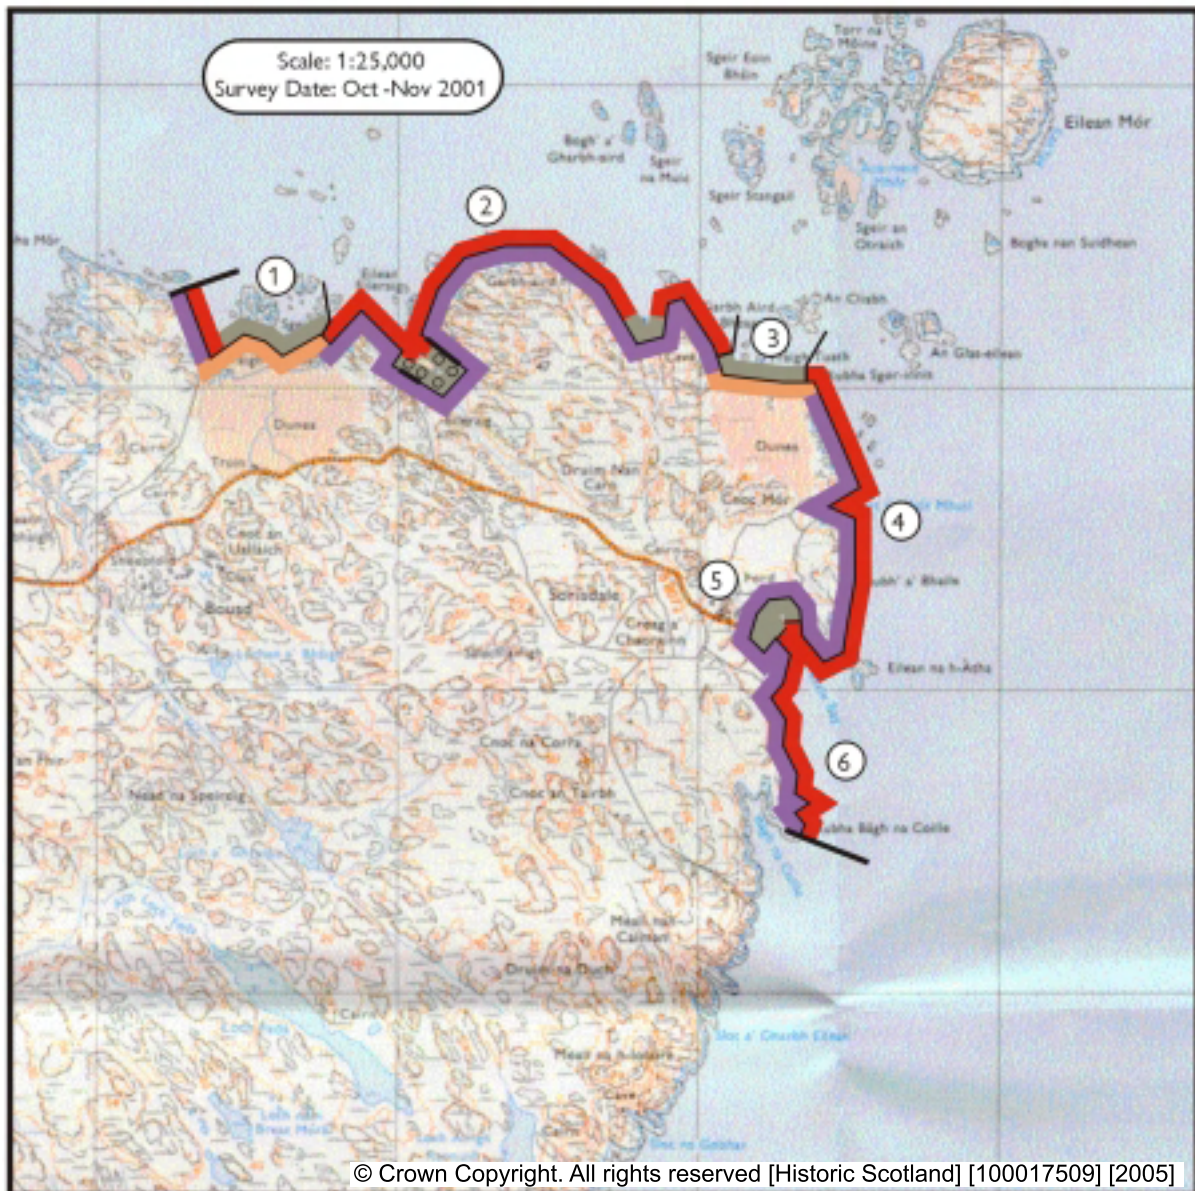
Sandy bay with extensive dune system in hinterland. This unit includes part of the rocky shoreline at the west side of the beach. Here, the foreshore is rock platform and the drift/rock interface is generally visible, hinterland is poorly drained rough grazing.

Steeply sloping, rocky shoreline. Hinterland is imperfectly drained rough pasture. There is an improvement in the quality of the land towards the western end of the unit - more grass, less heather. Currently used for sheep. This unit includes two small bays. The eastern bay is a deep narrow inlet with a deep sandy beach at its head. The western bay is a deep inlet with a sandy beach at its head. There is a storm beach above the foreshore here; it slopes gently up to a height of c. 1.5m-2m. Short stretches of coast edge to either side of the western bay are over 5m.

Sandy beach with dune system in hinterland

Steeply sloping rocky foreshore, hinterland is rough grazing. Poorly drained in places. In use for cattle grazing.

Sheltered bay with sandy foreshore. Soils in hinterland appear slightly deepened, some improved land in vicinity; some fenced areas.

Coast edge is steeply sloping rock platform.

Hinterland is extremely rough, very heathery. Poorly drained. Some blown sand visible in sheep scrapings. Iron rich seam of rock visible at end of Rubha Bagh na Collie.
