## Coll

### Map 10: Sloc na Criche to Bheinn Bheag

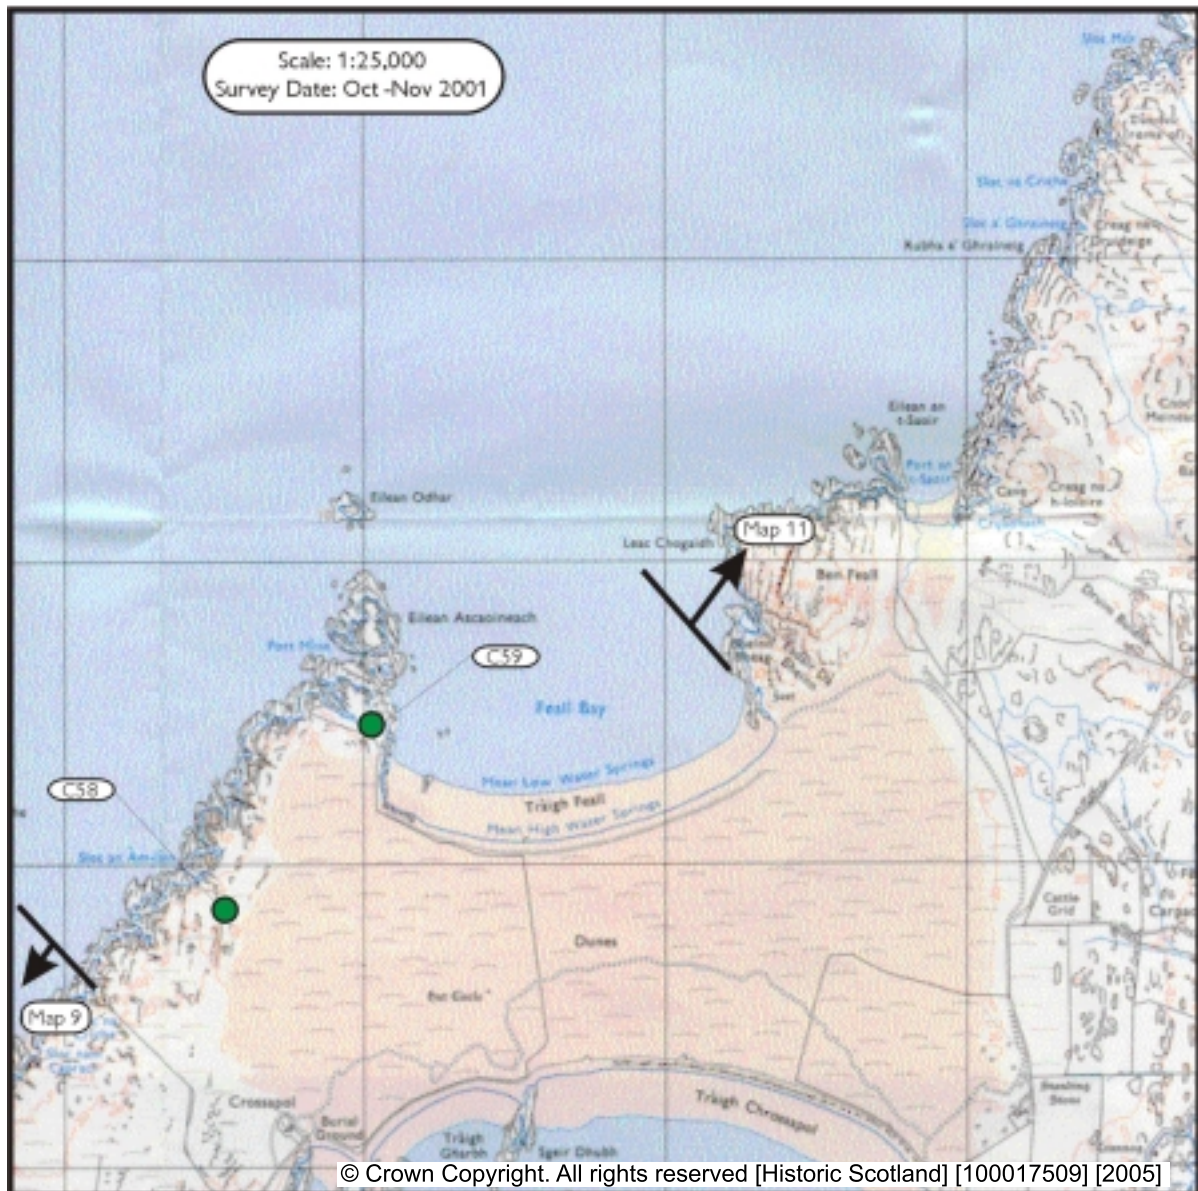
This map section extends from the low rocky coast edge to the E of Traigh Halum, along the long sandy beach of Traigh Feall to the foot of Ben Feall. There is no modern settlement within the coastal zone in this area. The first part of this section is rugged and spiked with frequent rock outcrops, although small cultivable plots are also present.

In this area, an earthen bank and several small mounds (C58), possibly grassed over clearance cairns, may indicate past episodes of cultivation. The boundary has been recorded by the OS and appears on the current map edition. It appears to mark the W limit of the dune area and may once have extended as far as Crossapol. The dunes to the centre of the area appear generally stable and are largely covered with vegetation. While there have been sites noted within this area in the past, no archaeological remains were noted within the coastal zone during this visit. It is probable that sites appear as the sand is shifted around by the wind, and that they are also covered up again by this process. For this reason, regular monitoring of the dune area is to be recommended.

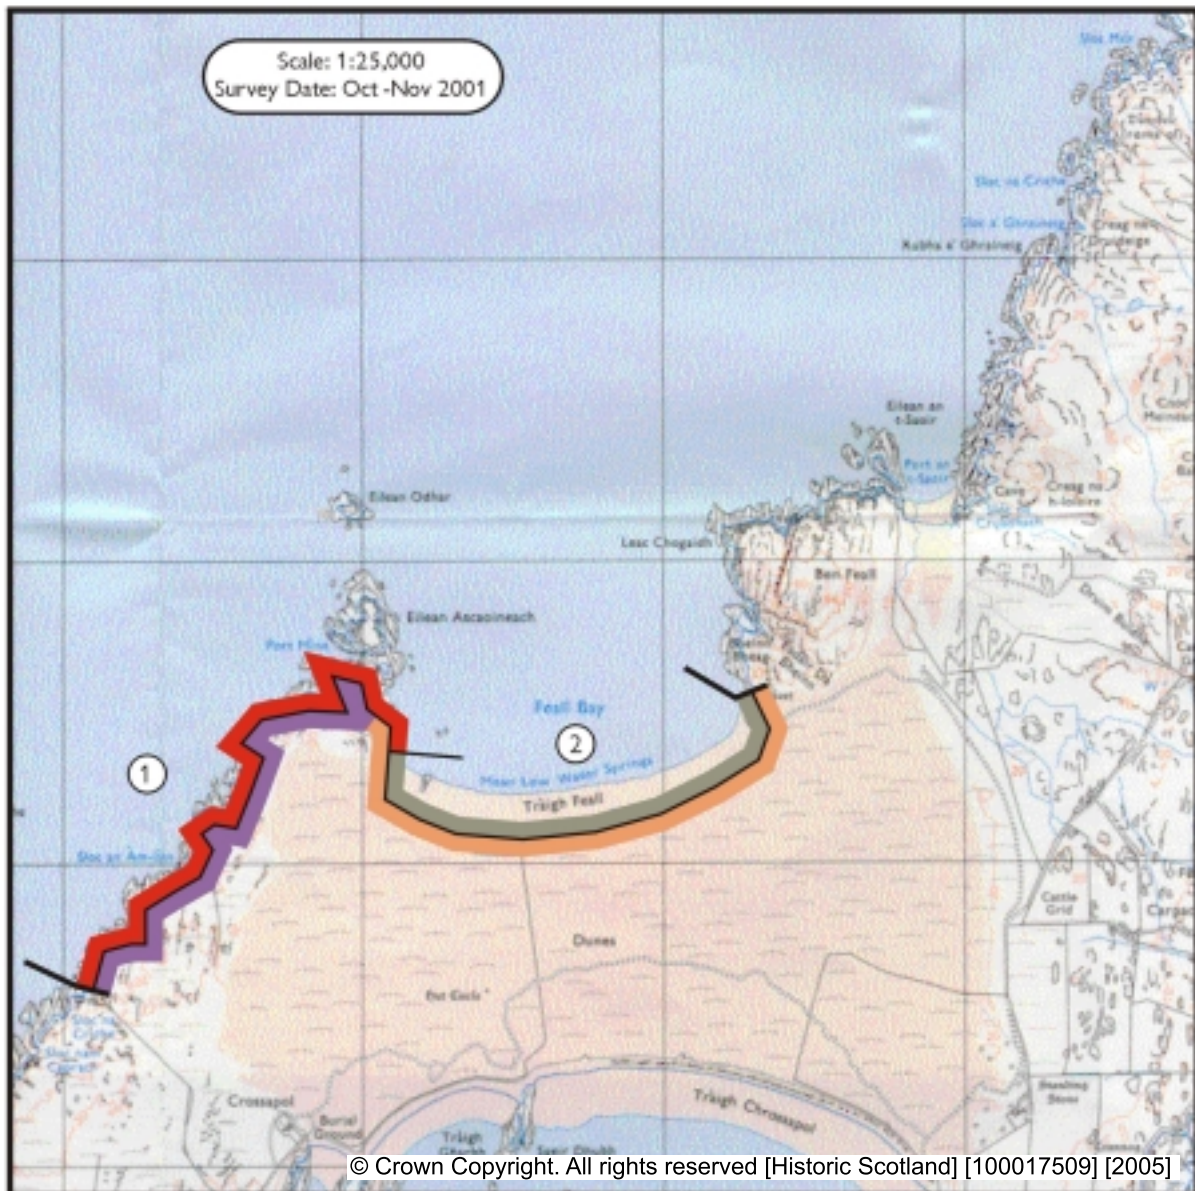
1. Sloc an Am-lain

Rock platform, some cobble cover

Coast edge <5m

Drift/rock interface occasionally visible

Rocky coast edge sloping steeply to sea. Cobble cover in small coves. The hinterland is fairly well drained rough grazing; closely cropped by sheep. The eastern half of the hinterland is dominated by an extensive dune system which does not extend all the way to the coast.

2. Traigh Feall

Sandy Foreshore

Drift/rock interface not visible

This unit is a wide sandy bay which slopes gently towards the sea. The hinterland is a massive dune system. The dunes are used as rough grazing (low stocking levels at time of visit).

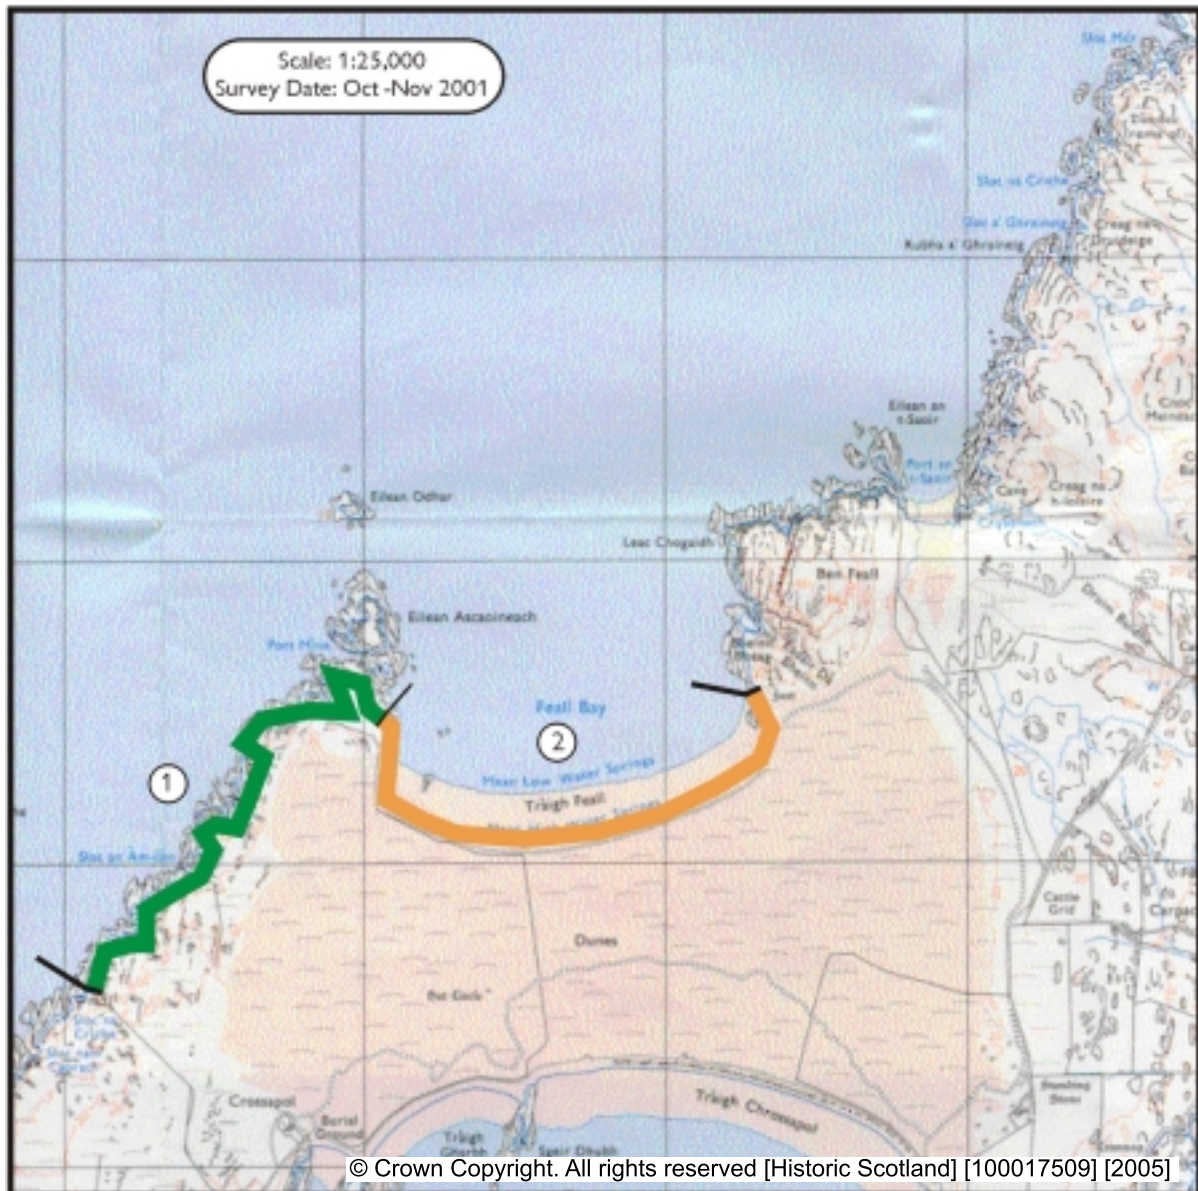
1. Port Mine

Stable

Rocky coast edge with little sign of recent erosion.

2. Feall Bay

Stable to eroding

The coast edge is formed from dunes. In general the coast edge within Feall bay appeared stable at the time of visit. Some areas appear more eroded, with slippage caused by undercutting of the coast edge by wind or sea. There is also signs of accretion within marram grass, where windblown sand is being trapped.
