Coll

Map 12: Bagh Fiaranuis to Grishipoll Bay

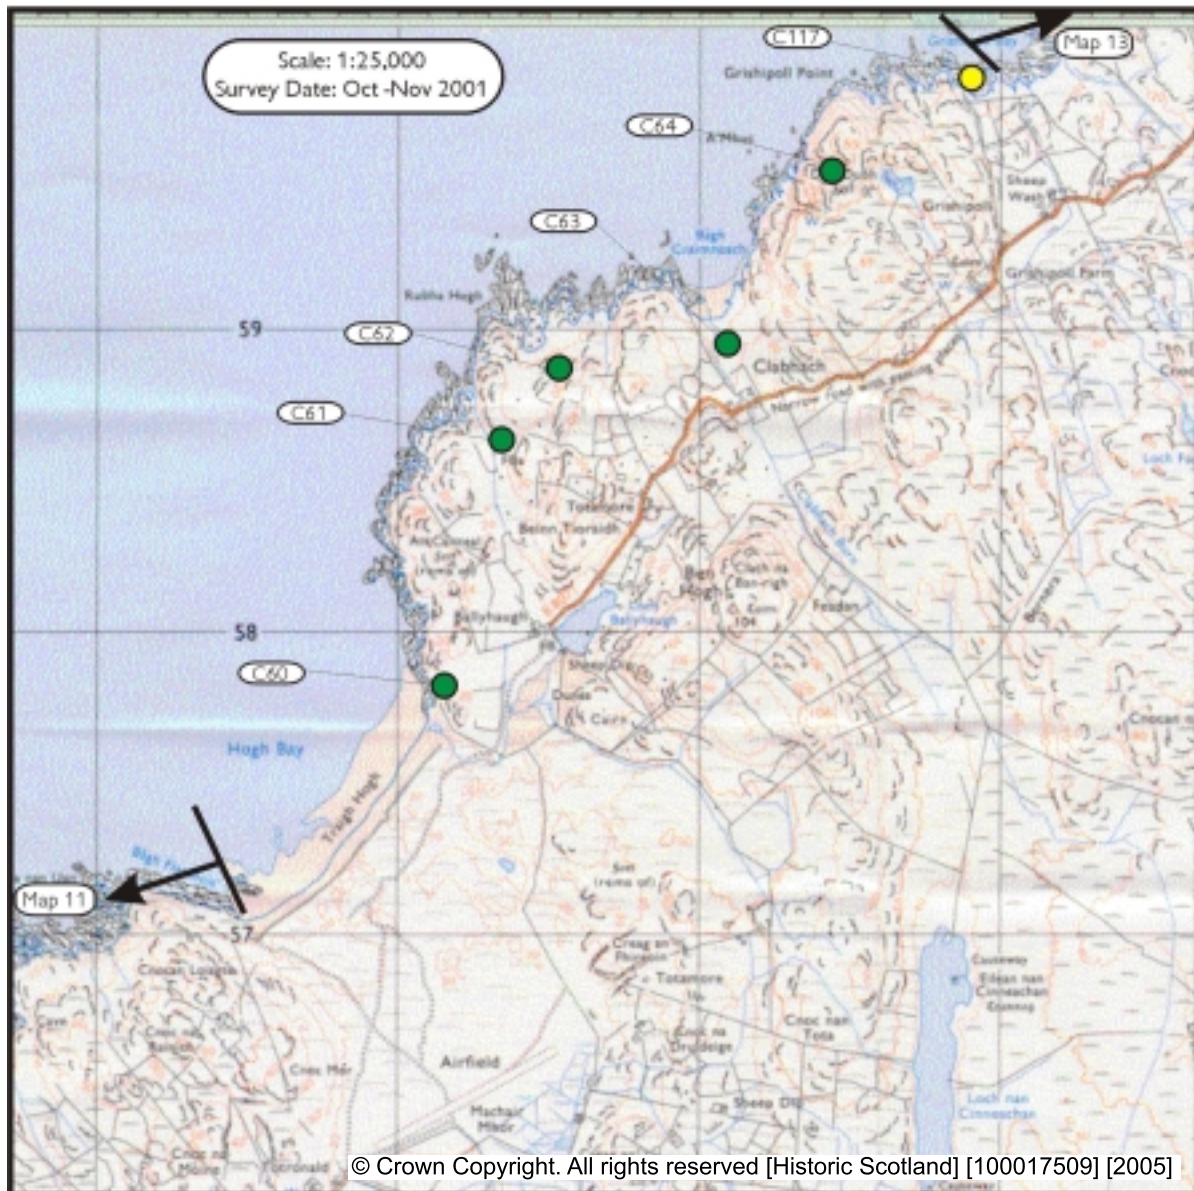
The majority of the sites identified in this area are related to 18-20th C agricultural activity. They include field and land boundaries, enclosures and old cultivated fields (C60-64). Chance finds of pottery, hammerstones and shell middens have been reported previously among the sand hills surrounding Grishipoll Bay, suggesting that this area has been the focus for activity, if not settlement, in the prehistoric period. No sign of any archaeological remains were visible during this visit, however.

C60 NM 17188 57828 Traigh Hogh (N of) Earthen boundary banks and cultivations 18-20th C Fair Survey	C63 NM 18077 58981 Clabach (NW of) Land boundaries, enclosures and cultivations 18-20th C Fair Survey
C61 NM 17383 58657 Ballyhaugh (W of) Boundary walls 18-20th C Fair Survey	C64 NM 18496 59524 Grishipoll (NW of) Land boundary and structure 18-20th C Fair Nil
C62 NM 17534 58833 Totamore (NW of) Enclosure 18-20th Fair Nil	C117 (NM15NE22) NM 188 599 Grishipoll Bay Possible settlement site: midden deposits 3rd-1st mill BC Fair Monitor

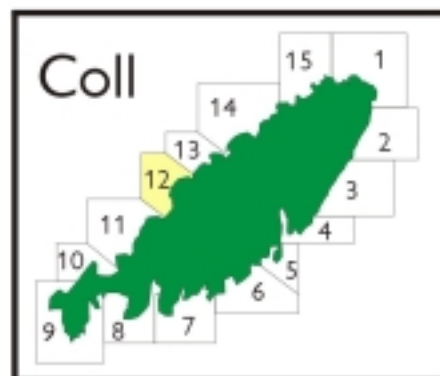
1. Traigh Hagh

NM 168 573

1.2 Km

Sandy foreshore

Coast edge <5m

Drift/rock interface not visible

A long sandy beach sloping gently towards the sea. Hinterland is an extensive dune system.

2. Rubha Hagh

NM 180 590

5.0 Km

Rock platform, occasional cobble cover

Drift/rock interface occasionally visible.

A rocky coastline sloping steeply towards the sea. There is limited cobble cover in coves. The hinterland is rough grazing; sheep stocking levels are relatively high and the grass is well cropped.

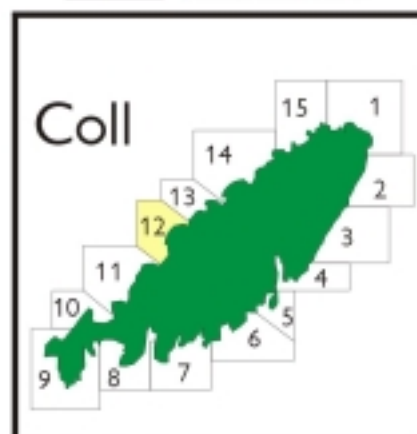
Erosion Class

1. Traigh Hogh

NM 168 573

1.2 Km

Definitely eroding

This long sandy beach is perhaps the least stable area of coast edge seen on Coll during the visit. The coast edge dunes are poorly covered by marram grass and eroding. The coast edge dune faces are near vertical and appear unstable.

2. Rubha Hogh

NM 180 590

5.0 Km

Stable

A rocky coast edge with no sign of recent erosion. The unit included one short stretch of sandy beach which is less stable.
