Coll

Map 13: Grishipoll Bay to Gallanach

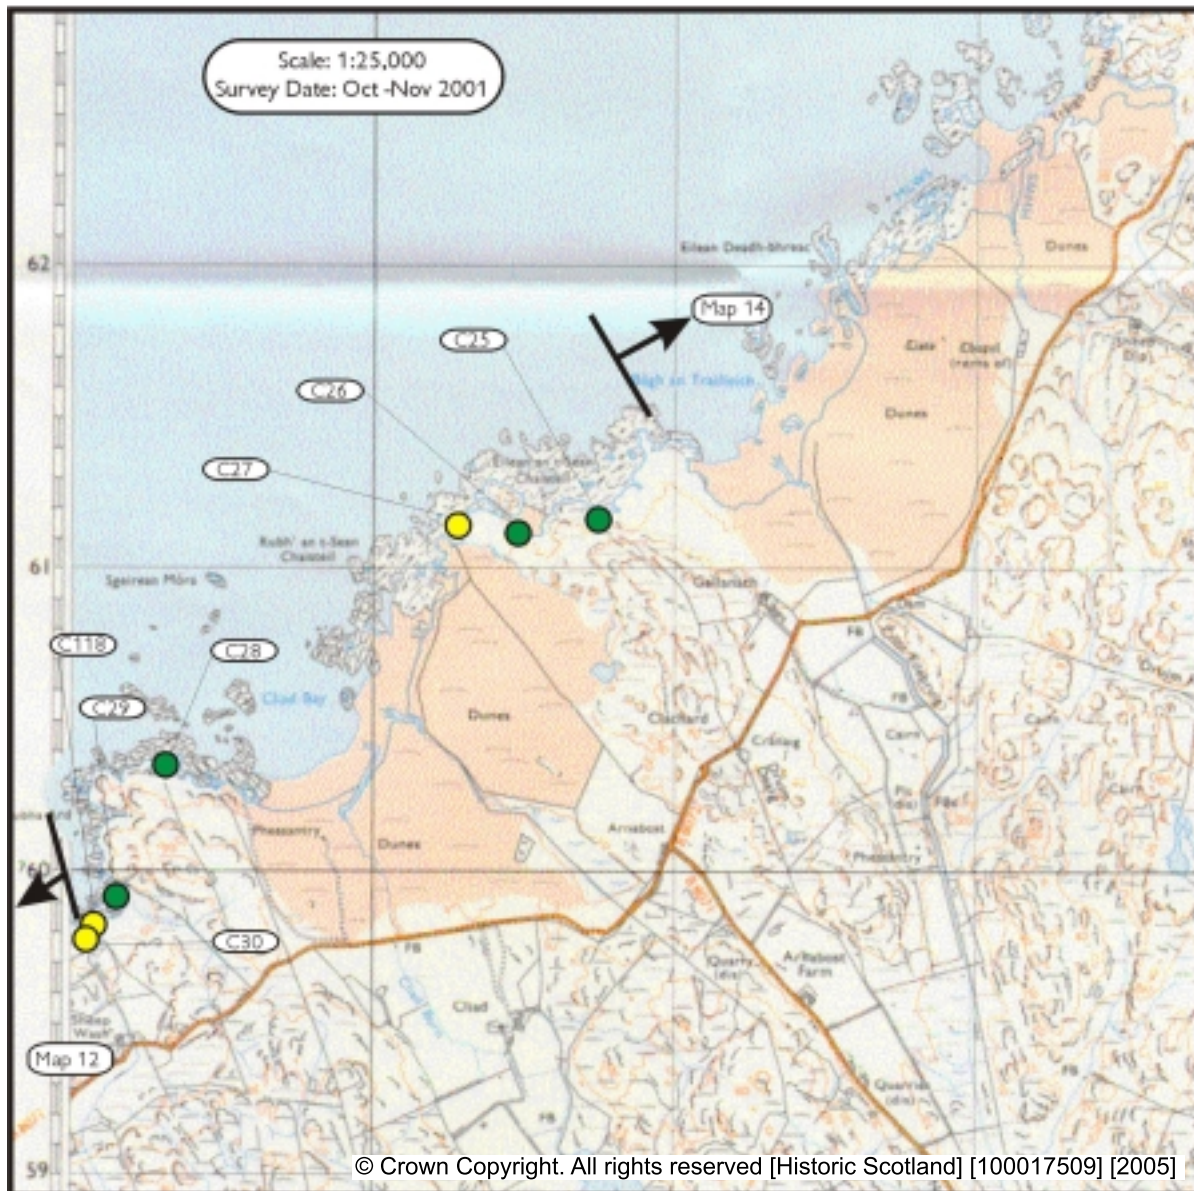
Beginning at Grishipoll, on rocky but relatively level and fertile land, this map section extends across the dune area at the head of Cliad Bay and into the rocky landscape which forms the coastline to the NW of Gallanach. There is no modern settlement within the coastal zone in this area. The dunes are mostly grass-covered and appear to be relatively stable. Much of the immediate hinterland is fertile and cultivable.

To the centre of this section, the coast edge around Cliad Bay is formed from low lying soft sediments and is eroding. The area is backed by dunes which are covered with vegetation and appear stable, however. To the east and west of this area the extremities of the Bay have a coastal edge of rock platform which is stable.

The ruins of Grishipoll House (C30), a laird's dwelling, are situated towards the start of this section. While the buildings presently standing were built in the mid 18th C, it is said that the site has been occupied since the late middle ages. It is enclosed by a walled garden and surrounded by numerous remnants of a former field system. Human remains, accompanied by a spear head, were discovered in this area in the 1950's and may indicate a burial of Viking date (C118). Of possible earlier date, the remains of a curvilinear structure were identified close to the coast to the N of Grishipoll House (C29). This may be a prehistoric hut circle. A second possible hut circle was noted at Rubh'an t-Sean Chaisteil (C27). Here, a rocky knoll is alleged to be the site of a dun, although no trace of any remains could be found. On low lying land, at the base of the knoll traces of an earthwork appear to define a curvilinear structure, however. This may be the remains of a house of 3rd-1st millenium date.

C25 NM 20748 61148 Gallanach (NW of) Track 18-20th C Fair Nil	C29 NM 19218 59873 Grishipoll Possible hut circle 3rd-1st mill BC Fair Survey
C26 NM 20554 61055 Gallanach (NW of) Enclosure 18-20th C Fair Nil	C30 (NM15NE16) NM 1903 5973 Grishipoll House House, garden and cultivated land 18-20th C Poor Monitor
C27 (NM26SW5) NM 20401 61141 Rubh'an t-Sean Chaisteil Alleged site of Dun, possible hut circle 3rd-1st mill BC Fair Monitor	C118 (NM15NE28) NM 191 598 Grishipoll Burial with grave goods 1st mill BC- 1st mill AD Fair Monitor
C28 NM 19371 60262 Grishipoll (N of) Structural remains and cultivations 18-20th C Fair Nil

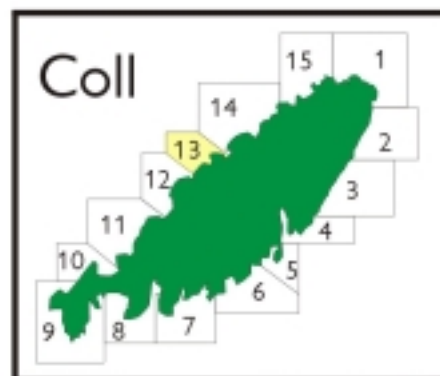
1. Rubha Ard
NM 192 603

Rock platform, occasional cobble cover

Coast edge <5m

Drift/rock interface occasionally visible.

A rocky coastline sloping steeply towards the sea. There is limited cobble cover in coves, and a storm beach at the eastern end of Grishipoll Bay. The hinterland is unfenced rough grazing. The hinterland in the area of Grishipoll Bay appears to have been improved in the past but is now poorly drained rough grazing.

2. Cliad Bay

Sandy foreshore

Drift/rock interface not visible

A wide, mostly sandy bay also containing some rock towards the eastern part of the unit. The hinterland is an extensive dune system.

3. Gallanach

Rock platform

Drift/rock interface occasionally visible

The coast edge is rocky and slopes steeply towards the sea. The hinterland is rough grazing. Where visible in sheep/rabbit scrapes, the soils appear sandy and well drained however there are also frequent poorly drained marshy areas.

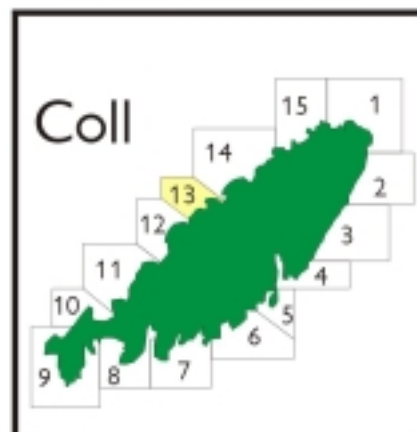
1. Rubha Ard
NM 192 603

Stable

A rocky coast edge with no sign of recent erosion.

3. Eilean an t-sean Chaisteil
NM 206 612

2. Cliad Bay
NM 200 604

This unit encompasses Cliad Bay. Some areas of coast edge here appear to be accreting due to deposition of windblown sand. Others are eroding, particularly the central part, where fence lines are hanging in mid air.
