COLL

Map 2: Rubha Bagh na Coille to Port Trealabhaig

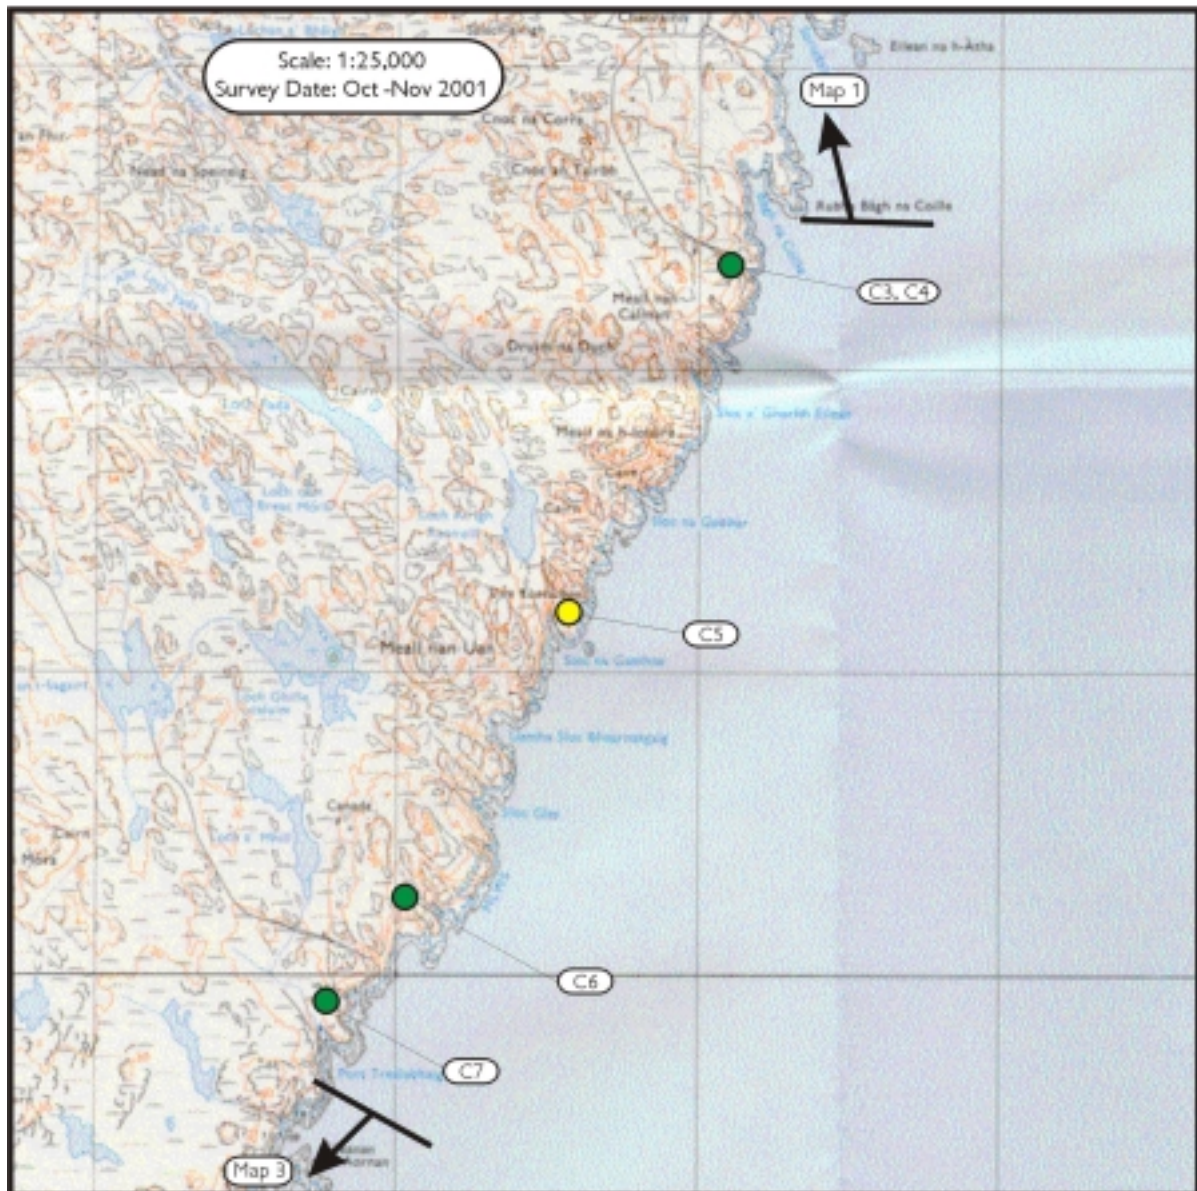
This map section extends along the high, rugged north east coast of Coll. There is no modern settlement in this area and access along the coastline is difficult and frequently impeded by steep-sided fissures, narrow valleys and rock outcrops. The area is very overgrown due to the low numbers of sheep stocked on the land and a low rabbit population. The coast edge in this area is formed from a steeply sloping rock platform and is currently stable.

The small number of sites which could be identified in this area most probably reflects the unsuitability of this area for settlement but it is possible that even where archaeological remains exist, these are not readily visible due to the nature of the terrain. An abandoned settlement at Port Trealabhaig (C7) appears to be of 18-20th C date. It appears to represent the remains of a single farmstead, with associated outbuildings and nearby cultivated fields. A cave at Bagh na Coille (C4) appears to be a contender for use as a shelter in the past, although no evidence of human activity was apparent from the surface remains. Dun Dolorichan (C5), alleged to be the site of a fort, is situated on a prominence which commands good views in all directions. The remains here are not well preserved and it is impossible now to reconstruct the original plan of the structure. It is apparent, however, that the knoll was bounded by several walls which are likely to have acted as defences. It is possible that further remains survive beneath the heather.

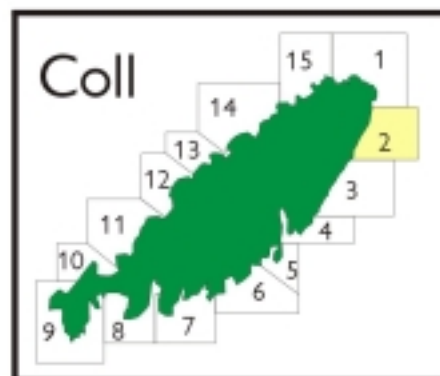
1. Meall nan Uan

Rock platform

Coast edge <5m

Drift/rock interface not generally visible

Coast edge is steeply sloping rock platform.

There is some cobble cover in the small coves which occur along the coast edge. Hinterland is extremely rough and poorly drained. No signs of animal grazing at time of visit.

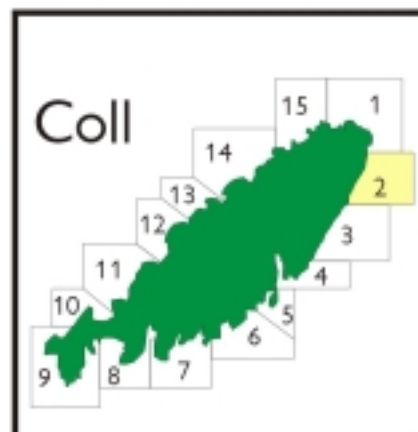
1. Meall nan Uan

Stable

A rocky coast edge with no signs of recent erosion.
