## Tiree

## Map 13: Sgeir Fada to Rubha Saltaig

Tiree Map 13

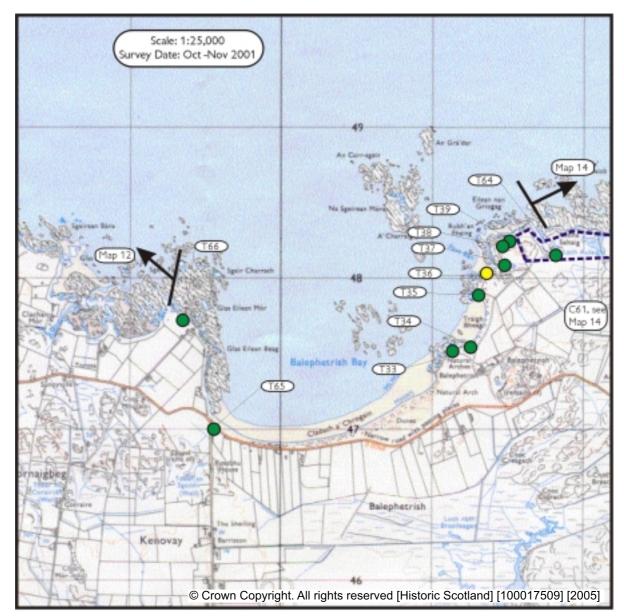
The majority of the sites noted in this section are thought to be of 18-20th C date. There are several kelp drying walls in evidence around the coast (T33, 66) and kelp kilns also (T35, 38). Ruinous old land and field boundaries are also common (T34, 37, 39), while an abandoned house (T65) stands close to the junction of the Kennovay/Balephetrish roads. Only two sites of probable earlier date were noted within the coastal zone. At An Dun (T36) to the NW of Balephetrish, fragmentary remains of a curvilinear structure are located on the summit of a crag, surrounded by the sea. The building measures some 10m in diameter and has stone walls which incorporate outcrops of bedrock. Parts of both the inner and outer wall face survive. The site appears to be a defended settlement probably of later 1st millennium date. A cairn (T64) at Loch Aulaig may be a prehistoric burial monument or, alternatively, could be a clearance pile of later date.

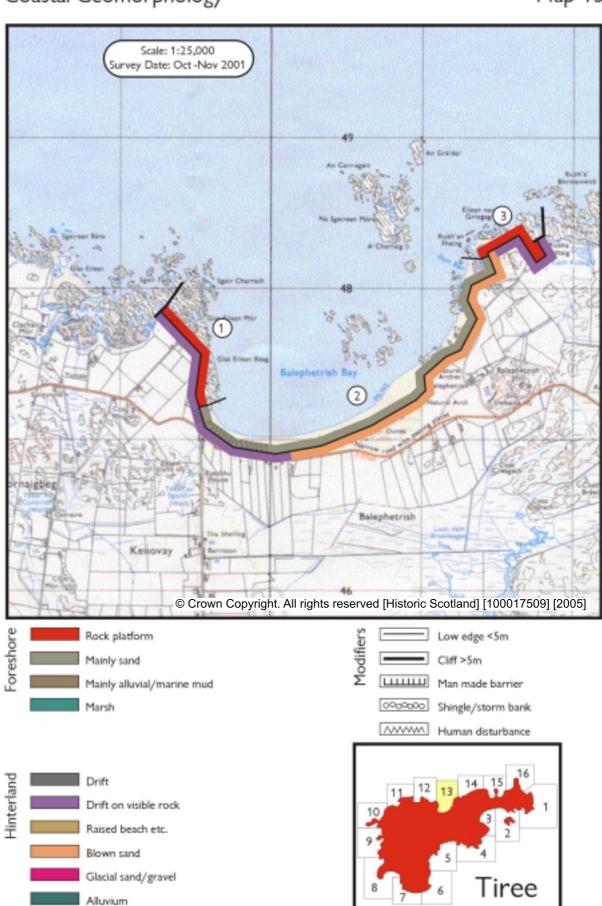
1. Sgeir Charrach NL 995 475 0.9 Km Rock platform Coast edge <5m

Drift/rock interface generally visible Rocky shore with shingle/shell/sand cover inbetween rocks and on upper foreshore. There is a very small area of rubble, c 20m long dumped in front of the coast edge at te start of the unit. The hinterland is good fenced pasture.

2. Balephetrish Bay NM 007 471 3.3 Km Sandy foreshore Coast edge <5m

Drift/rock interface not visible

A wide sandy bay. The hinterland is dunes over most of the unit, these become more extensive towards the eastern end of the bay. The dunes lie between the road and the coast edge; further inland there is good fenced pasture. At the western end of the bay the hinterland is good fenced pasture. There is a sea wall at the extreme west end of the unit, where the road passes adjacent to the coast edge. There has been much dumping of building rubble over a >200m stretch of coast edge at the western end of the unit where the road nears the coast, presumably in an attempt to protect the road from erosion. Further to the east of the rubble, erosion has revealed an old stony beach in a 200m long exposure. A gabion wall is eroding from dunes at NM 00482 46960.

3. Eilean nan Griogag
NM 016 483
0.8 Km
Rock platform
Coast edge <5m
Drift/rock interface visible
Rocky shoreline punctuated by small sandy
coves generally <100m long. Hinterland is very
poorly drained in many places. Rough grazing.

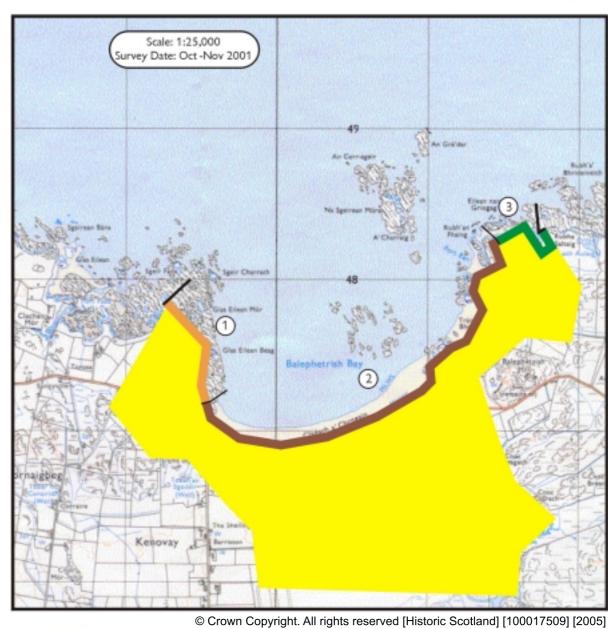
Erosion Class Tiree Map 13

1. Aird Mor NL 995 475 0.9 Km

Eroding to stable

The coast edge within this unit is generally rocky and stable but there is some limited erosion of soils above the coast edge.

3. Eilean nan Griogag NM 016 483 0.8 Km Stable

Rocky coast edge with little sign of recent erosion.

2. Balephetrish Bay

Definitely eroding

This long sandy bay is actively eroding. Many blowouts are visible in the hinterland. There is evidence of attempts to halt the erosion. Gabion cages are eroding from a dune face at NM 00482 46960. There has been much dumping of rubble over a >200m stretch towards the western end of the bay, apparently in an attempt to armour the coastline where the road comes near.
