# Tiree

## Map 3: Gott Bay to Scarinish

Tiree  
Map 3

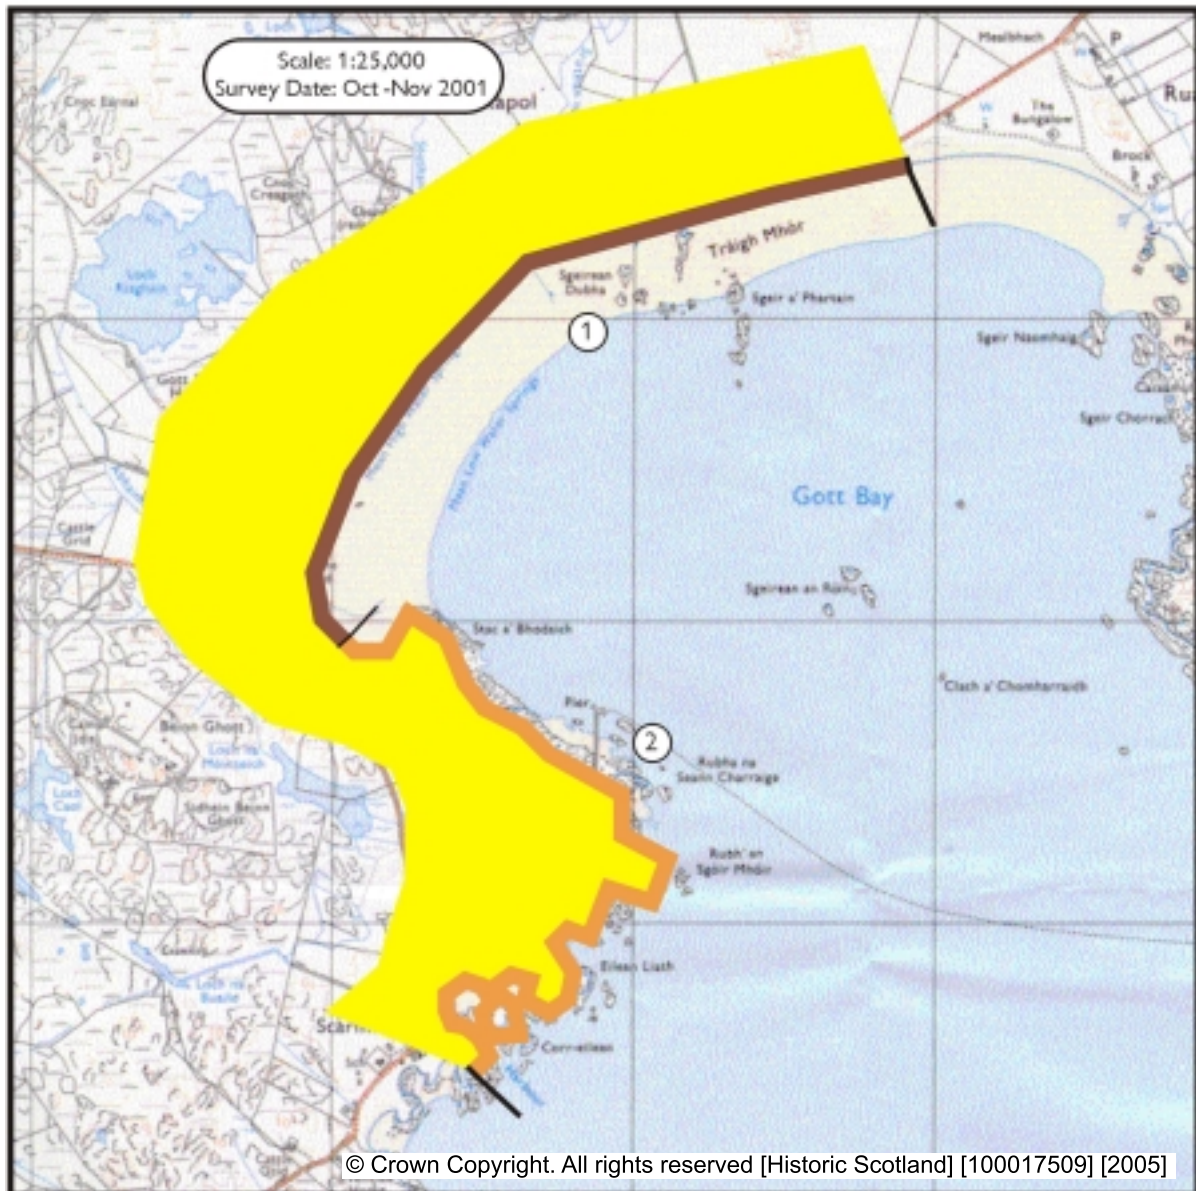
1. Gott Bay  
NM 045 471  
3.0 Km  
Definitely eroding  
Gott Bay appears for the most part to be stable, however fence lines have been moved back c. 5m in the recent past, implying problems with retreating shorelines. There are some blowouts in the dunes at the western end of the bay. There is active, localised, erosion of the dunes in front of the hotel, and in the area of Silversands for some 300m.

2. Scarinish  
NM 050 451  
4.7 Km  
Eroding to Stable  
The coast edge in this unit is generally low lying but rocky and is stable. There is sand in coves and some erosion of coast edge above the rock platform, particularly at the start of the unit and further south towards Scarinish. Dumping along the coast edge (see Geology/Geomorphology) in some areas appears to have been designed to protect the coast edge from erosion in these areas.
