Tiree

Map 4: Scarinish to An t-Ard

Tiree
Map 4

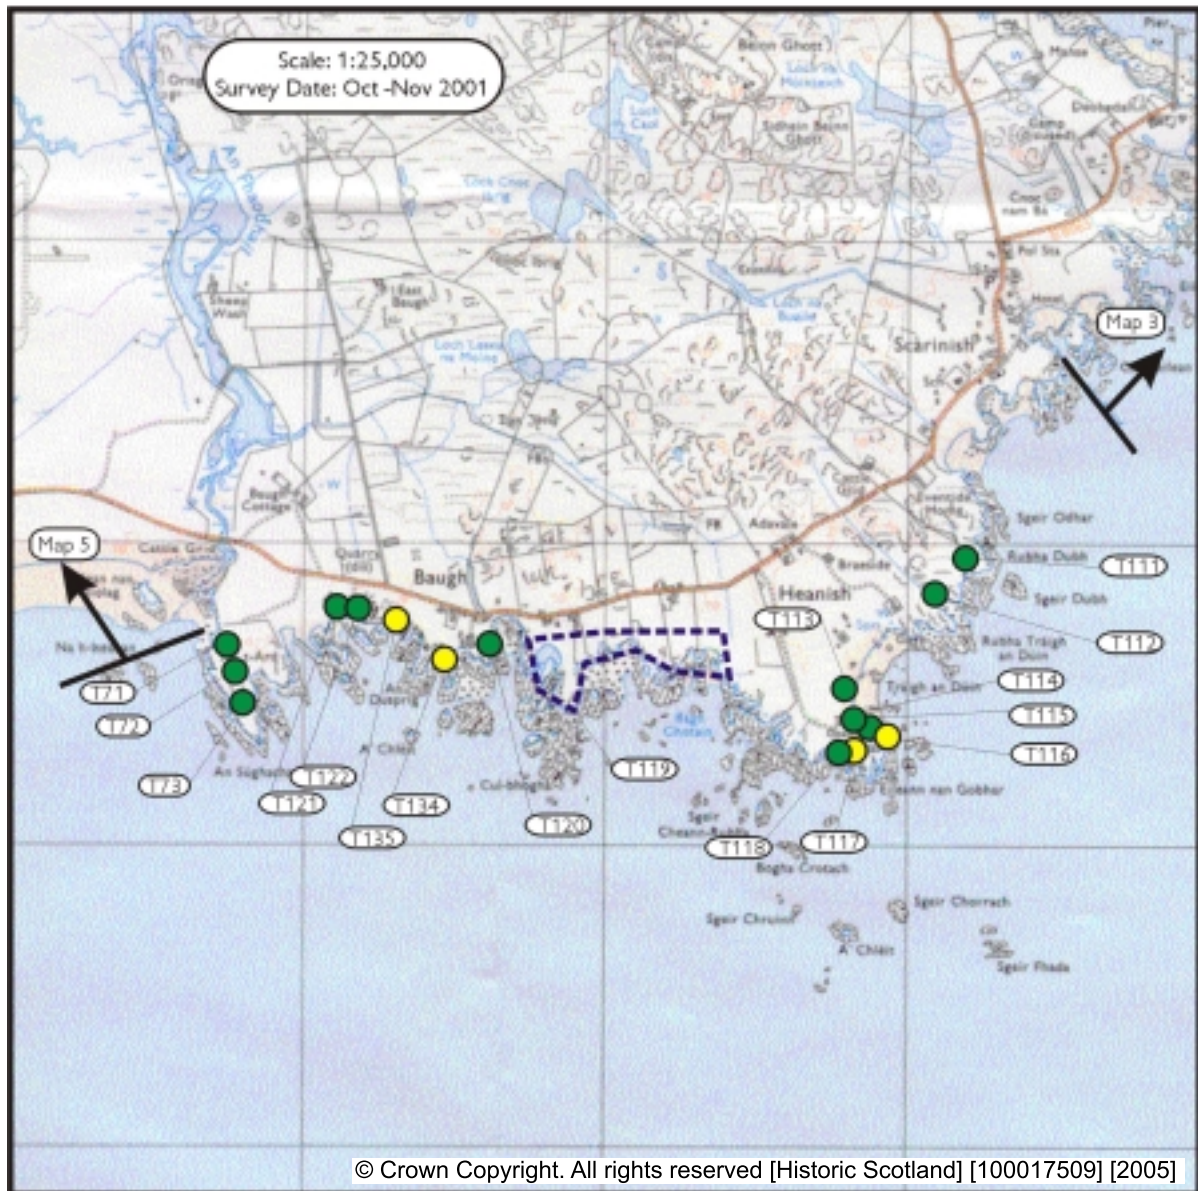
This map section extends along the south eastern coast of the island, from Scarinish, past Heanish to Baugh. The modern B8065 road runs behind the coast edge throughout this section and modern settlement is dispersed along both sides of it. The coastline in this area is rocky and uneven but generally low-lying with a fertile hinterland. There are a number of small promontories and headlands, between which there are to be found both cobble and sandy beaches. The south facing part of the coast is notably more rugged, with rock outcrops more frequent and sandy beaches fewer in number than to the east.

The coast edge within this section is generally formed from low lying rock platform. At Scarinish, Hynish and Baugh there are areas where the coast edge is formed from soft sediment. The coast appears relatively stable, although some localised areas of erosion were noted. At Baugh the presence of salt marsh suggests that this area is being inundated and gradual erosion is occurring.

The majority of sites noted in this area have been ascribed an 18-20th C date and include field and land boundaries (T71, 72, 111, 114, 118, 119). Amongst these, there are occasional traces of associated abandoned settlements, such as to the E of Hynish Bay where a possible house platform was identified (T72). Evidence of kelp working also abound in this area; traces of old kelp walls and kilns were identified in numerous locations along the coast (T71, 112, 113, 115, 119). A possible fish trap was noted lying in the intertidal zone between Dun Heanish and Eilean na Gobhar and rock cut basins have been recorded here and along the coast in several locations (T116, 134). Few surface traces remain of the possible defended house at Dun Heanish (T116); although the remains may be preserved beneath the ground. The remains of a substantial land boundary, now almost completely covered with accumulated sand deposits and vegetation, appears to extend across the headland upon which the dun is situated and may be part of an associated defensive barrier or enclosure (T114, 118).

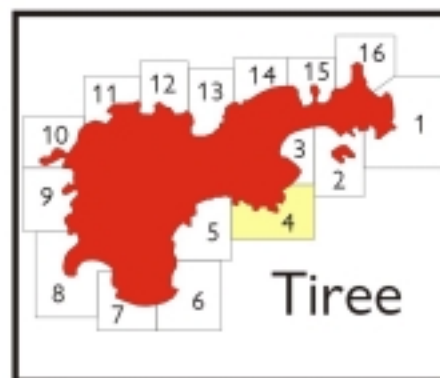
1. Heanish

Rock platform, occasional cobble cover

Coast edge <5m

Drift/rock interface generally visible

Rocky foreshore sloping steeply to sea. This unit includes three small sandy bays. Traigh an Duin has intermittent dumping of building rubble and rubbish, especially at the north end of the bay.

The bay at Baugh has salt marsh at its inner end.

The hinterland is generally rocky, poorly drained rough grazing. Some sand is exposed in sheep scrapings behind Traigh an Duin.

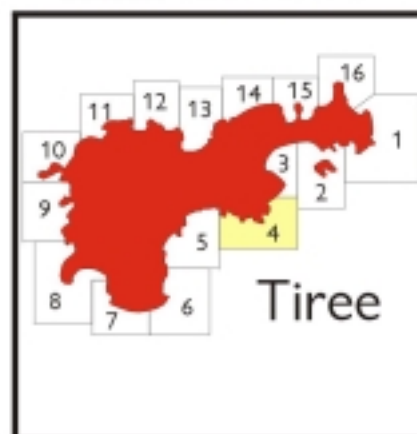
1. Heanish

Eroding to stable

The coast edge in this unit is generally low lying but is rocky and for the most part stable. There is some erosion of the coast edge above the rock platform. The bay at Traigh an Duin is more sandy and appears more vulnerable.

Rubble has been dumped along the coast edge here.
