MAP 11 - LONG CRAIG TO DYSART

- **Built heritage and archaeology** - The only visible sites along the foreshore by Kirkcaldy are a series of tank traps which have been reused possibly as a defence against erosion (NT27929012), Kirkcaldy Harbour and harbour capstan (NT29SE44;44.1) and Kirkcaldy Harbour Maltings (NT29SE68). A late 16th century dovecot (NT29SE10) and Ravenscraig Castle (NT29SE11) occupy cliff-top sites overlooking Kirkcaldy Sands. This 15th - 16th century castle built for Mary of Gueldres, Queen to James II, represents one of the earliest attempts to provide for defence by and from artillery (Walker and Ritchie 1987, 105). The town of Dysart has long had associations with the fishing and coal mining industries. Remains of one older harbour by Partan Craig (NT39SW20:site description 6) and a second more recent harbour (NT39SW21) are reminders of the maritime connections of the town

MAP CLASS: **EROSION**
 (Assessment date: 24 January 1996)
 NT29/39. Scale 1: 25 000

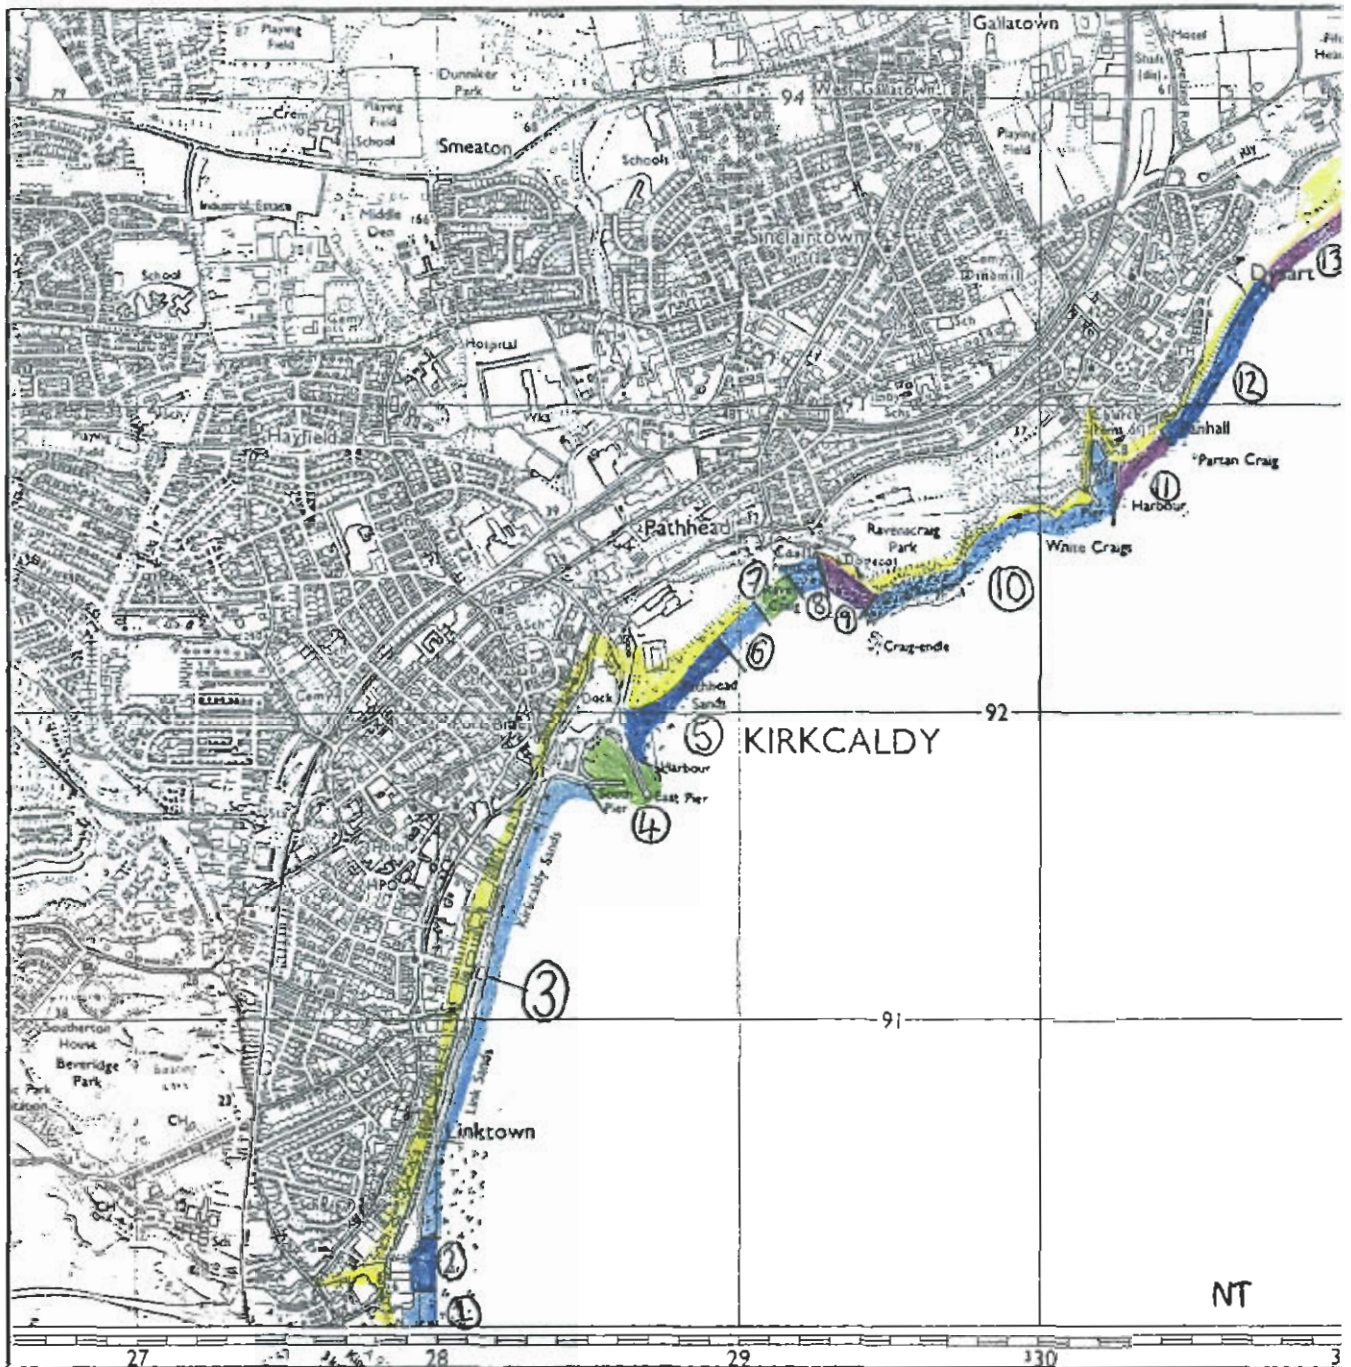
MAP 11: LONG CRAIG TO DYSART

- **Hinterland geology and coastal geomorphology; Erosion class** - From the eastern boundary of this sector, Link and Kirkcaldy sands extend for approximately kilometres along Kirkcaldy sea-front to Kirkcaldy harbour. At the north end of Pathead sands, a low coastal edge rises steeply to form cliffs, a topographical variation reflected by a change from blown sand and raised beach to drift, boulder clay over visible rock. The resulting rock promontory and cliffs (c. 15 metres O.D.) stretch from Ravenscraig Castle round to Ravenscraig Park before the coast edge descends once again southwest of Dysart Harbour. Substantial land-fill has occurred north east of Dysart town originating from the workings of the colliery. The presence of sand beaches and a sea-wall along the sea-front at Kirkcaldy suggest that sediments may be accreting along most of this sector. Exceptions include some areas of the cliff at Ravenscraig Park (Geology unit 9) where erosion of the cliff face is visible with resulting deposition of material onto the foreshore. The same is true in-front of the Dysart colliery workings (erosion unit 13) where erosion of the low coastal edge is resulting in the deposition of land-fill material onto the foreshore.

EROSION UNITS.

- 1**
NT279901
0.1 km
Accreting or stable
Sand and shingle foreshore may be accreting.
- 2**
NT279902
0.1 km
Definitely Accreting
Sand and shingle foreshore is definitely building up.
- 3**
NT282910
1.6 km
Accreting or stable
Kirkcaldy and Link Sands backed by hard coastal defence.
- 4**
NT286918
0.2 km
Stable
No access to Kirkcaldy harbour walls and inner harbour but they appear to be stable.
- 5**
NT288922
0.5 km
Definitely accreting
Pathead Sands and sand dunes are building up on the north side of Kirkcaldy Harbour East Pier.
- 6**
NT290923
0.2 km
Accreting or stable
Sand may be accreting at the north eastern end of Pathead Sands.
- 7**
NT291924
0.1 km
Stable
Ravenscraig Sands appear stable.
- 8**
NT292925
0.1 km
Accreting or stable
The sands below Ravenscraig Castle may be building up.

- 9**
NT293924
0.2 km
Both accreting and eroding
The shoreline appears to be accreting but a low cliffline below Ravenscraig Park and Ravenscraig Castle Dovecot is gradually eroding.
- 10**
NT298924
1.0 km
Accreting or stable
Shingle foreshore with rocky outcrops below Ravenscraig Park and sand around White Craigs may be accreting. The same is the case for Dysart Harbour.
- 11**
NT303928
0.2 km
Both accreting and eroding
The foreshore north east of Dysart harbour wall appears to be accreting but the low coastal edge comprising land-fill may be eroding.
- 12**
NT306932
0.6 km
Definitely accreting
Shingle appears to be building up along Dysart sea-front.
- 13**
NT309935
0.4 km
Both accreting and eroding.
The foreshore appears to be accreting but the low coastal edge comprising land-fill may be eroding.

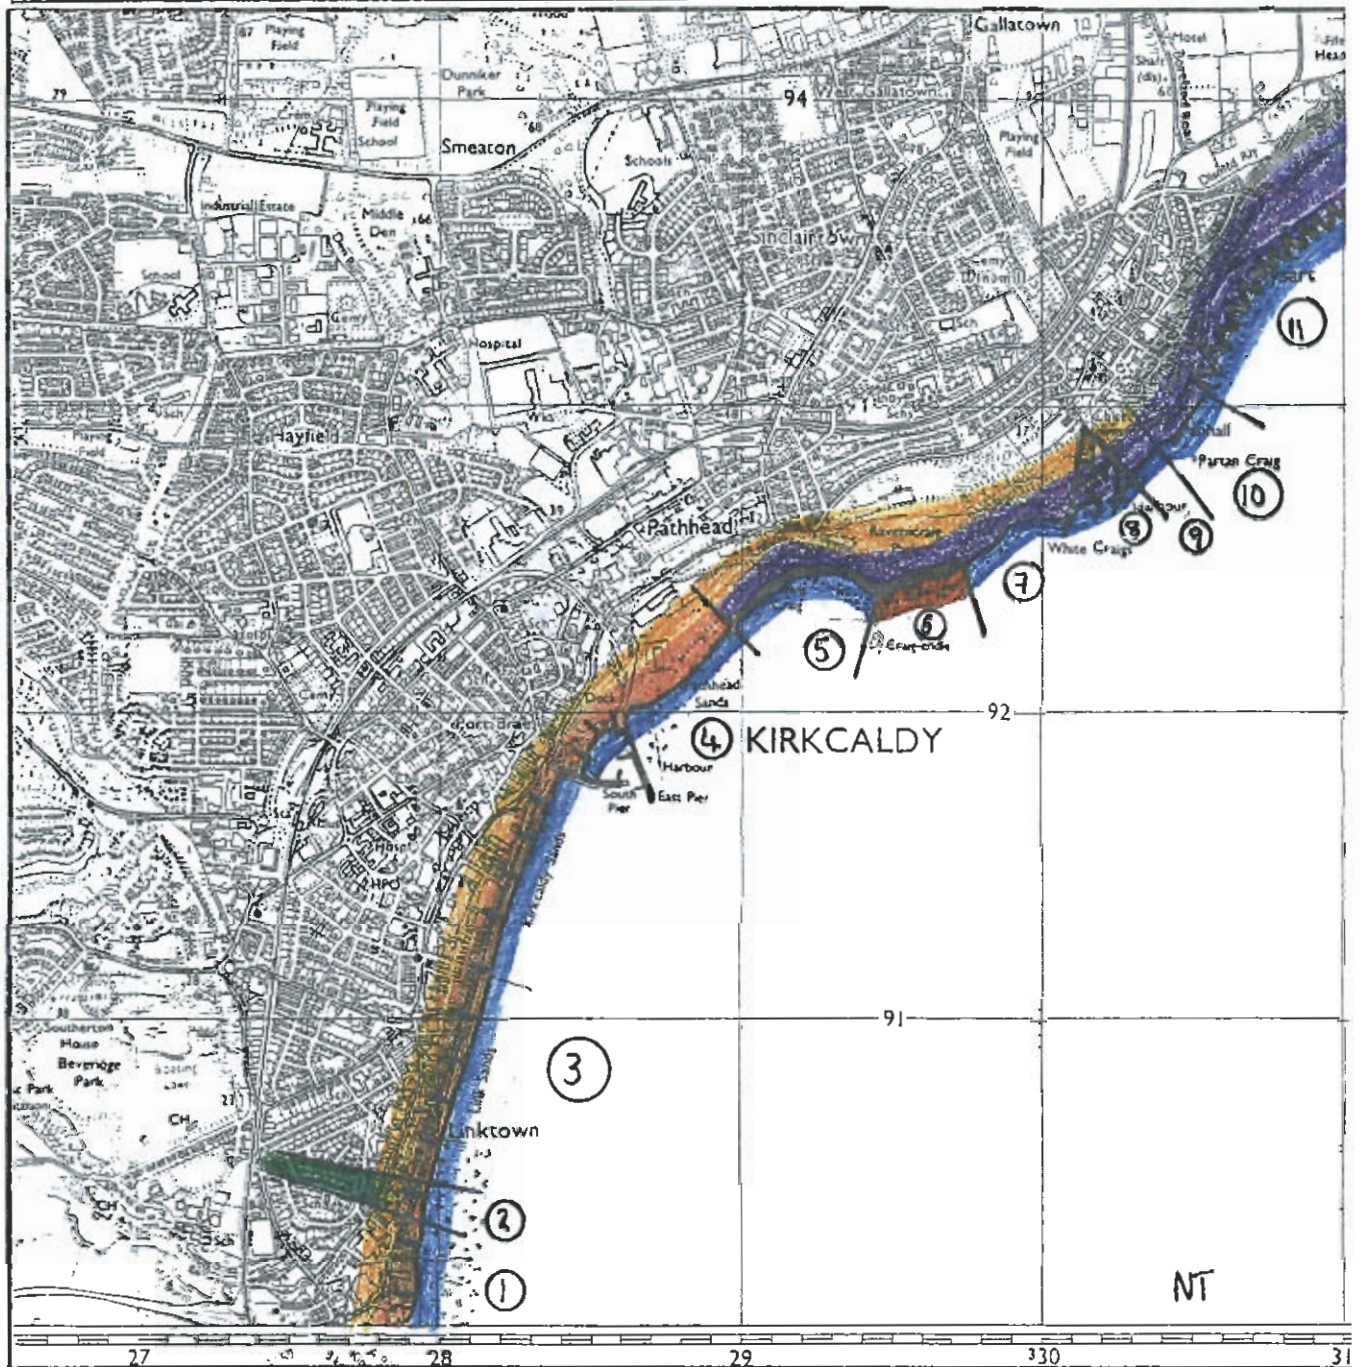
MAP 11: SEAFIELD COLLIERY TO DYSART

GEOLOGY UNITS

1
 NT278902
 0.3 km
 Mainly sand
 Man-made barrier
 Blown sand in front of raised beach and marine deposits
The southern end of a long sea-wall protecting Kircaldy sea-front.

2
 NT279904
 0.1 km
 Mainly sand
 Man made barrier
 Blown sand in front of raised beach and marine deposits with alluvium from river basin.
Localised deposits of alluvium in the hinterland from the ancient route of a river.

3
 NT282911
 1.5 km
 Mainly sand
 Man made barrier
 Blown sand in front of raised beach and marine deposits.
Link Sands and Kircaldy Sands consist of fine grained sand. Kircaldy Harbour and sea-front are all protected by sea-walls

4
 NT289922
 0.5 km
 Mainly sand
 Low edge (< 5 metres)
 Blown sand in front of raised beach and marine deposits.
Un-protected section of coast by Pathead sands.

5
 NT292924
 0.5 km
 Mainly sand
 Cliff (> 5 metres)
 Drift, boulder clay over visible rock with raised beach and marine deposits.
Ravenscraig Bay consists of sand and shingle with bed-rock outcrops, and a high coastal edge behind consists of bedrock with a boulder clay covering

6
 NT296924
 0.3 km
 Mainly rock platform
 Cliff (> 5 metres)
 Drift, boulder clay over visible rock with raised beach and marine deposits.
Rock platform uncovered for the most part with cliffs behind in front of Ravenscraig Park.

7
 NT299926
 0.4 km
 Mainly sand
 Low edge (< 5 metres)
 Drift, boulder clay over visible rock with raised beach and marine deposits.
A sandy foreshore fronts a low coastal edge comprising boulder clay with bed rock visible in places

8
 NT302927
 0.1 km
 Mainly sand
 Man made barrier
 Drift, boulder clay over visible rock with boulder clay behind.
Dysart Harbour walls

9
 NT304928
 0.1 km
 Mainly sand
 Low edge (< 5 metres)
 Drift, boulder clay over visible rock with raised beach deposits behind.
East of Dysart Harbour.

9
 NT304928
 0.2 km
 Mainly sand
 Low edge (< 5 metres)
 Drift, boulder clay over visible rock with boulder clay behind.
Sand and shingle foreshore by Partan Craig.

10
 NT307934
 0.8 km
 Mainly sand
 Human disturbance
 Drift, boulder clay over visible rock with boulder clay behind.
Land-fill on the coastal edge from mining industries.

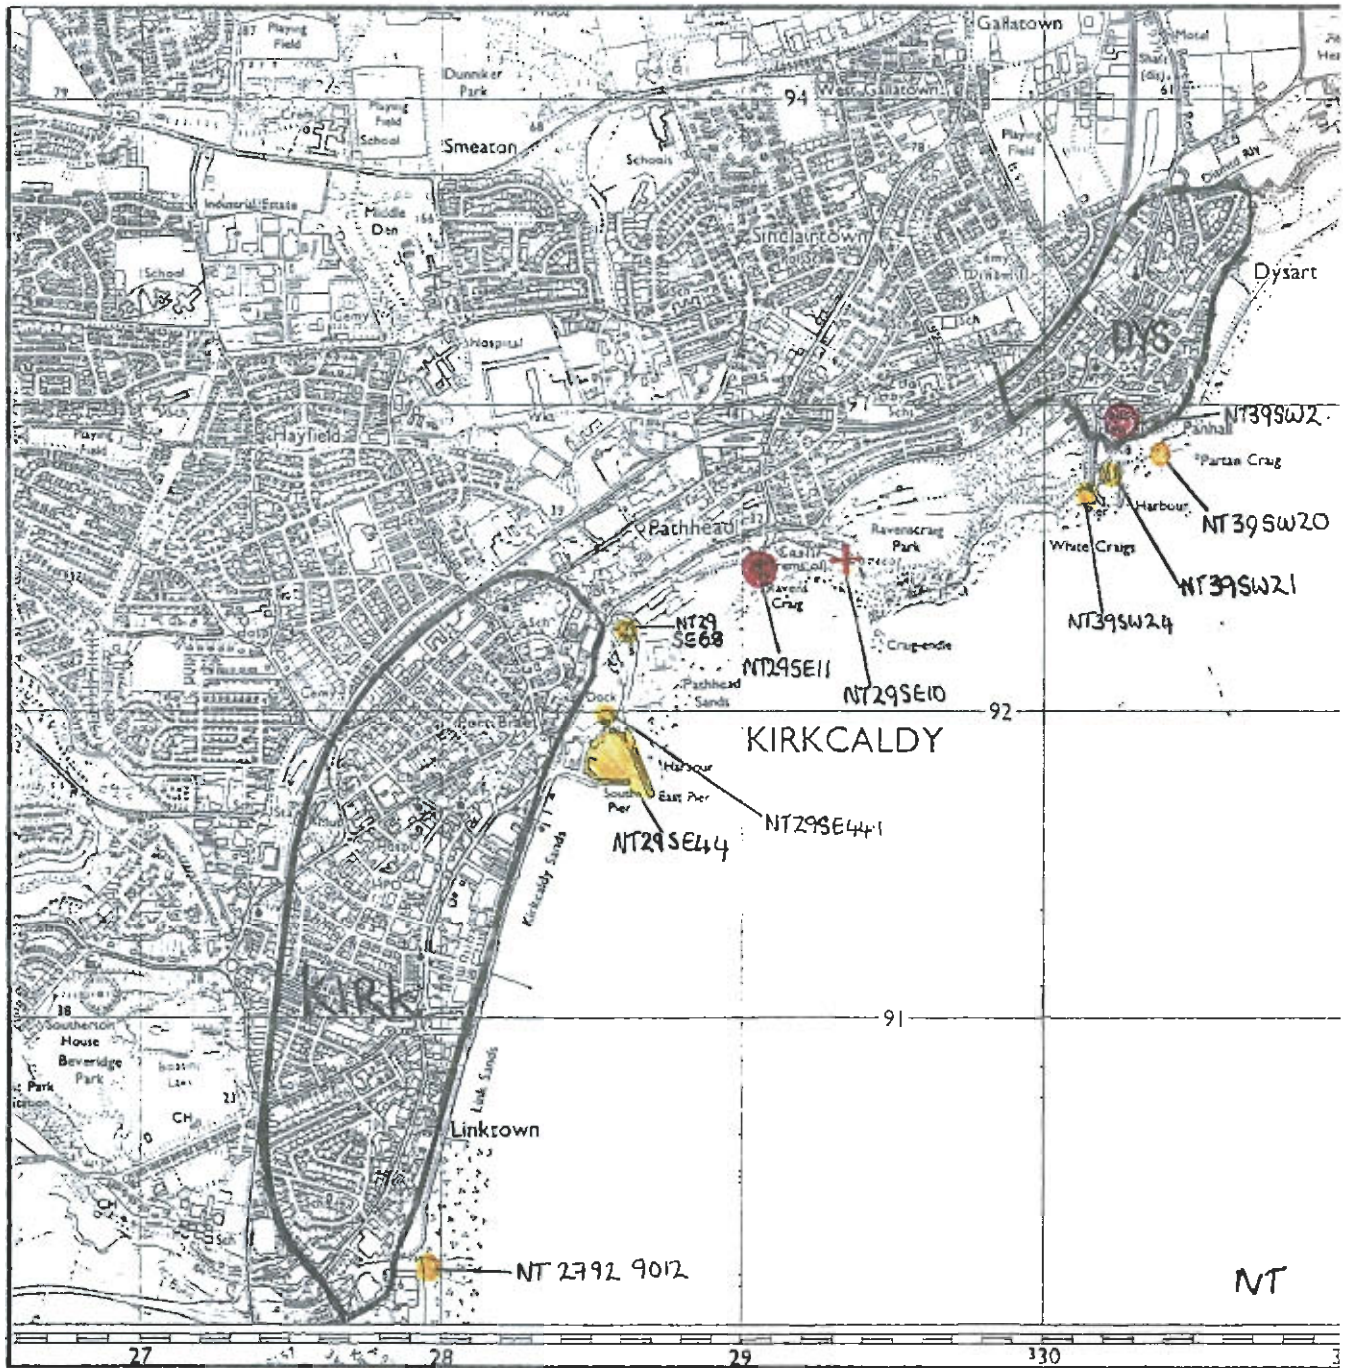
**MAP 11: LONG CRAIG
TO DYSART**

**ARCHAEOLOGY AND
BUILT HERITAGE**

NT27929012
Kinghorn
Re located tank traps used as ero-
sion defence
20th Century
Fair
Nil

NT29SE44
KIRKCALDY HARBOUR
TRANSPORT/PORTS;
HARBOURS
17th - 19th Century
Fair
Survey

NT29SE44.1
KIRKCALDY HARBOUR;
CAPSTANS
CAPSTANS,
Fair
Nil

NT29SE11
RAVENS CRAIG CASTLE,
CASTLE; ARTILLERY FORTI-
FICATION,
PROTECTED ANCIENT
MONUMENT
15th Century
Fair
Nil

NT29SE10
RAVENS CRAIG DOOCOT
DOVECOT
LISTED BUILDING
Late 16th Century
Fair
Nil

NT39SW21
DYSART HARBOUR
HARBOUR
17th - 19th Century
Fair
Survey

NT39SW20
DYSART; OLD HARBOUR
HARBOUR
ARCHAEOLOGICAL SITE OF
REGIONAL IMPORTANCE
*See site description 6
17th - 19th Century
Fair
Survey, Monitor
