MAP 14 - LEVEN

- **Built heritage and archaeology** - The main sites of interest on this short coastal sector are two foreshore sites on Leven Links. One is a U shaped wooden fish trap (NT38750075) in fair condition and one a stone cairn with visible cells (NT38790080) which may also be a fish trap. Both these sites need to be investigated further to confirm their origin.

MAP CLASS: EROSION
 (Assessment date: 23 January 1996)
 NS88/98. Scale 1: 25 000

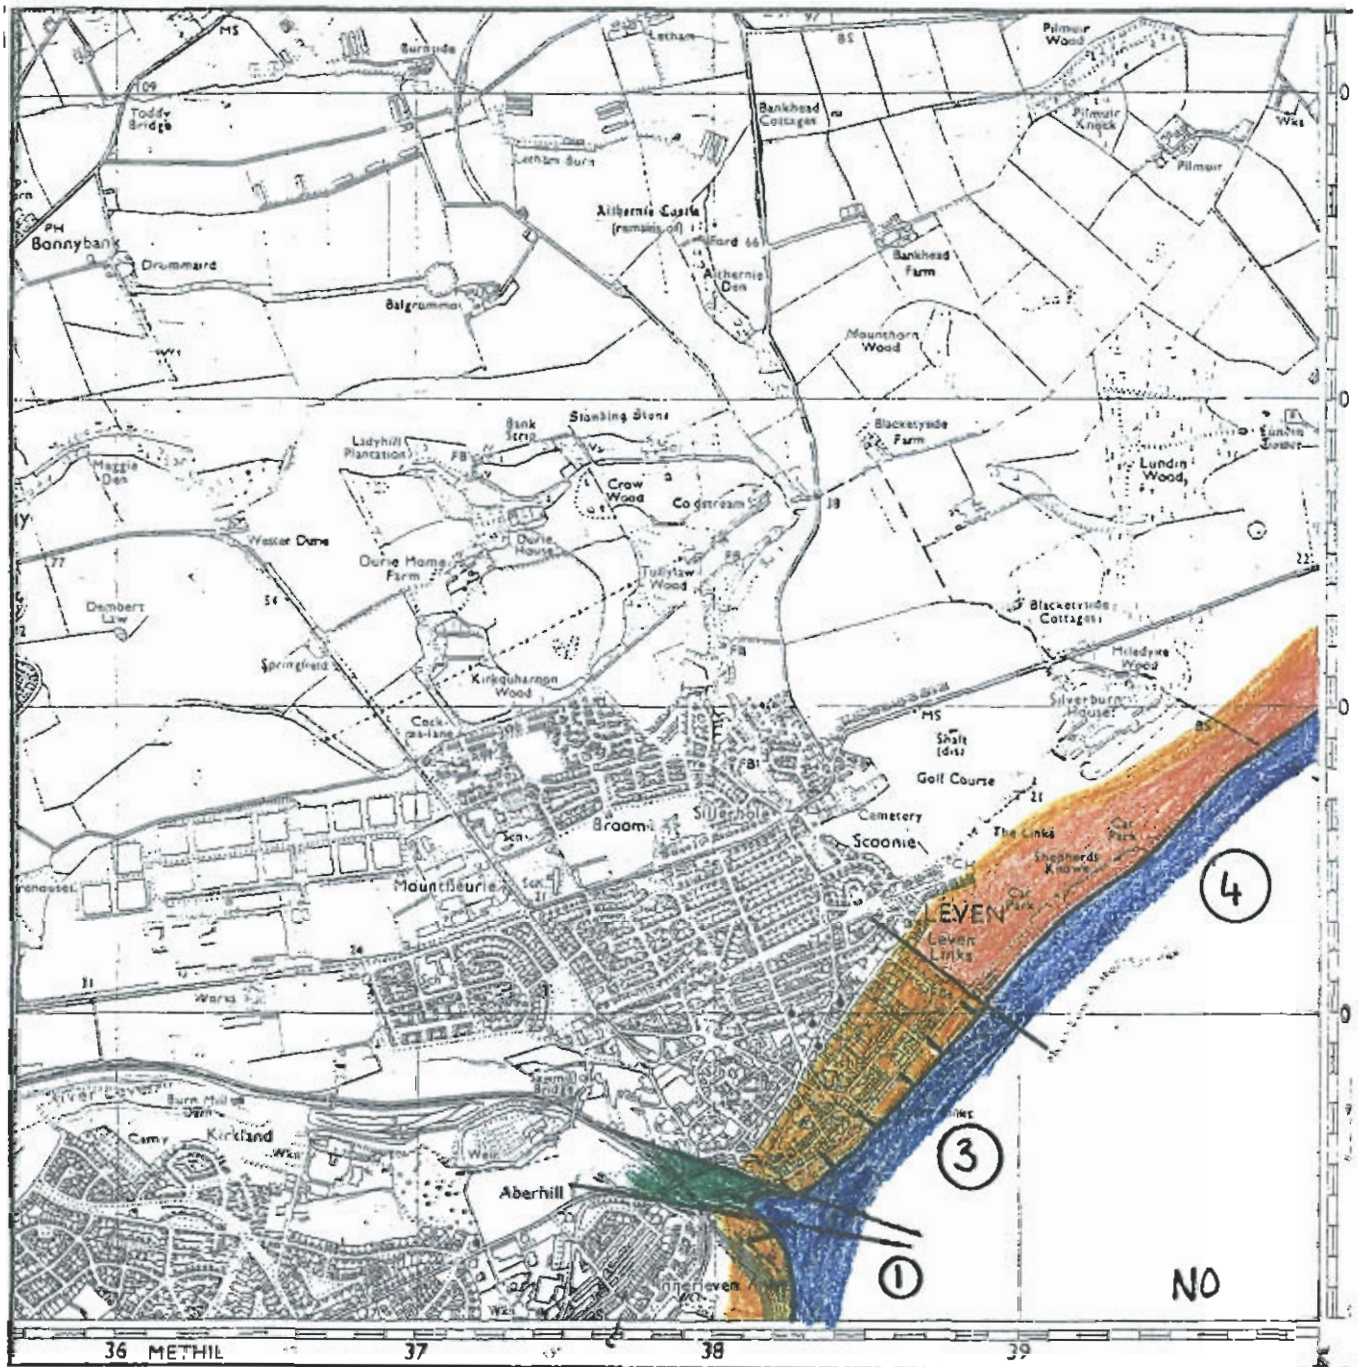
MAP 14: LEVEN

1
NO383002
0.3 km
Mainly sand
Man-made barrier
Raised beach and marine deposits
Around the mouth of the River Leven, sand deposits have built up on the foreshore.

2
NO381004
0.1 km
Mainly sand
Man made barrier
Alluvium
From the basin of the mouth of the River Leven

3
NO386006
0.9 km
Mainly sand
Man made barrier
Raised beach and marine deposits
Sea-wall protects shore front as far as Leven Links.

4
NO394015
1.5 km
Mainly sand
Low edge (< 5 metres)
Blown sand with raised beach deposits behind.
Thick layer of sand on a rock platform with blown sand behind. Beach between here and Largo Bay in the east is the most extensive beach in the survey area.

- **Hinterland geology and coastal geomorphology; Erosion class** - At Leven, a broad band of sand foreshore stretches westwards towards Lundin Links and Largo Bay. Along the coastal edge, the drift geology comprises raised beach materials (Geology units 1, 3) and blown sand (Geology unit 4). There is also a localised accumulation of alluvium associated with the mouth of the River Leven (Geology Unit 2). While the majority of the coast edge is either accreting or stable, there is evidence that unprotected sections of blown sand coastal edge are being affected with resulting erosion of the coast edge causing deposition of sediments onto the foreshore (Erosion unit 3).

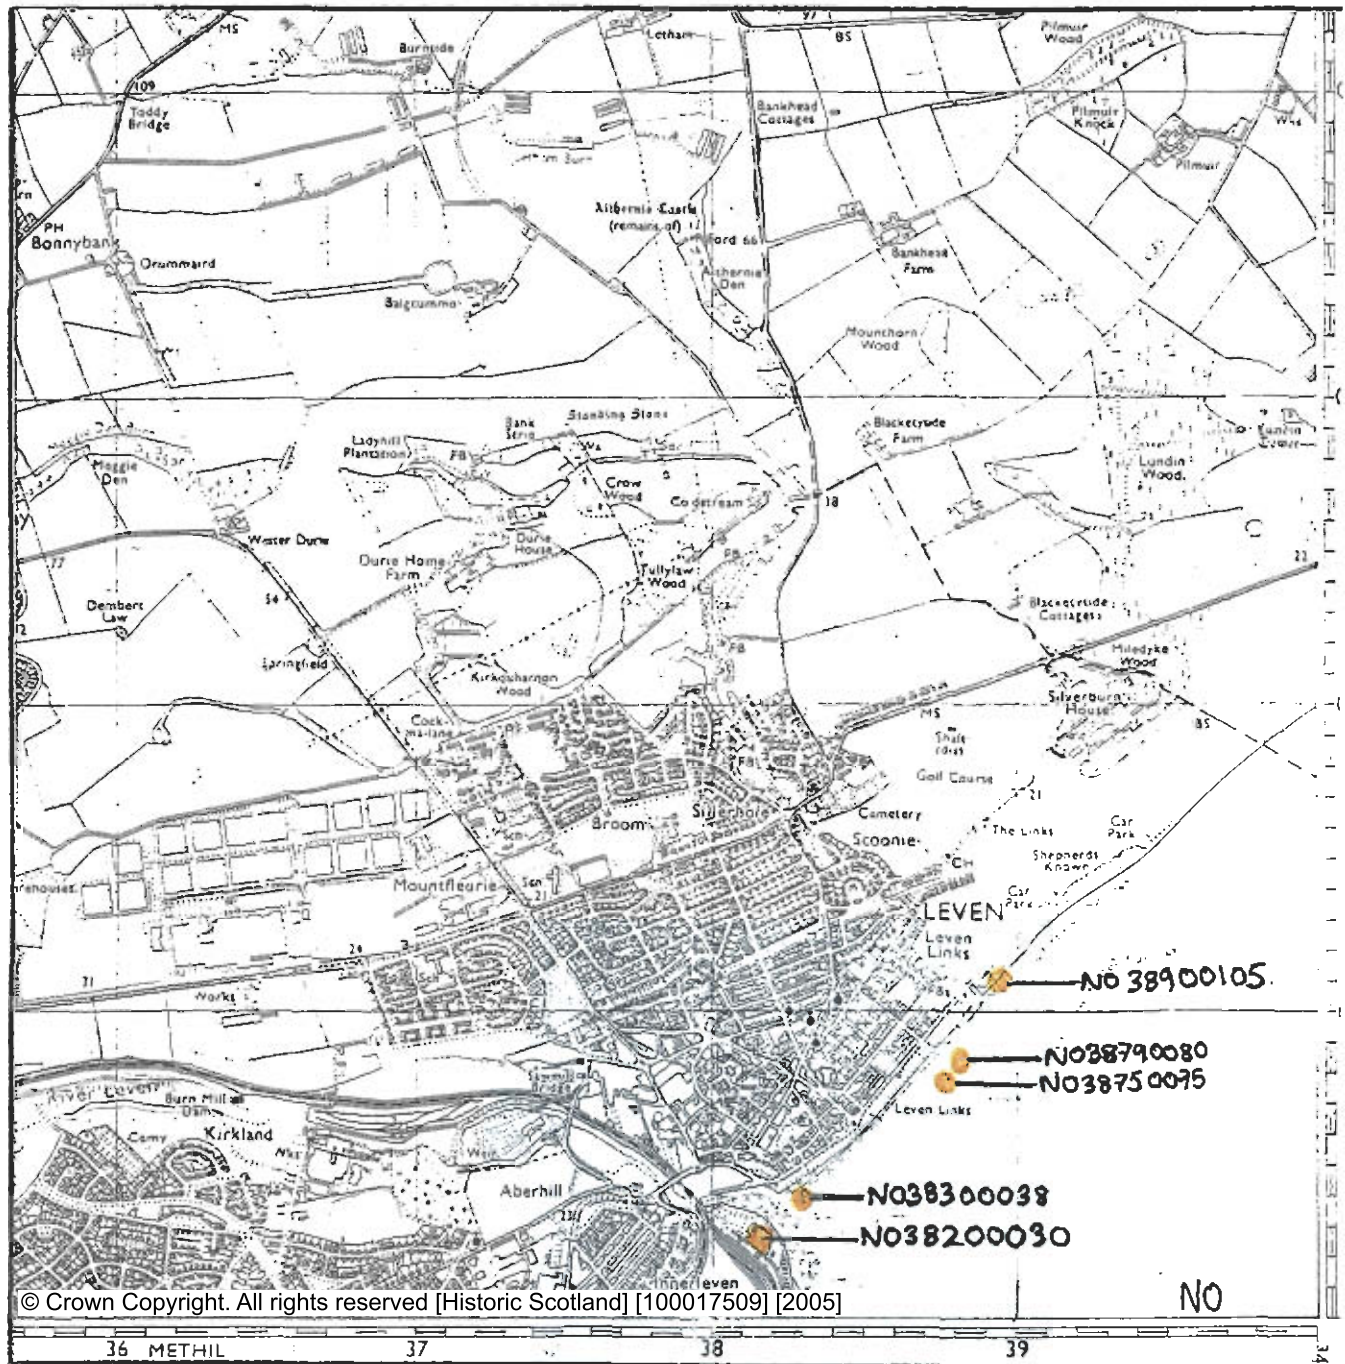
MAP 14: LEVEN

Leven
Power Station
20th Century
Good
Nil

Leven
Wooden channel markers.
19th - 20th Century
Fair
Survey

Leven
U shaped wooden fish trap
Uncertain
Fair
Survey

Leven
Stone cairn with cells visible, possible fish trap
Uncertain
Fair
Survey, Monitor

Leven
4 concrete/wooden glider traps and sewerage stations
20th Century
Fair
Nil
