MAP 15 - LUNDIN LINKS TO LARGO BAY

MAP CLASS: **EROSION**
 (Assessment date: 22- 23 January 1996)
 NO40/50. Scale 1: 25 000

LUNDIN LINKS TO LARGO BAY

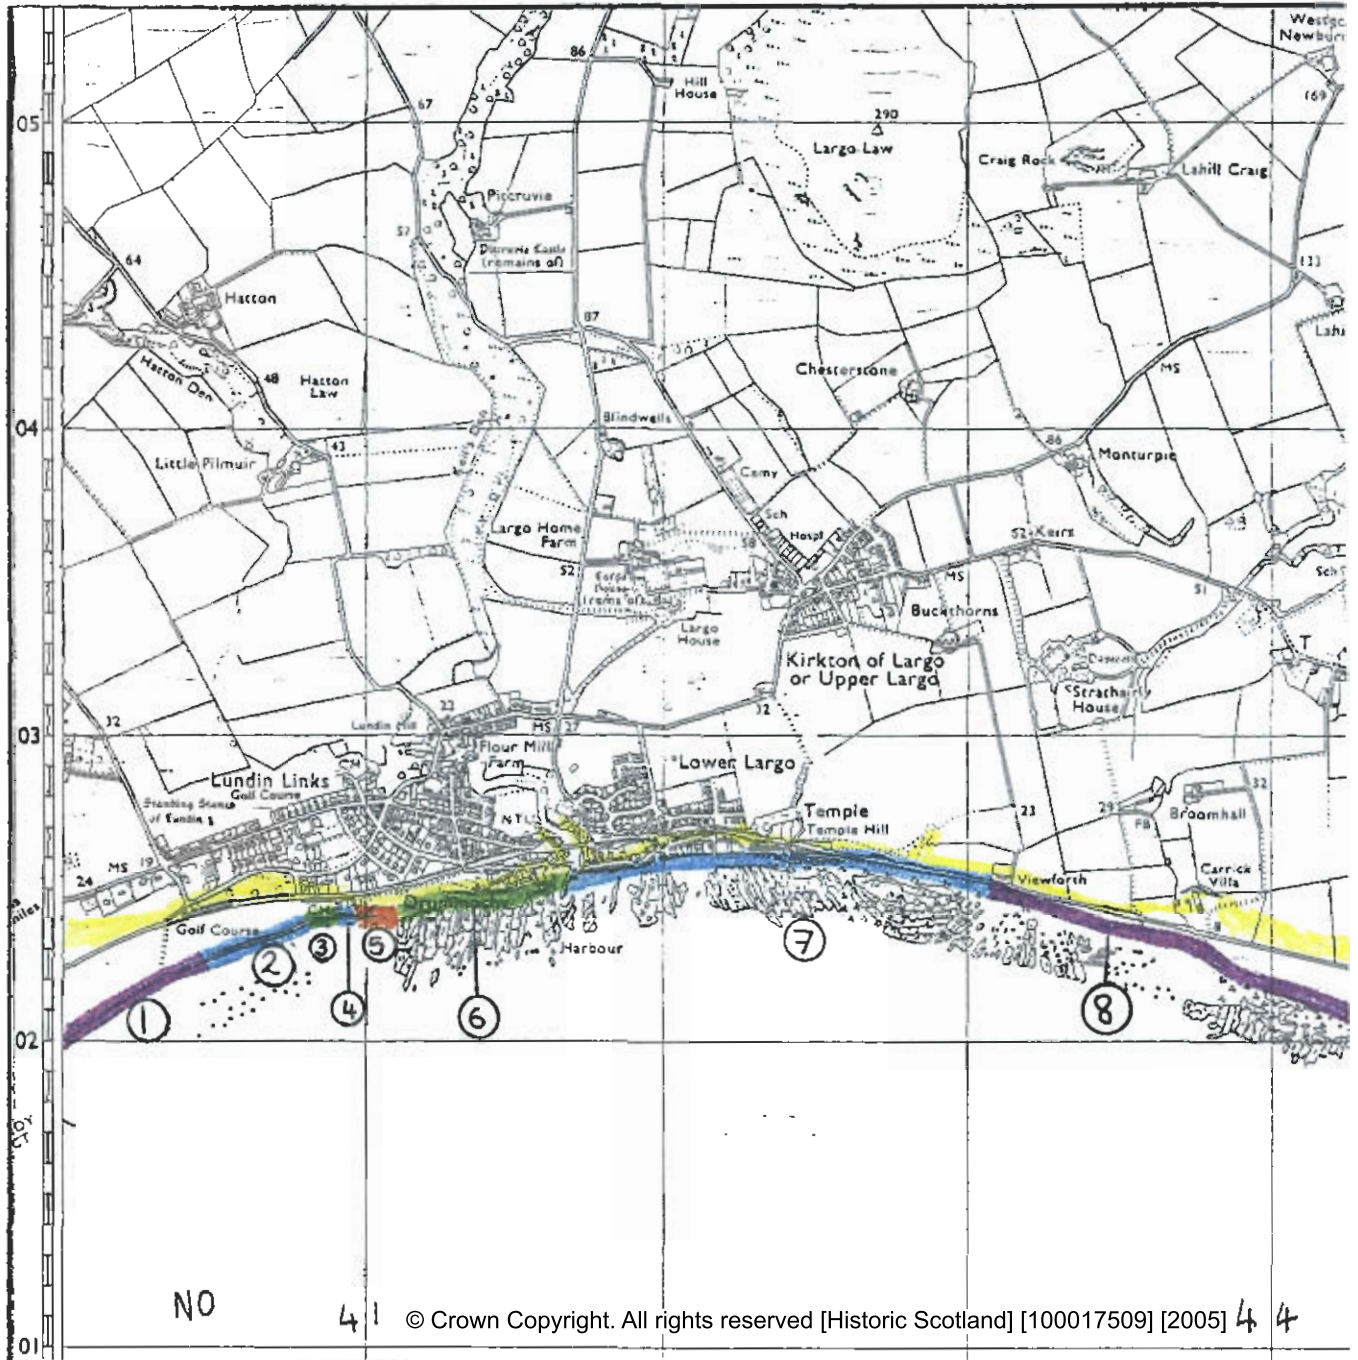
MAP 15: LUNDIN LINKS TO LARGO BAY

EROSION UNITS.

Sand dunes may be eroding and sand building up on Lundin Links beach.

Sand may be accreting on the beach

Localised build up of sand on foreshore

Localised erosion of sand dunes

Rocky foreshore and sea-wall protecting coastal edge.

Sea-wall protecting coastal edge and build up of sand along the upper shore with bed-rock outcrops.

Dunes eroding, sand accreting along the foreshore.

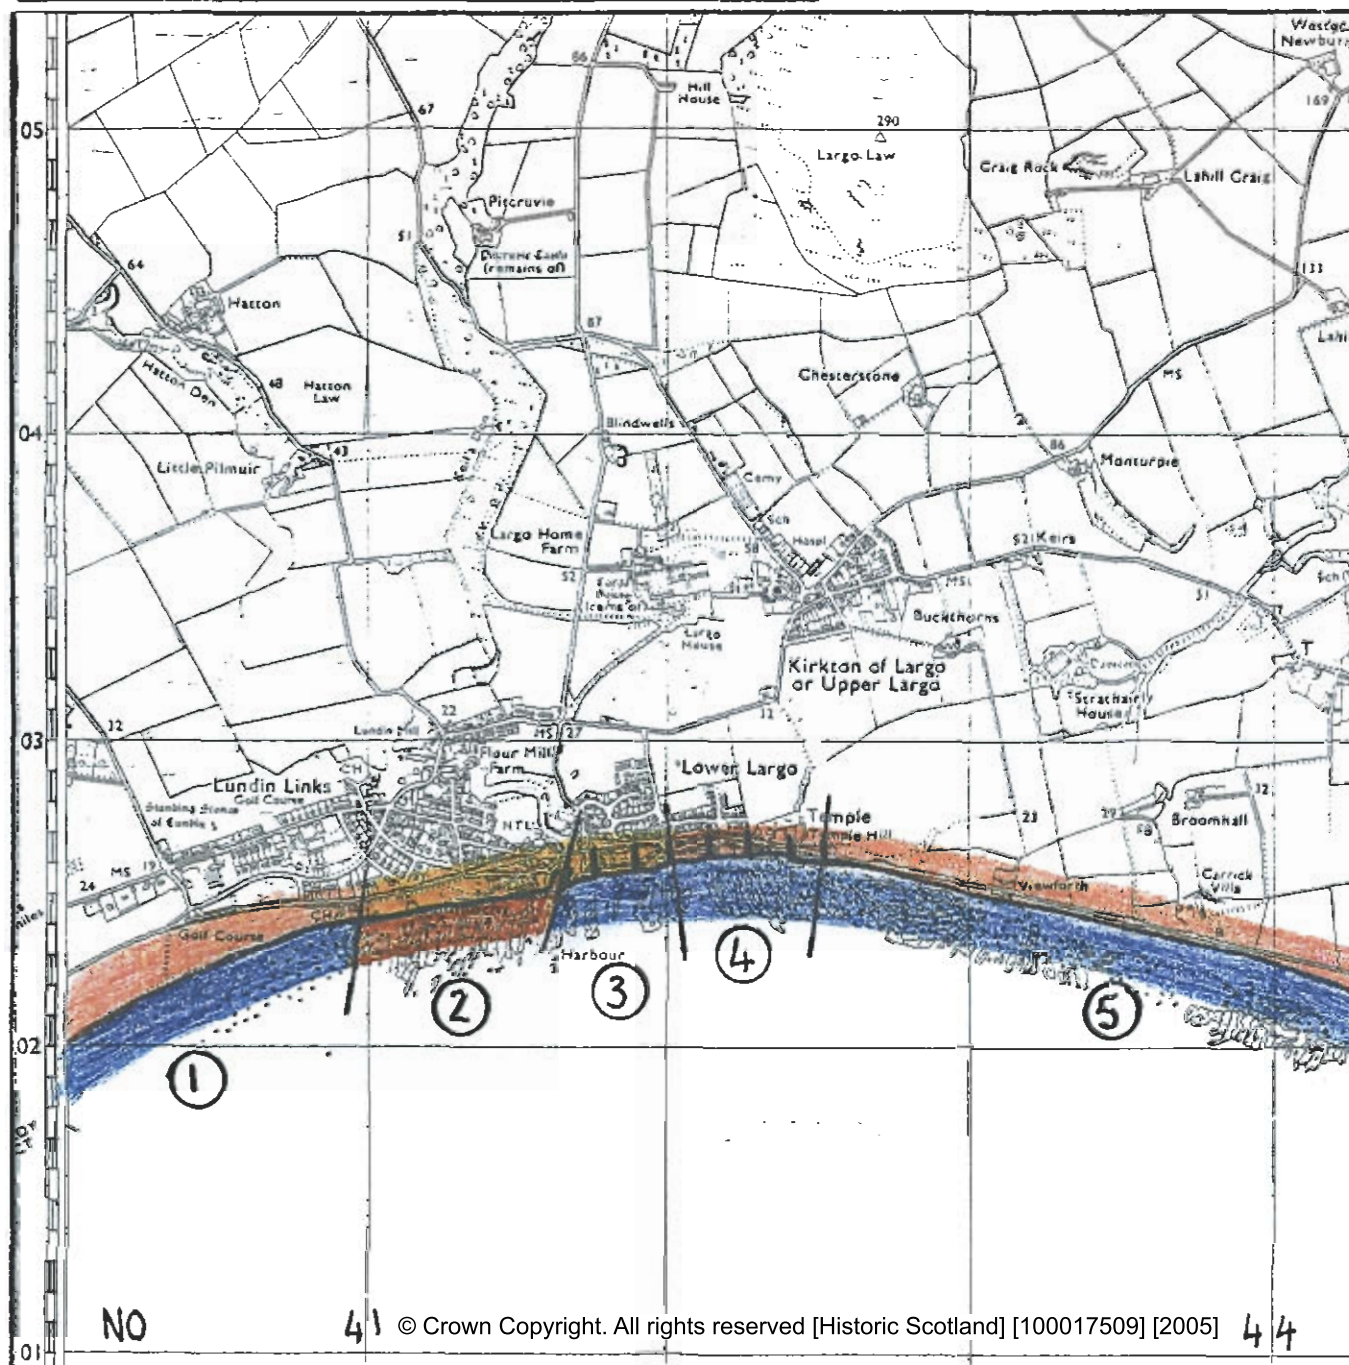
**MAP 15: LUNDIN LINKS TO
LARGO BAY**

GEOLOGY UNITS

Sand beach continues in-front of a blown sand system and beach narrows to the west of this segment to consist of a thin veneer of sand on intertidal rock.

Beach is at its narrowest at this point with little sand coverage. This suggests that currents transport sediment eastwards to Largo Bay itself.

Limited sand over a rock platform with a raised beach behind a protected shorefront.

Sea-wall protecting Lower Largo sea-front continues to Temple Hill.

Sandy beach interspersed with rocky outcrops and low dune system behind the foreshore.

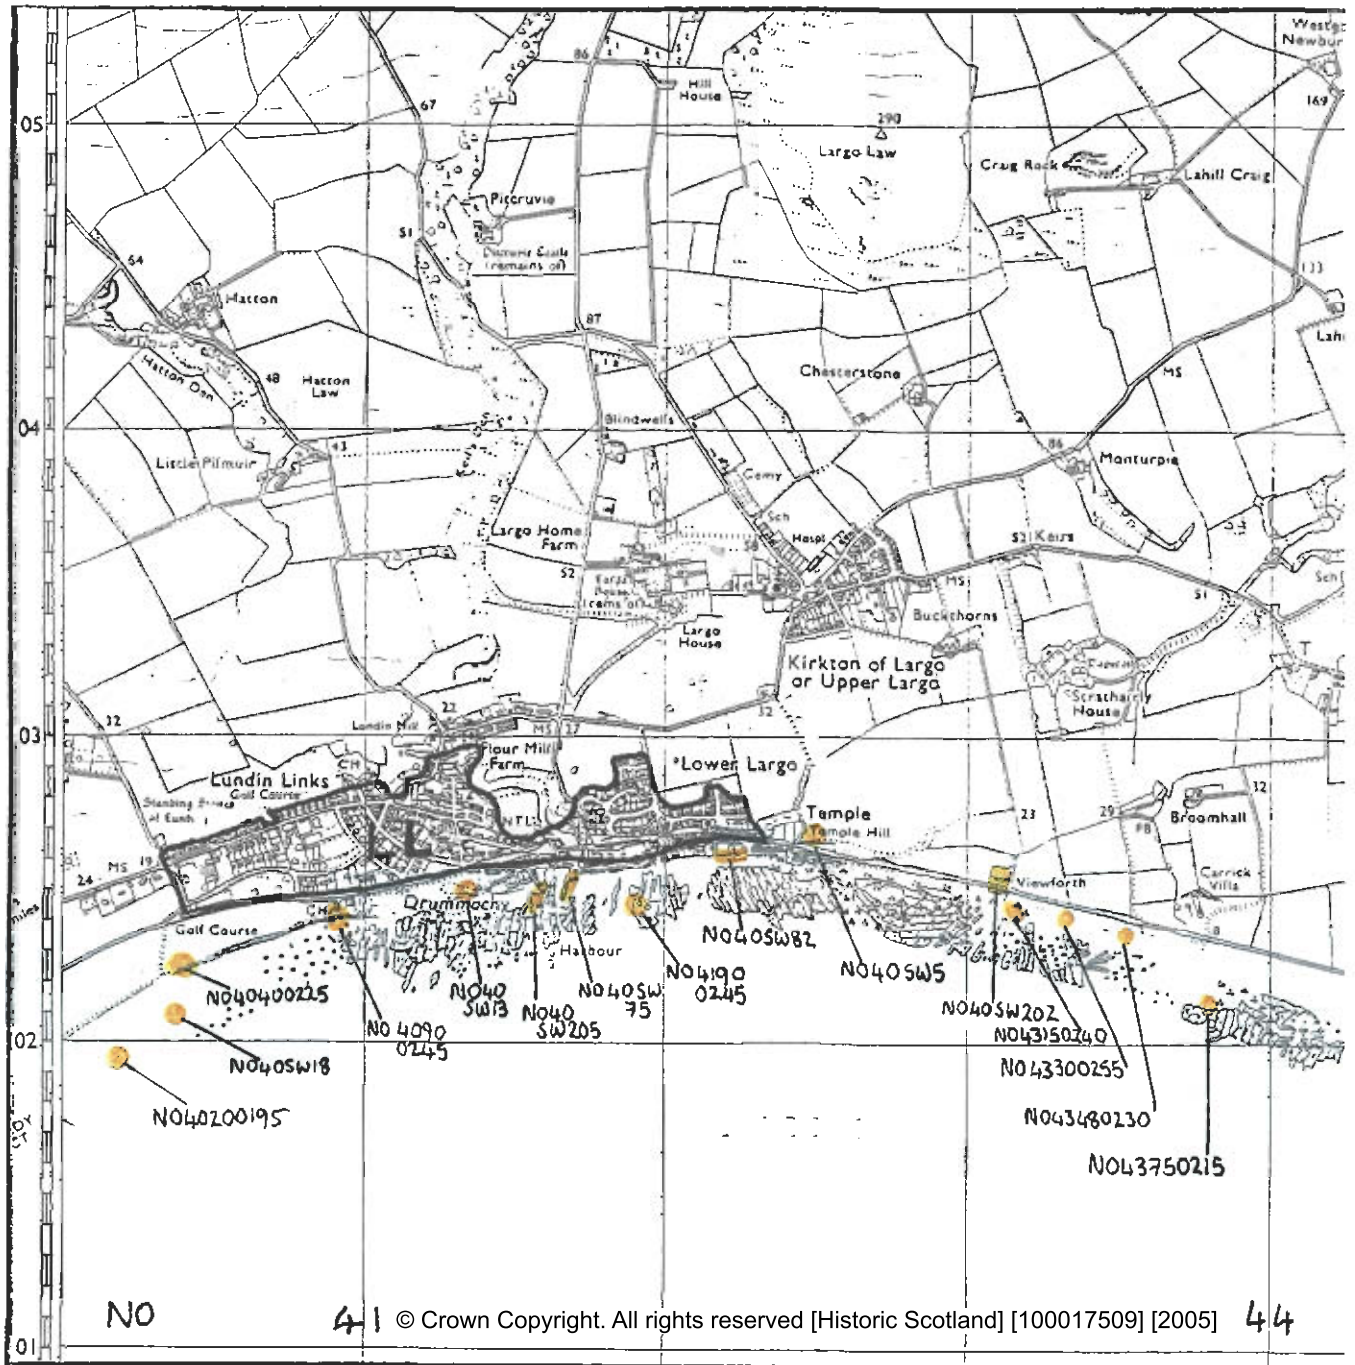
MAP 15: LUNDIN LINKS TO LARGO BAY

NO40200195
Lundin Links
Two posts, possibly glider traps
Uncertain
Fair
Nil

NO40400225
Lundin Links
Concrete tank traps
Mid 20th century
Fair
Nil

NO40900245
Lundin Links
2 concrete bunkers with an enclosure
Mid 20th Century
Fair
Survey

NO40SW13
LUNDIN LINKS
BURIAL, PICTISH CEMETERY
ARCHAEOLOGICAL SITE OF RE-
GIONAL IMPORTANCE
***See Site description 5**
Uncertain
Poor
Survey, Monitor

NO41900245
Lower Largo
Fish Trap, U-shaped line of round wooden
stakes
17th - 19th Century uncertain
Fair
Survey

NO43300255
Largo Bay
Coastal defence buildings and revetments
Uncertain
Fair
Survey

NO43750215
Largo Bay
Metal mooring hoop set in to bedrock
Uncertain
Fair
Nil

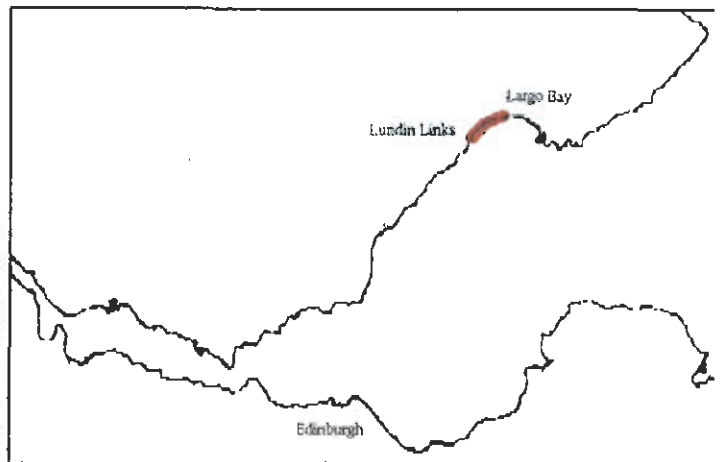
MAP 15: LUNDIN LINKS TO LARGO BAY

Sites behind the foreshore at Lundin Links and Lower Largo (LL)

LOWER LARGO
RAILWAY VIADUCT
ARCHAEOLOGICAL SITE OF RE-
GIONAL IMPORTANCE
19th Century
Not seen
Nil
