MAP 18 - LONG SHANK TO ANSTRUTHER WESTER

**MAP 18: LONG SHANK TO
ANSTRUTHER WESTER**

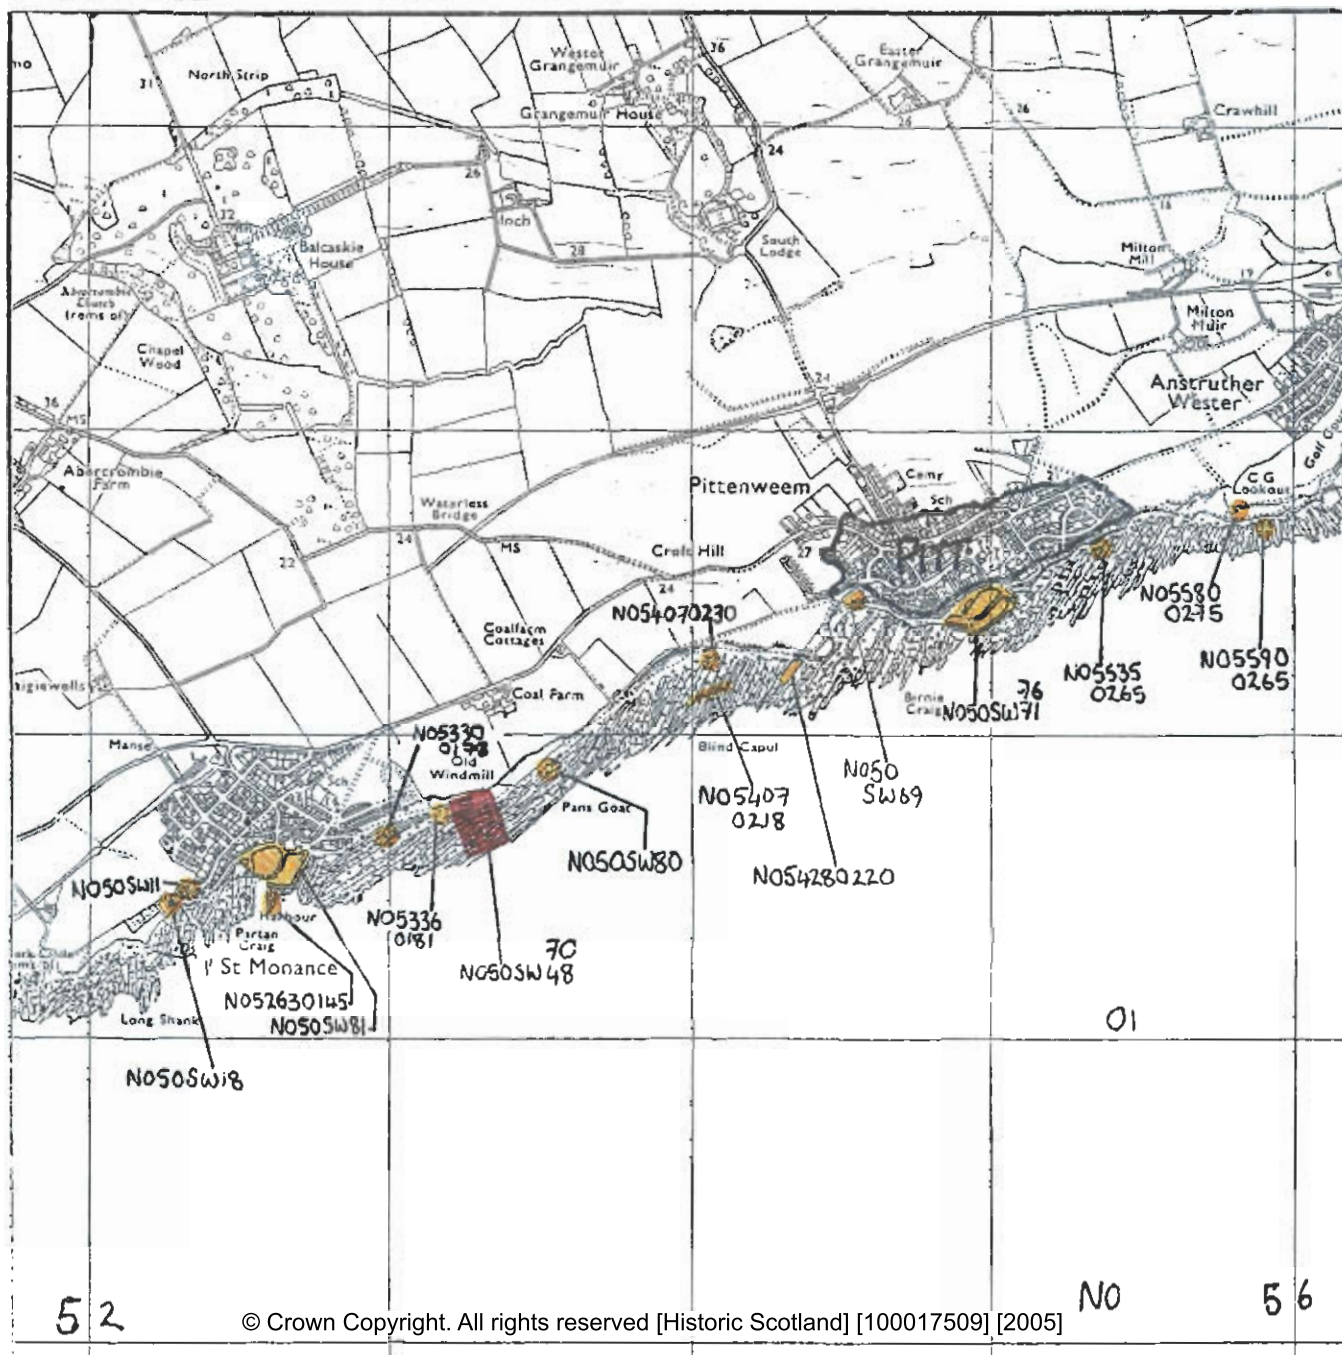
MAP 18: LONG SHANK TO ANSTRUTHER WESTER

ARCHAEOLOGY AND BUILT HERITAGE UNITS

NO52630145
St Monance
Concrete harbour defence; aerial photograph seen on the ground
19th - 20th Century
Fair
Nil

NO50SW81
ST MONANCE HARBOUR HARBOUR
ARCHAEOLOGICAL SITE OF REGIONAL IMPORTANCE
*See site description 6
17th - 19th Century
Fair
Survey, Monitor

NO50SW70
ST MONANCE; COALFARM SALT PANS
PROTECTED ANCIENT MONUMENT ARCHAEOLOGICAL SITE OF REGIONAL IMPORTANCE
18th - 19th Century
Fair
Monitor

NO50SW48
ST MONANCE; COALFARM WINDMILL
PROTECTED ANCIENT MONUMENT ARCHAEOLOGICAL SITE OF REGIONAL IMPORTANCE
18th -19th Century

NO54070230
Pittenweem
Wood and stone wall in the eroding face.
Uncertain
Poor
Monitor

NO50SW71
PITTENWEEM HARBOUR ARCHAEOLOGICAL SITE OF REGIONAL IMPORTANCE
*See detailed site description 6
17th - 19th Century
Fair
Survey, Monitor

NO55800275
Cellardyke
Coastguard lookout (possibly military)
Mid 20th Century
Fair
Survey

NO55900265
Anstruther
Stone and shell filled pits in section.
Uncertain
Fair
Monitor
