Introduction to Map 1: Rubha Glas to Rubha Ruadh

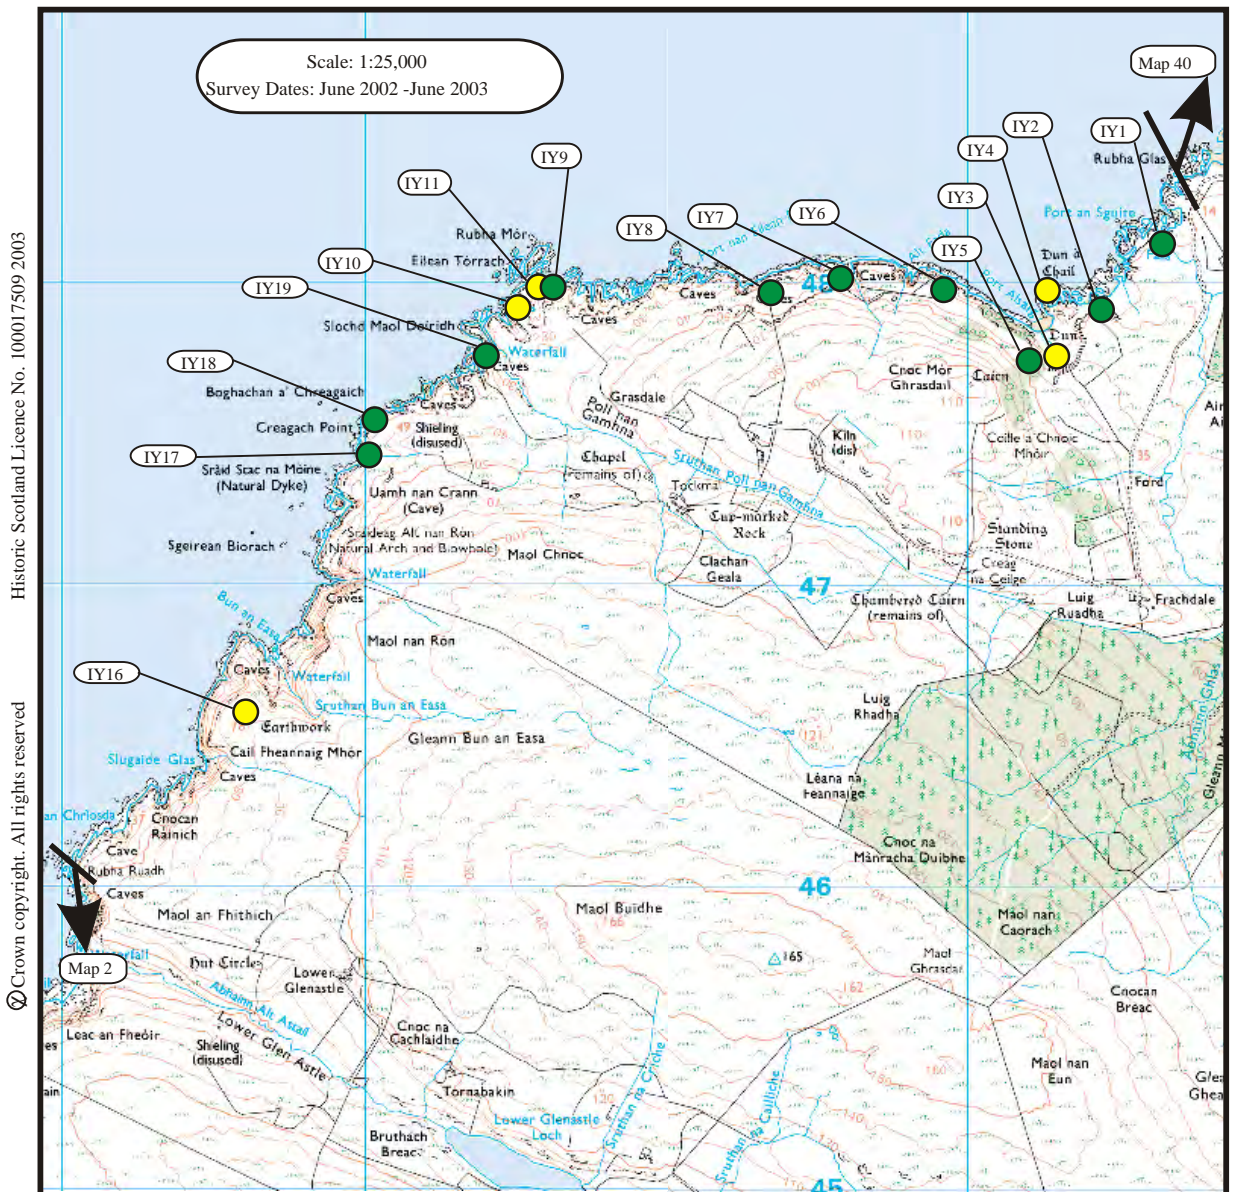
This map section covers some 6.3km of coastline, an upland area comprising both grazing land and moorland on the northwest side of the Oa Peninsula. Much of the coastal zone within this area is made up of cliffs and rocky shore, and is stable. There are no modern roads or settlements within the coastal zone, although the remains of 19th C deserted settlements lie in valleys within the hinterland.

A total of fifteen sites were identified within this map section; five of these had been recorded previously and ten are recorded here for the first time. Of these sites, ten represent remains of 18-20th C date and include enclosures, cultivation remains and land boundaries. These remains are most likely associated with deserted settlements such as Tockmal, which lie inland. Four sites could not be dated from their visible components. These include two probable dun sites (IY3 and IY4), an enclosed promontory (IY10) and an most unusual ditched and banked enclosure at Gleann Bun An Easa (IY16). One previously recorded site (IY11) an alleged dun, could not be relocated during this survey.

It is recommended that four sites (IY3, IY4, IY10) are kept under surveillance to monitor for any changes in their condition. Three of these sites are located on close to the coast edge and therefore vulnerable to erosion; the fourth is the site at Gleann Bun An Easa (IY16) which lies some 60m from the coast but which is of high archaeological potential and therefore deserving of continued monitoring.

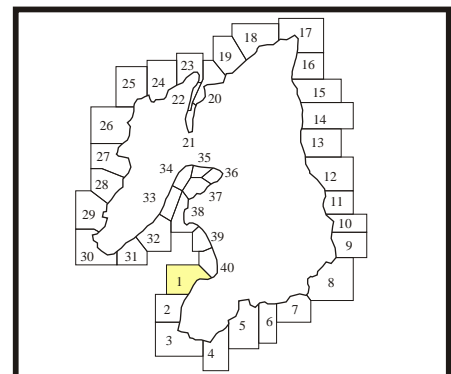
1. Tockmal

Rock platform

Coast edge mostly >5m

Drift on visible rock.

Coast edge mostly high and rocky. Some cobble cover in coves, storm beach within Port an Sguite. The hinterland is steep; it is in use for rough grazing. Vegetation in places very thick or overgrown, especially towards northern end of unit. The hinterland is in general poorly drained. The coast edge from Rubha Mor south becomes more indented.

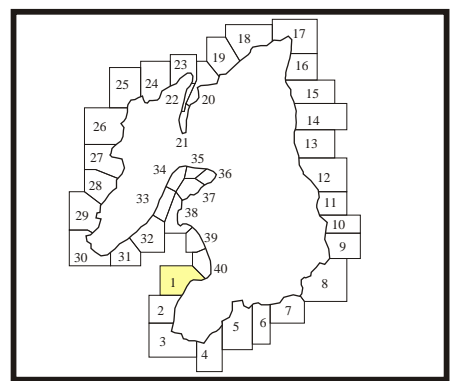
1. Tockmal

Stable

The coast edge in this unit is rocky and stable. No signs of erosion.
