## **Introduction to Map 11: Torr a'Muilinn to McArthur's Head**

This map section covers some 3.7km of coastline. It extends northwards along the eastern coast of Islay. The coastline in this area lies little more than 10m OD and is rough and rocky. The coast edge within this map section has been classified as stable. There is no modern settlement and much of the hinterland comprises of rough grazing and moorland. There are no roads within this area, although short sections of a rough track extend close to the coast to McArthur's Head.

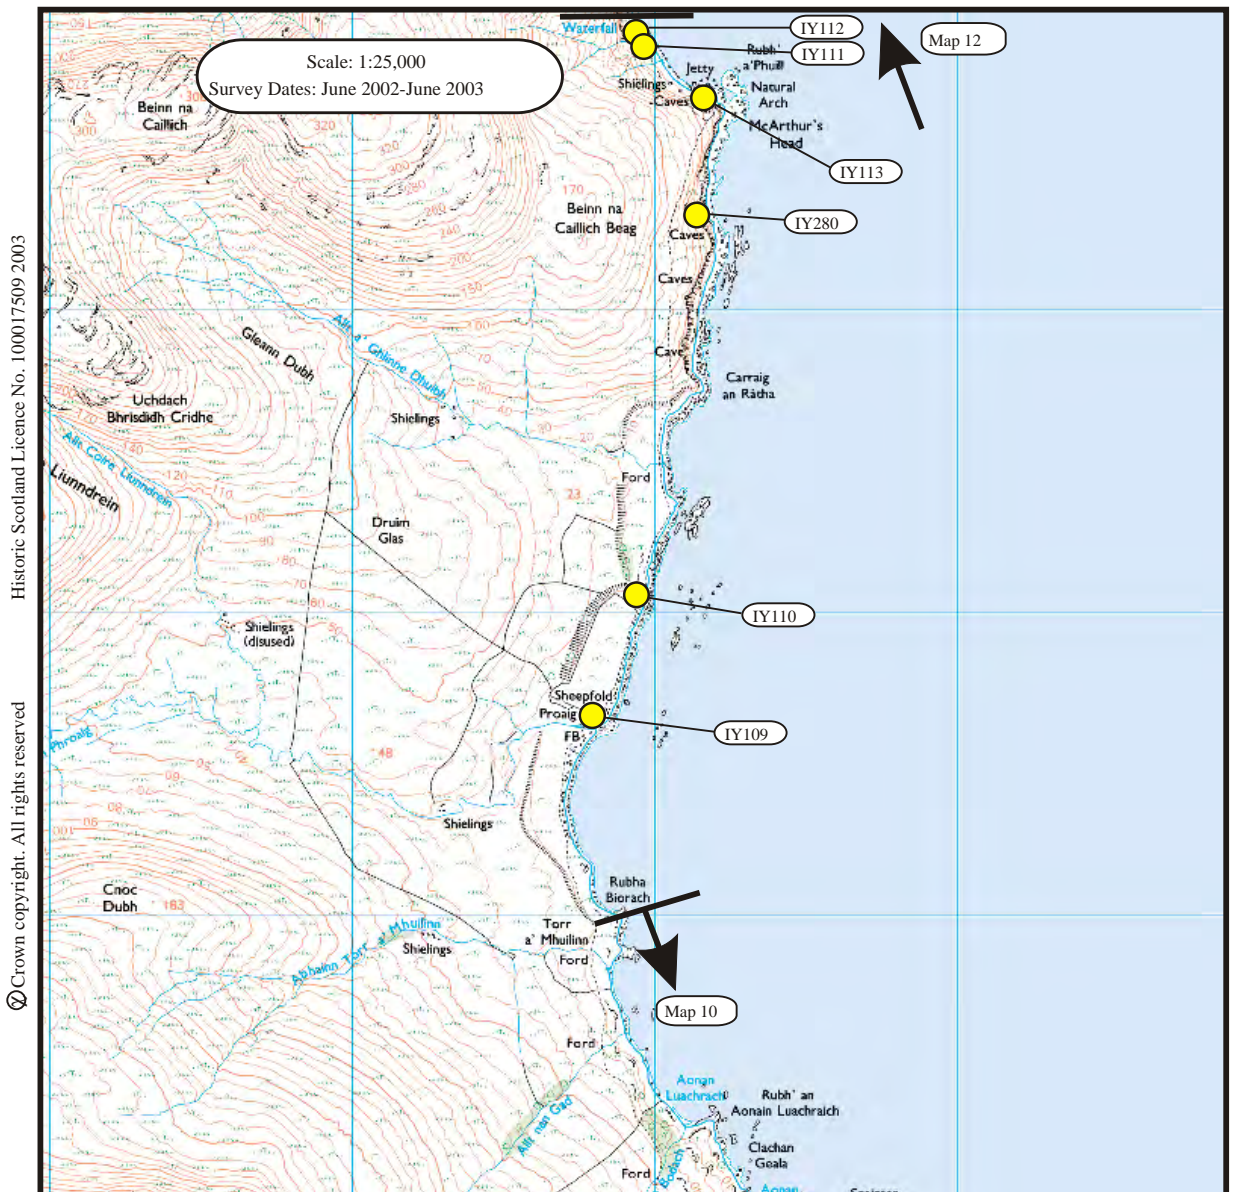
A total of six sites were identified within this map section; all of these had been recorded previously. Four sites are of 18-20th C date. These include the lighthouse and associated buildings at McArthur's Head (IY113), structural remains which may be bothies (IY111 and IY112) and a partially renovated farmstead at Proaig (IY109).

A cave lies behind a raised beach at McArthur's Head and contains a shell midden (IY280). Of uncertain date, the midden is concentrated in a small mound and is composed mainly of limpet and cockle shells. It is recommended that this site should be monitored

Of uncertain date also is a large shaped earthfast boulder at Proaig Bay (IY110). This has a broad flat upper surface into which a bowl shaped depression has been made. There is no indication of its function nor any reason to suspect that it is of recent date, as has been previously stated.
