Introduction to Map 20: Gortantaoid Point to Cnuic na Croise

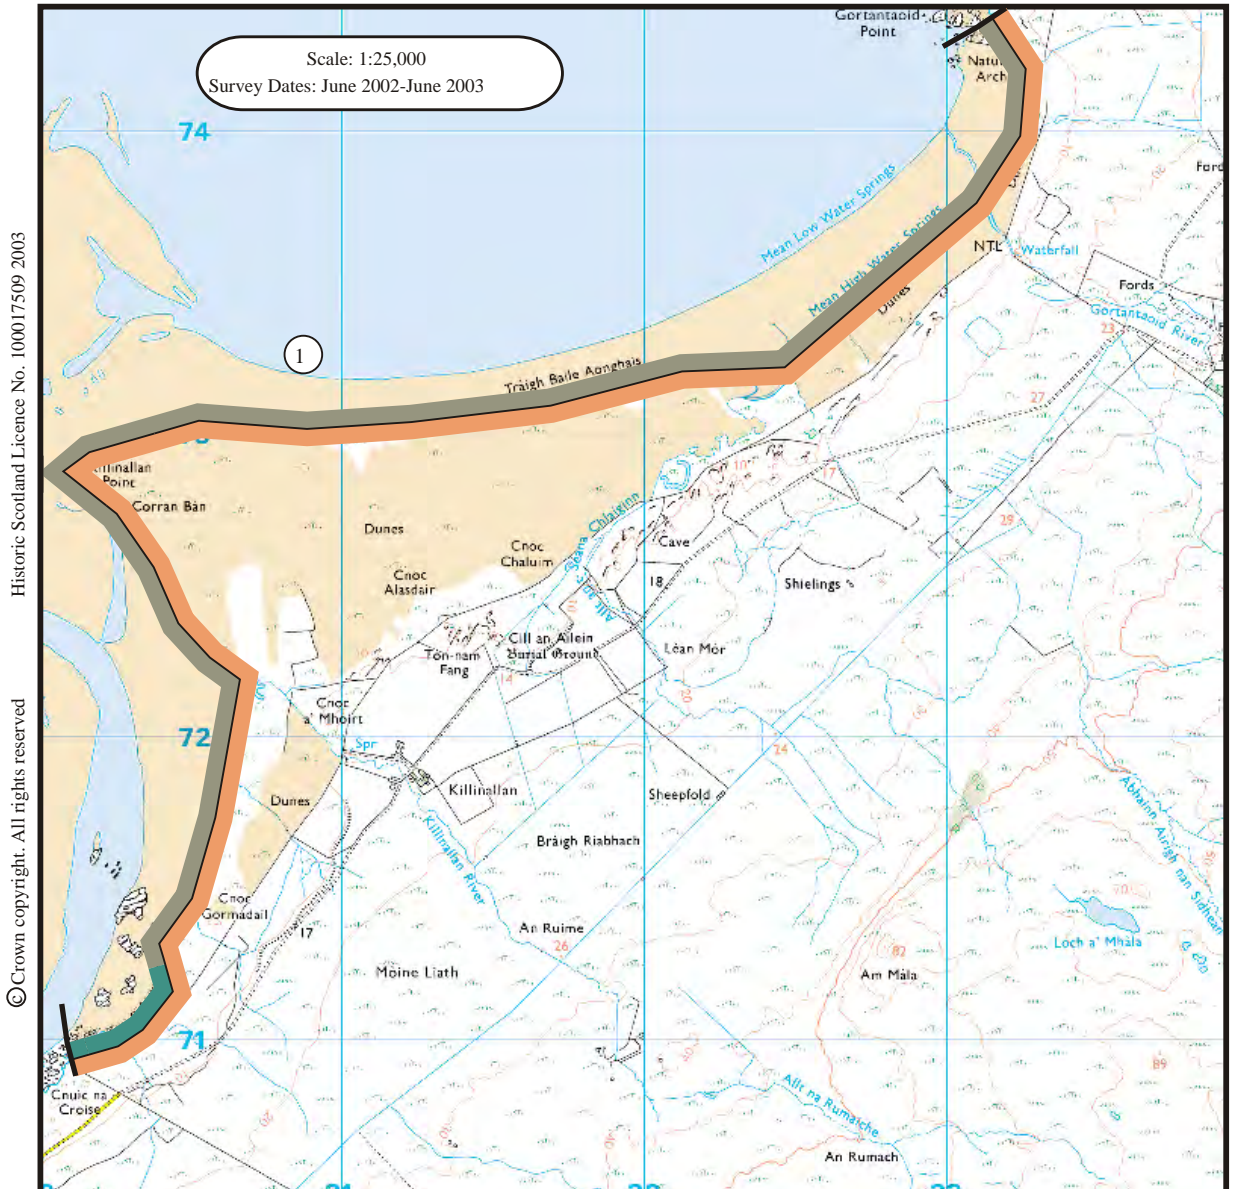
1. Killinallan Point

This unit encompasses a large sandy area around Killinallan Point. There is a level sandy beach with an extensive dune system in the hinterland. The dunes rise over 5m in height at Killinallan Point. This coast edge not classed as >5m because of the unstable nature of dune systems. The dunes are covered by marram grass. There is salt marsh at the coast edge for the last c. 250m of the unit. The salt marsh is narrow, at most c. 15m wide.
