Introduction to Map 32: Rubha Dearg to Rubh' a'Phuirt Mhoir

This map section covers some 5km of coastline. This section extends up to the mouth of Loch Indaal and is formed from generally low-lying coast with sloping rough ground to the hinterland. The coast edge in this map section has been classified as stable. The public A847 road runs behind the coastal zone and the dispersed modern settlement in the area is aligned along or focused upon the road. The road provides ready access to the coast in several areas, although there are no paths or tracks leading along the coast edge. Within the coastal zone, there is rough grazing land and boggy ground.

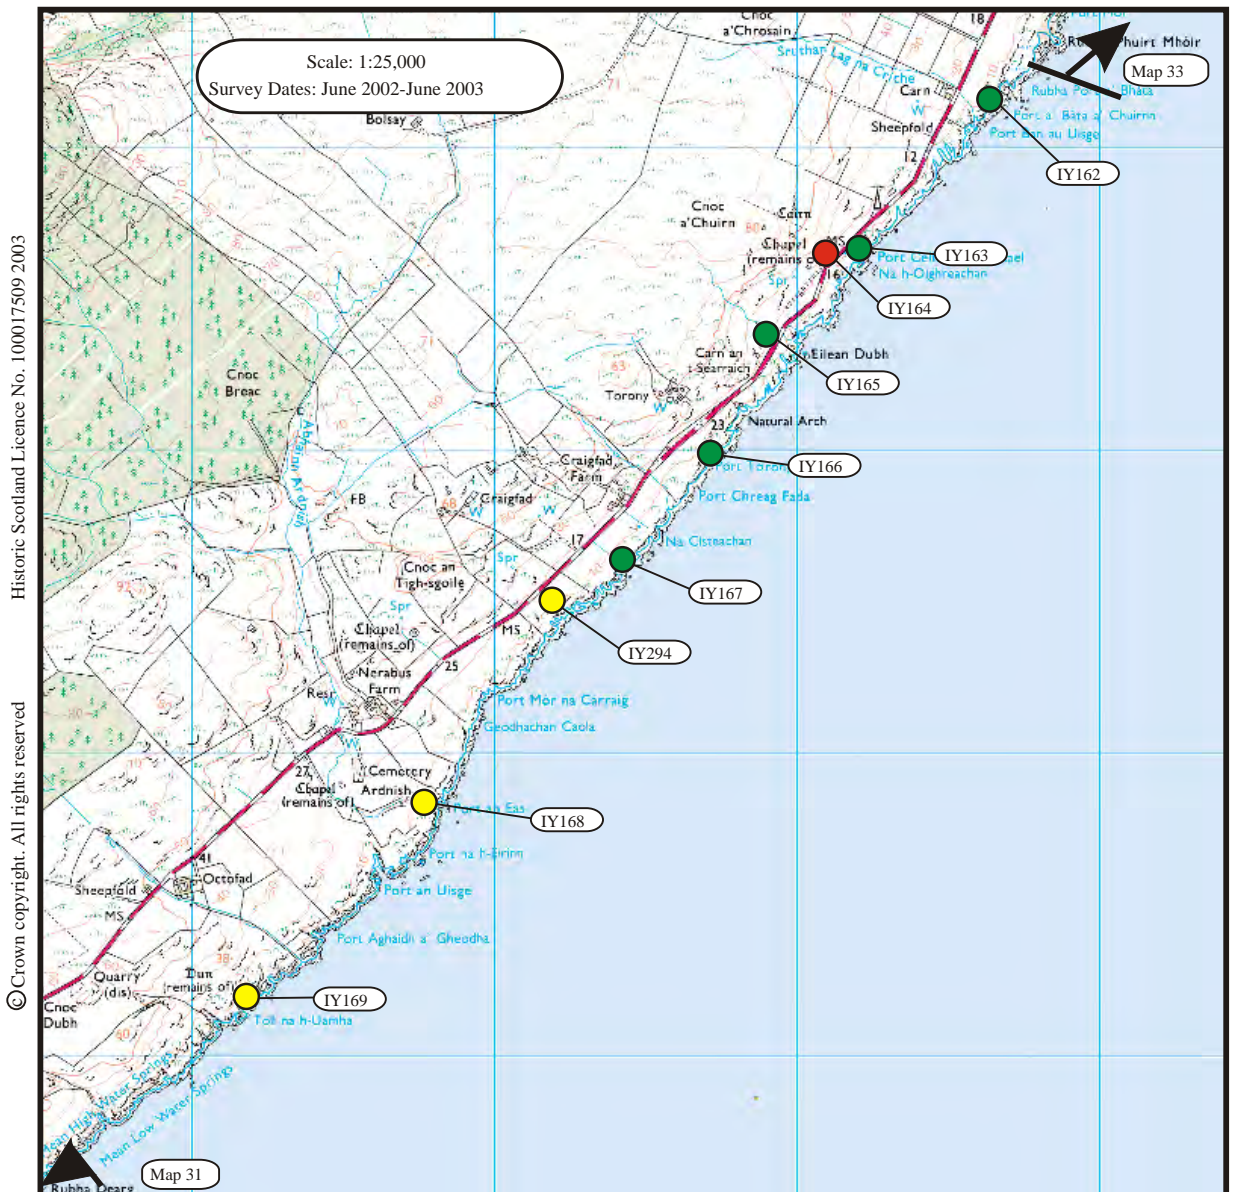
A total of nine sites were identified within this map section; four of these had been recorded previously. Six sites are thought to be of 18th-20th C date. These include land boundaries and cultivation remains (IY162, IY163, IY165, IY166, IY167) and a mill complex at Ardnish (IY168).

A chapel site at Ceallachan Mhicheil (IY164) is visible as a stone and rectilinear earthen banked enclosure containing the footings of a subrectangular chapel. It has been alleged that there was a burial ground and possibly a chapel at Craighfad (IY294) also, and graves are said to have been found there in the 1970's. There is now nothing to be seen but it is recommended that the site should be monitored for future developments.

A dun at Octofad (IY169) is located on a high rocky headland which is accessed via a narrow neck of land no more than 5m wide. The summit is surrounded by a stony bank, which may originally have formed a single structure. While almost invisible from the surrounding hinterland, the site commands good views over Loch Indaal.

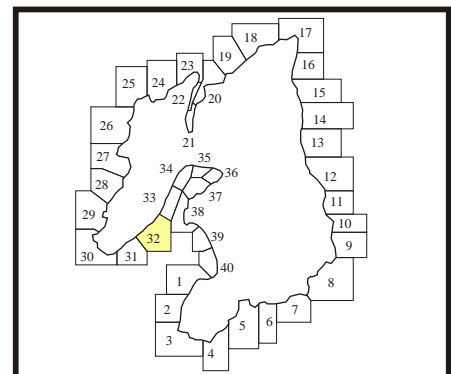
1. Craigfad

Rock platform

Coast edge <5m

Drift on visible rock.

Rocky coast edge with some cobble cover in coves. Dumping of a large amount of farm/building waste was noted at the end of a geo near Octofad. At the extreme north end of the unit there are raised beach deposits, and some salt marsh by the coast edge (<100m long and not shown). The hinterland is overgrown, poorly drained, rough grazing. There is also some scrub vegetation.

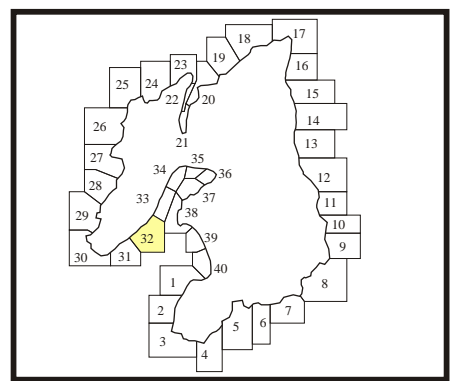
1. Craigfad

Stable

The coast edge in this unit is rocky and stable. No signs of erosion.
