Map 1: Scuthvie Bay to Lop Ness

Landscape, Built Heritage & Archaeology

Hinterland Geology & Coastal Geomorphology

Sunday
Map 1

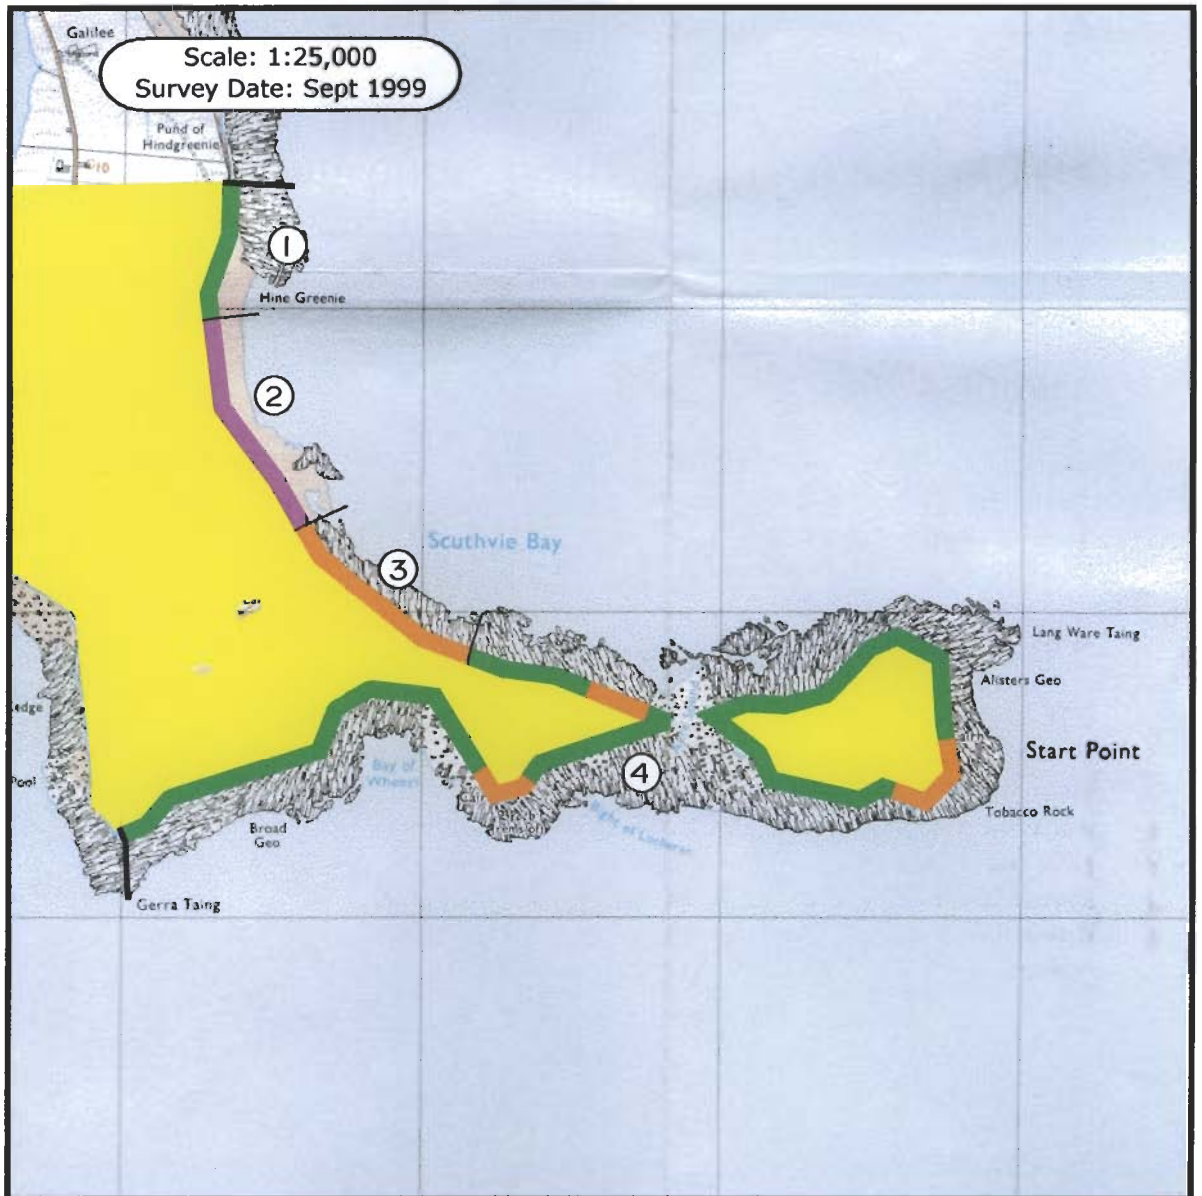
Erosion

While there are large stretches of eroding coast edge to the western side of Start Island there is also a great deal of sand accretion on the lower-lying eastern side. Most of the accretion is due to sand blow; stabilising vegetation has trapped further blown sand, culminating in the formation of coast ridge sand dunes.

The dunes at the coast edge are stable. This is generally due to the vegetation of lyme grass.

There are large areas of accreting sand along the upper foreshore and coast edge running into the dunes. Some of the accretion along the upper foreshore may constitute seasonal storm wash. There are also small areas where the coast edge has been eroded although this tends to be localised.

There is less evidence of accretion to the south and as the sand dunes decrease in size and the coast line becomes more definite there is localised erosion of the sandy edge. This is mainly due to cobble throw against the soft unprotected sand or till edge.

The coast edge is stable throughout most of this section and includes the tidal island of Start Point. In many places the coast line is protected by cobble upper foreshore as it grades up to the coast edge. Most prominent points of localised erosion are at Neuky, east of Mount Merry Buryan. Although there is a small sea defence wall at Buryan there is some erosion around the sides and to the west of the point. There is also a very small area of accreting shales and shell which constitutes a berm or small ayre on the western tip of Start Point island by the farm.
