Map 1: Scuthvie Bay to Lop Ness

Landscape, Built Heritage & Archaeology

Hinterland Geology & Coastal Geomorphology

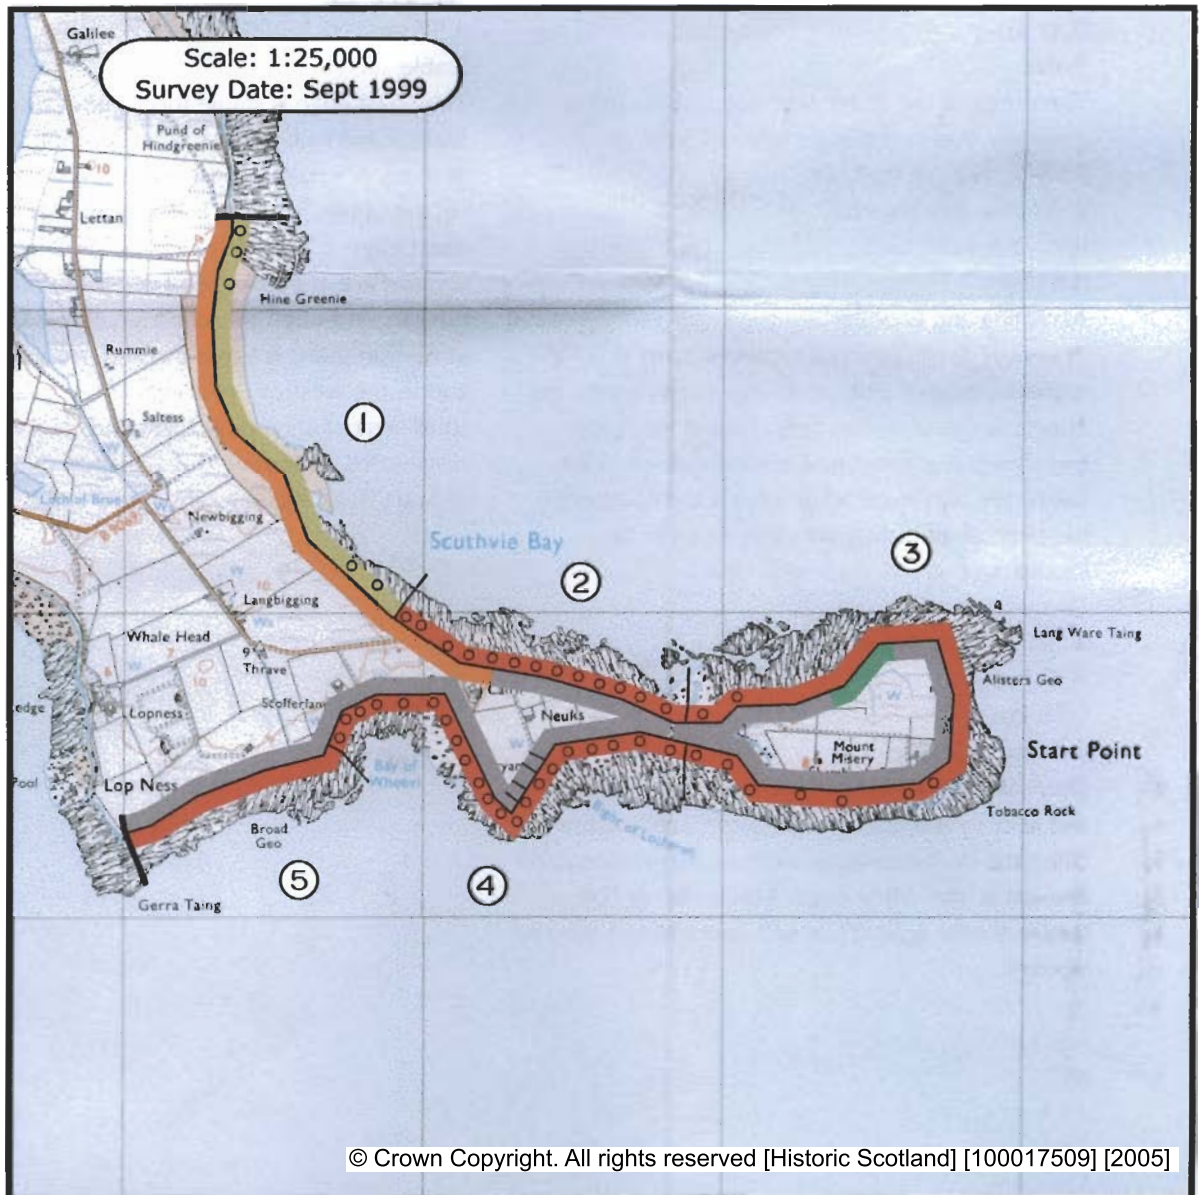
Sunday
Map 1

The bay has a large gently sloping sandy beach with sand dunes along the coast edge coast edge and hinterland. There are some cobbles to the north and the far south of this section of the upper foreshore although the main part of the beach is devoid of cobbles. The dunes rise to over 5m to the north and are generally stabilised by lyme grass along the coast edge with other tussock grasses to the hinterland side. The dunes divide into two smaller ridges to the south. On the hinterland side of the dune ridge ragwort is ubiquitous within fenced, grassed fields. Freely draining skeletal sands make up the soils.

The rock platform has cobbles along the upper foreshore increasing from 50% in the west to 80% at the east end of the section. The vegetated sand dune ridges fade out to sandy soils before Park. Fenced fields are down to grass with less ragwort apparent. Slopes are gently sloping at most. The soils are freely draining brown calcareous types. The littoral zone between Start point and the Sanday mainland has many rocks over a shingle shore area.

The rock platform is generally devoid of cobbles to the north and eastern side of this tidal island with some cobble cover along the upper foreshore to the south west. To the west by the causeway there are two substantial berms on a storm beach which are made up of shingle and shells for the most part. A large wet area of hinterland to the north east is classed as saltings. The field boundaries are made up of stone walls set back 7 to 15 m from the coast edge. A lighthouse and buildings lie to the western side and are set back into the hinterland. Apart from the saltings the soils are imperfectly or freely drained.

The rock platform has perhaps 80% cobble cover to the east and less than 50% to the west with a storm beach on the east shore of Weevie Bay. The fenced fields are down to grass with freely draining soils for the most part. A small sea wall lies to the south of Buryan.

The cobble grades out to negligible cover by Gerra Taing. Although the coast edge is well defined it rarely exceeds 3 m in height. Again slopes on the hinterland are negligible to gentle gradients with fenced grassed fields on imperfectly to freely draining soils.

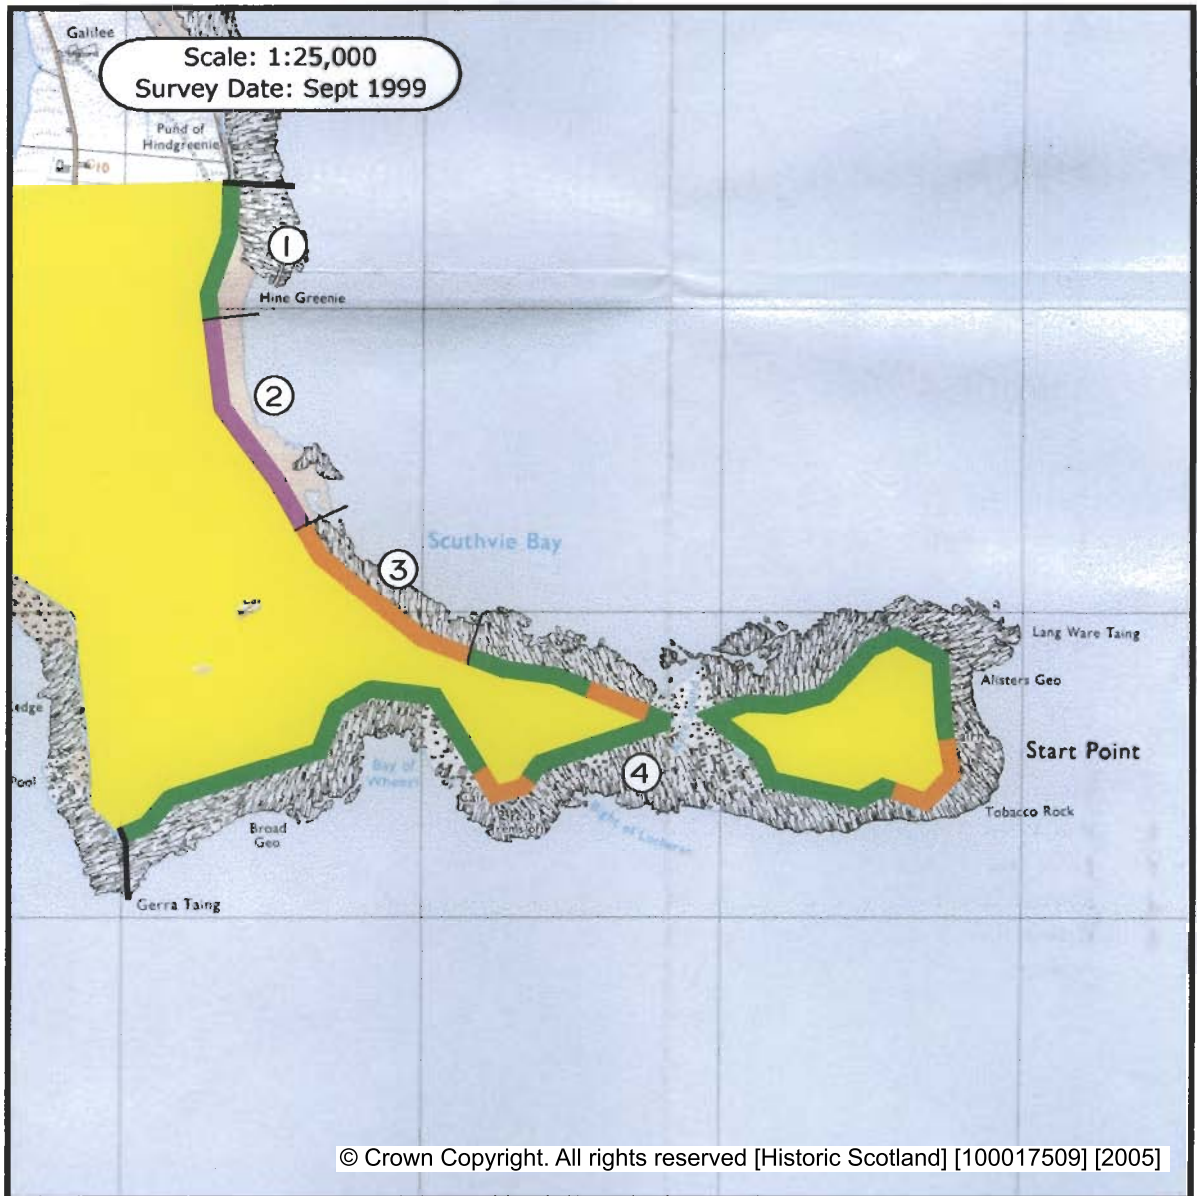
While there are large stretches of eroding coast edge to the western side of Start Island there is also a great deal of sand accretion on the lower-lying eastern side. Most of the accretion is due to sand blow; stabilising vegetation has trapped further blown sand, culminating in the formation of coast ridge sand dunes.

The dunes at the coast edge are stable. This is generally due to the vegetation of lyme grass.

There are large areas of accreting sand along the upper foreshore and coast edge running into the dunes. Some of the accretion along the upper foreshore may constitute seasonal storm wash. There are also small areas where the coast edge has been eroded although this tends to be localised.

There is less evidence of accretion to the south and as the sand dunes decrease in size and the coast line becomes more definite there is localised erosion of the sandy edge. This is mainly due to cobble throw against the soft unprotected sand or till edge.

The coast edge is stable throughout most of this section and includes the tidal island of Start Point. In many places the coast line is protected by cobble upper foreshore as it grades up to the coast edge. Most prominent points of localised erosion are at Neuky, east of Mount Merry Buryan. Although there is a small sea defence wall at Buryan there is some erosion around the sides and to the west of the point. There is also a very small area of accreting shales and shell which constitutes a berm or small ayre on the western tip of Start Point island by the farm.
