Map 10: Scuthi Head to Howland

Landscape, Built Heritage & Archaeology

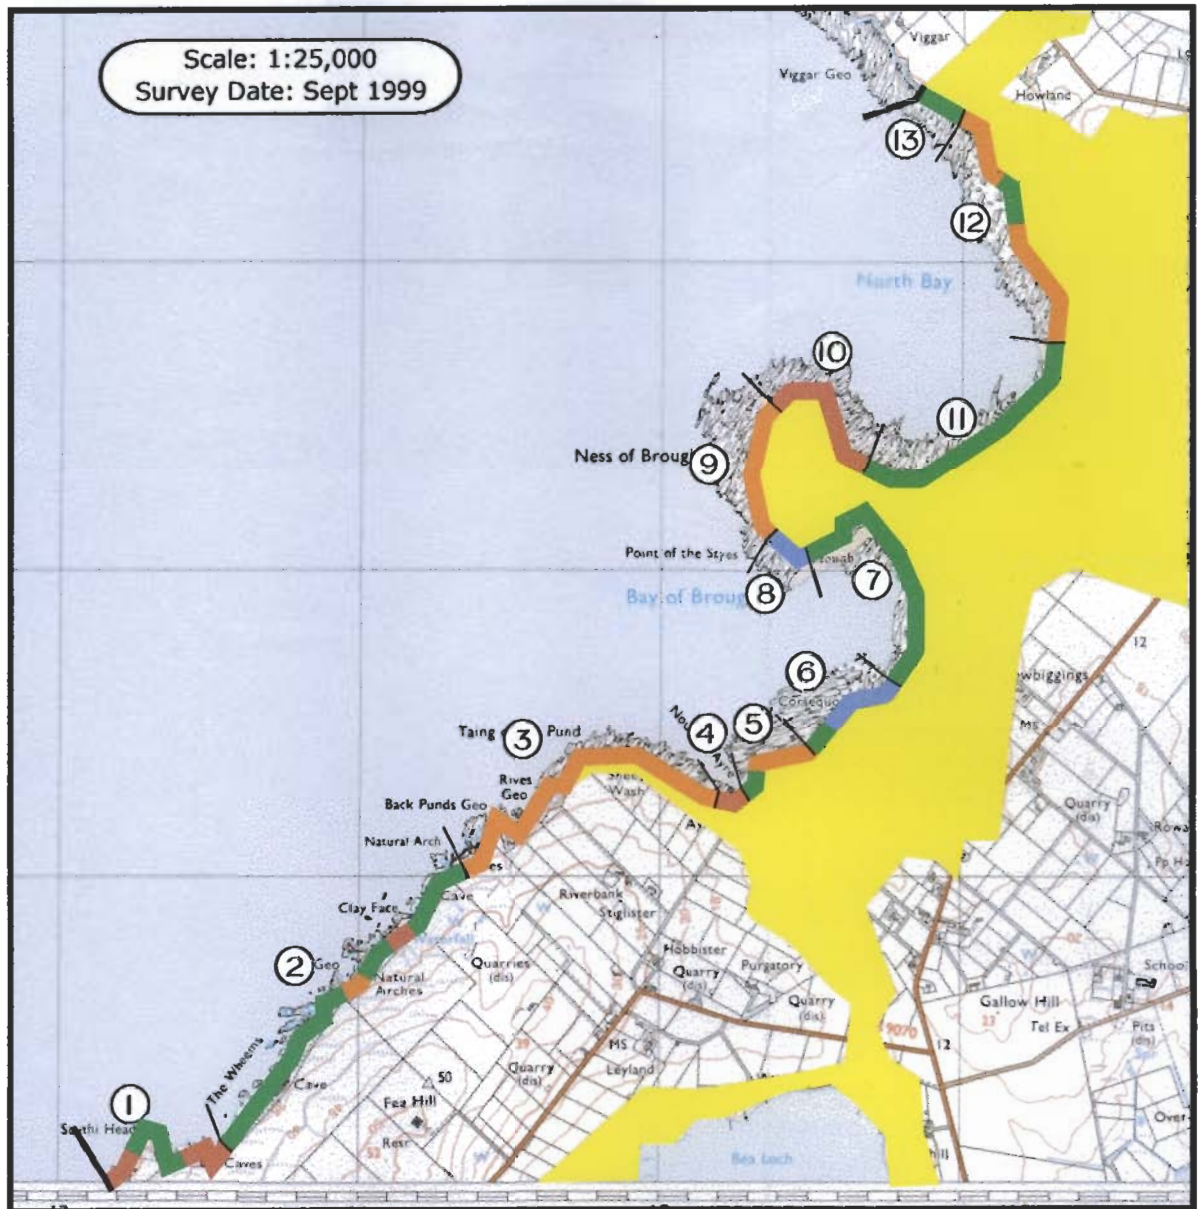
The geomorphology can be separated into three areas. The south is high cliffed with moderate to steep slopes, the centre of this unit from Broughtown to Hermisgarth is relatively low lying with storm beaches and sands, and the third smaller area to the north has a coast edge of moderate height with gently to moderately sloping ground.

Apart from the sections around Ayre and Ness of Brough the majority of the coast line in this unit is stable. There is also some accretion of shingle and cobbles in two areas around the Bay of Brough.
