## Map 10: Scuthi Head to Howland

### **Landscape, Built Heritage & Archaeology**

# Hinterland Geology & Coastal Geomorphology

# Sanday Map 10

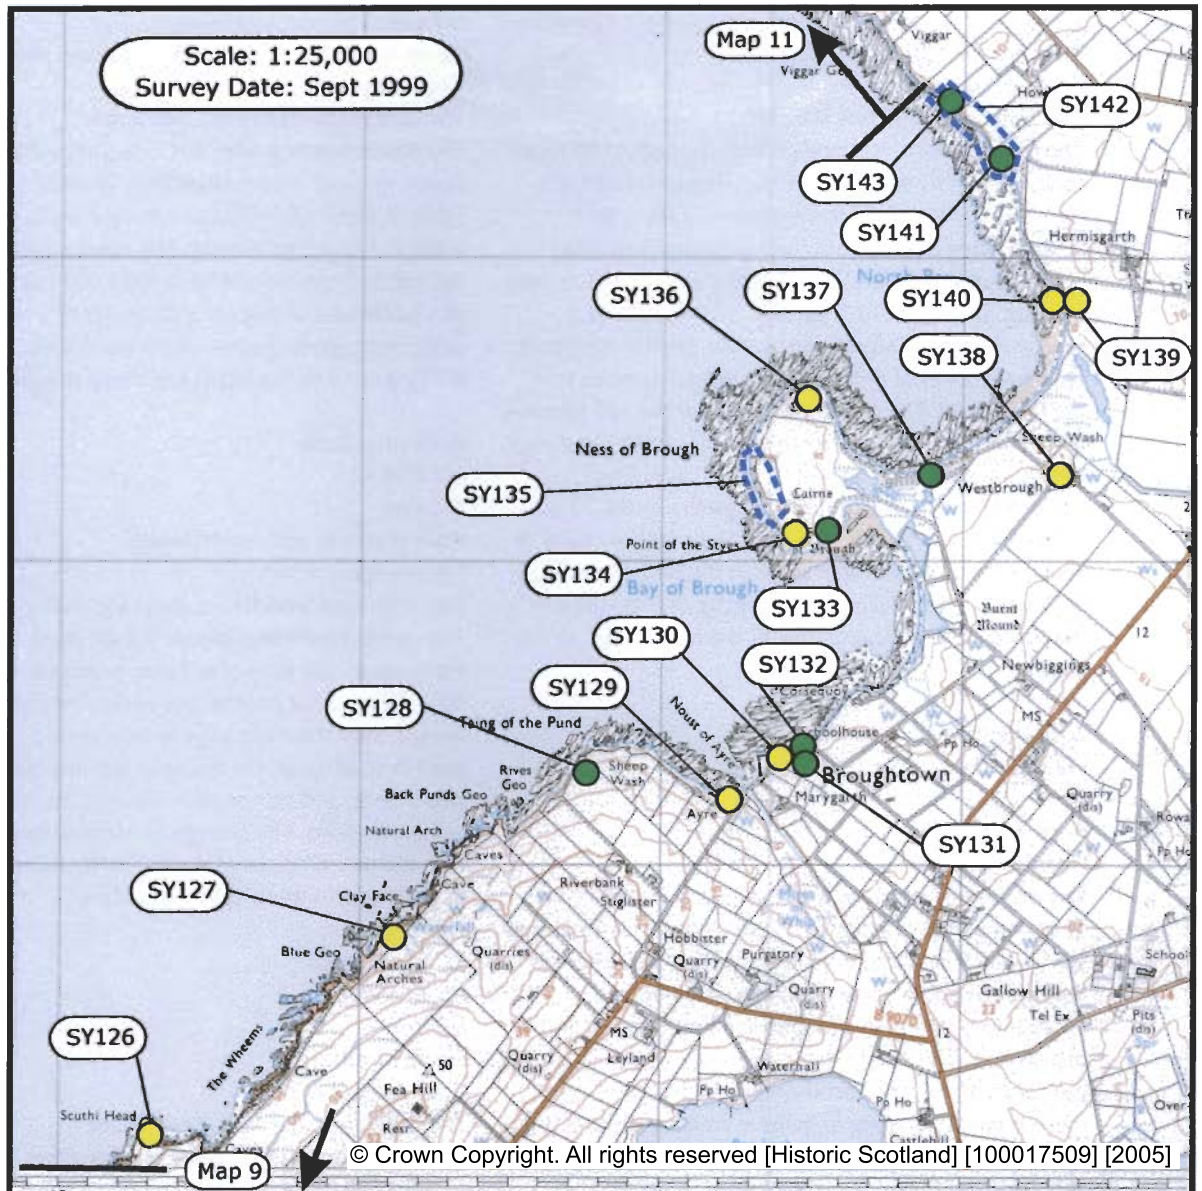
This map section commences at a central point on the west coast of the island. The coastline in this area is characterised by low banks and a relatively regular pattern of small fields of pasture in the hinterland. Exceptions occur at Scuthi Head, a high promontory and at Ness of Brough, where more open, rough land prevails. The section continues from here as far as the north side of North Bay, where despite a harder coast edge, erosion is occurring. Modern settlement in this area is concentrated around Broughtown, but most houses are set back from the coast, focusing instead on the road.

At Scuthi Head, a series of stout banks mark out parallel rectangular enclosures and a probable structure on a narrow promontory (SY126), surrounded by high cliffs. The site is one of the most likely locations on Sanday on which to find a defensive fort of prehistoric date. In this case, however, the regularity and rectangular shape of the enclosures are more indicative of a later, possibly early historic or medieval date.

Interestingly, there are other examples of large-scale earthworks in this area, although such remains are not otherwise commonly found on Sanday. At Fea Hill, a substantial land boundary or treb dyke (SY127) runs uphill from the coast and can be followed for over 100m, while part of an enclosure survives at Ayre (SY128). This theme can be developed further if two sites from the preceding Map 9 are included: at Mires (SY125) two banks of uncertain purpose are located in a valley base; while at Grunavi Head a bank and ditch close off access to a small promontory.

Remains exposed in the coast section at Ayre (SY129) apparently represent a rectilinear structure; associated anthropogenic deposits suggest a domestic context. The structure is buried by a layer of ploughsoil, up to 1m deep, suggesting that it is likely to be of some antiquity. This site may be associated with a nearby mound (SY130), which is eroding and has the appearance of a typical 'farm mound' or settlement of extended duration.

A possible human burial, eroding from the banks towards the south side of the Bay of Broughtown appears to be aligned east-west and may therefore be Christian. It is possible that, if confirmed, this burial may be part of a cemetery, possibly associated with the hitherto unconfirmed church site, previously thought to have stood at Chapel Head, nearby.

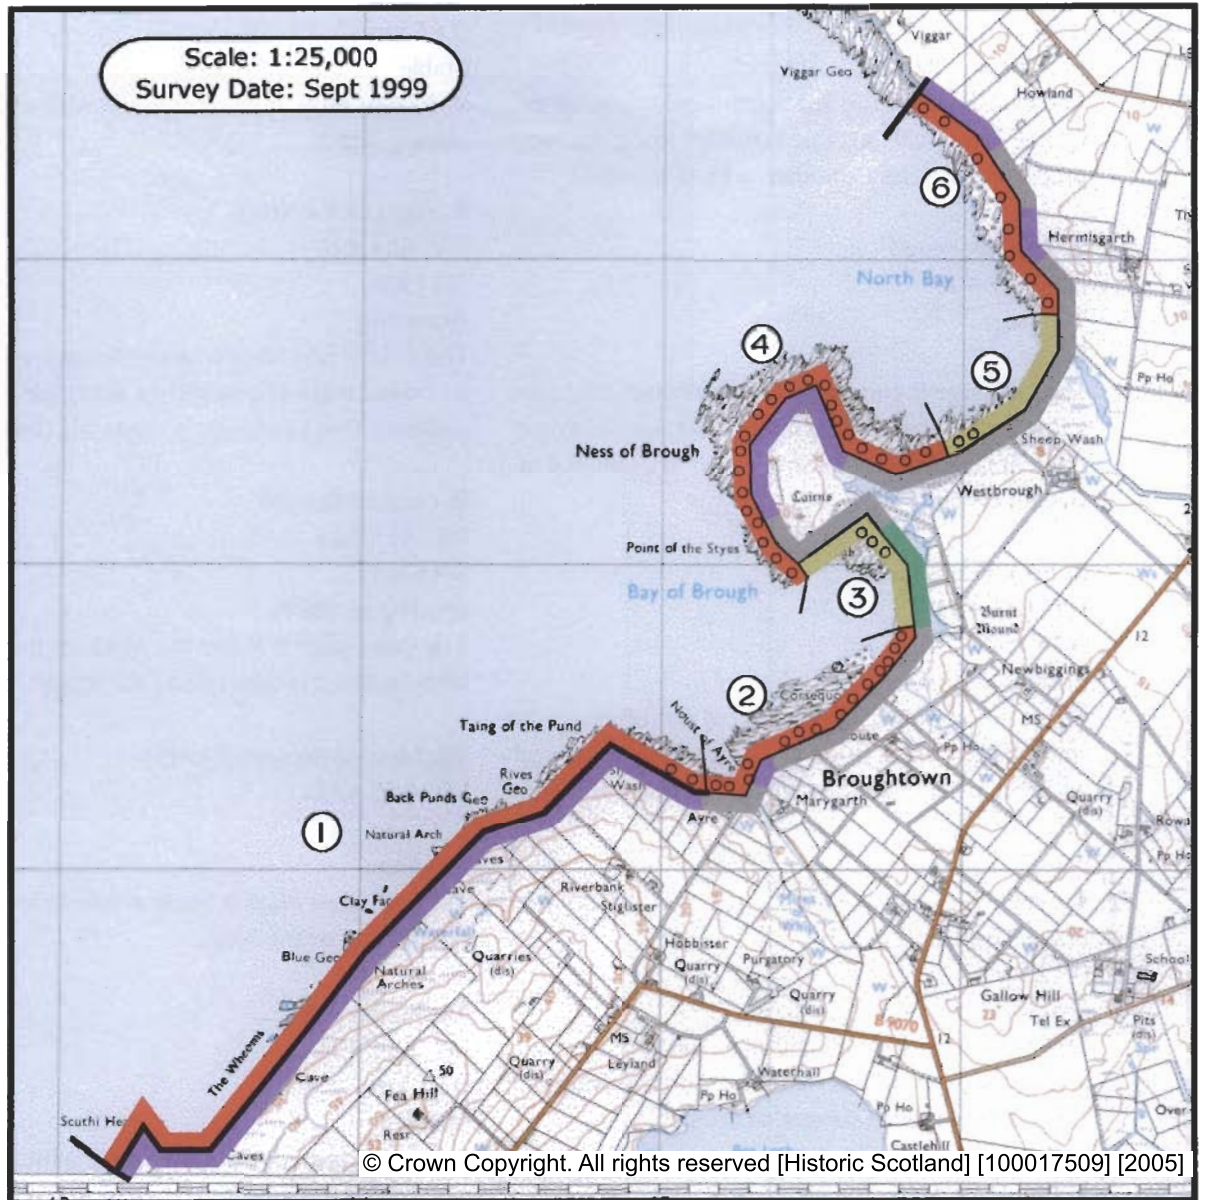
The geomorphology can be separated into three areas. The south is high cliffed with moderate to steep slopes, the centre of this unit from Broughtown to Hermisgarth is relatively low lying with storm beaches and sands, and the third smaller area to the north has a coast edge of moderate height with gently to moderately sloping ground.

The rock platform has negligible cover with a cliff faced coast edge > 30 m in some areas. Between Belfour's Geo and Scuthie Head there is some gullying with landslip along natural structural weakness creating hummocks and gullies. There is also a soil > 35 cm deep towards Scuthie Head. The soils lie directly over a saprolite, soft red sandstone or marl for the most part. One gully north of Belfour's Geo stretches 40 m into the hinterland. The other main areas of the cliff face are fairly coherent. Further north at Taing of the Pund rock shards have been thrown back over 40 m. The hinterland is fenced although this generally lies 20 - 30 m from the coast edge. The near hinterland is down to rough grazing with arable crops in the far hinterland. Soils tend to be poorly to imperfectly drained gleys in the south with more imperfectly drained podzol to the north.

The rock platform grades into cobble cover with a small storm beach at Ayre running up to the road. There is then some cobble cover around a small jutting promontory and then a long storm beach to the end of this section. The coast edge is generally well defined. To the north of the small promontory by Noust of Ayre there is much dumping of general waste and scrap onto the upper foreshore and along the coast edge. The cobbles give 100% cover further to the north. The hinterland is grassed with a stone wall along the northern end. The promontory is fenced and grassed and lies between the road. A wet area of hinterland lies beyond the road at Noust of Ayre and to the extreme north. Apart from these two waterlogged areas soil are mainly freely drained podzol.

The storm beach grades out slowly into shingle overlying sand. The cobbles then increase to the north again. A berm of cobble and shingle lies to the south along the upper foreshore. The coast edge is less well defined but runs onto a lip of sand and cobbles with a wet hinterland of saltings and a body of water. There is some fencing along parts of the hinterland. The soils at the ridge and to the north are freely drained.

The storm beach begins with shingle cover and increases in size to cobble cover to the north. A red till 30 - 40 cm thick overlies the rock. The storm beach washes over the coast edge in two areas to the west and north of Ness. On the west side the cobbles grade into a berm and shingle with the rock to drift interface being obscured. The Brough of Ness is mainly unfenced with old two dilapidated walls. The hinterland is down to grass over a freely drained podzol.

The sandy foreshore is generally free from shingle and cobble to the centre of the section. A small ridge of sand lies at the coast edge with grassed skeletal sands which is now fairly flat to gently sloping.

The sandy foreshore grades onto rock platform with a more well defined coast edge. There is some tipping of farm waste at the beginning of the section. The rock to drift interface is not always visible due to a large depth of reddish till which is >1.5 m in places. Soils are freely drained podzol with fenced grass fields.
