Map 11: Howland to Scar

Landscape, Built Heritage & Archaeology

Hinterland Geology & Coastal Geomorphology

Sanday Map 11

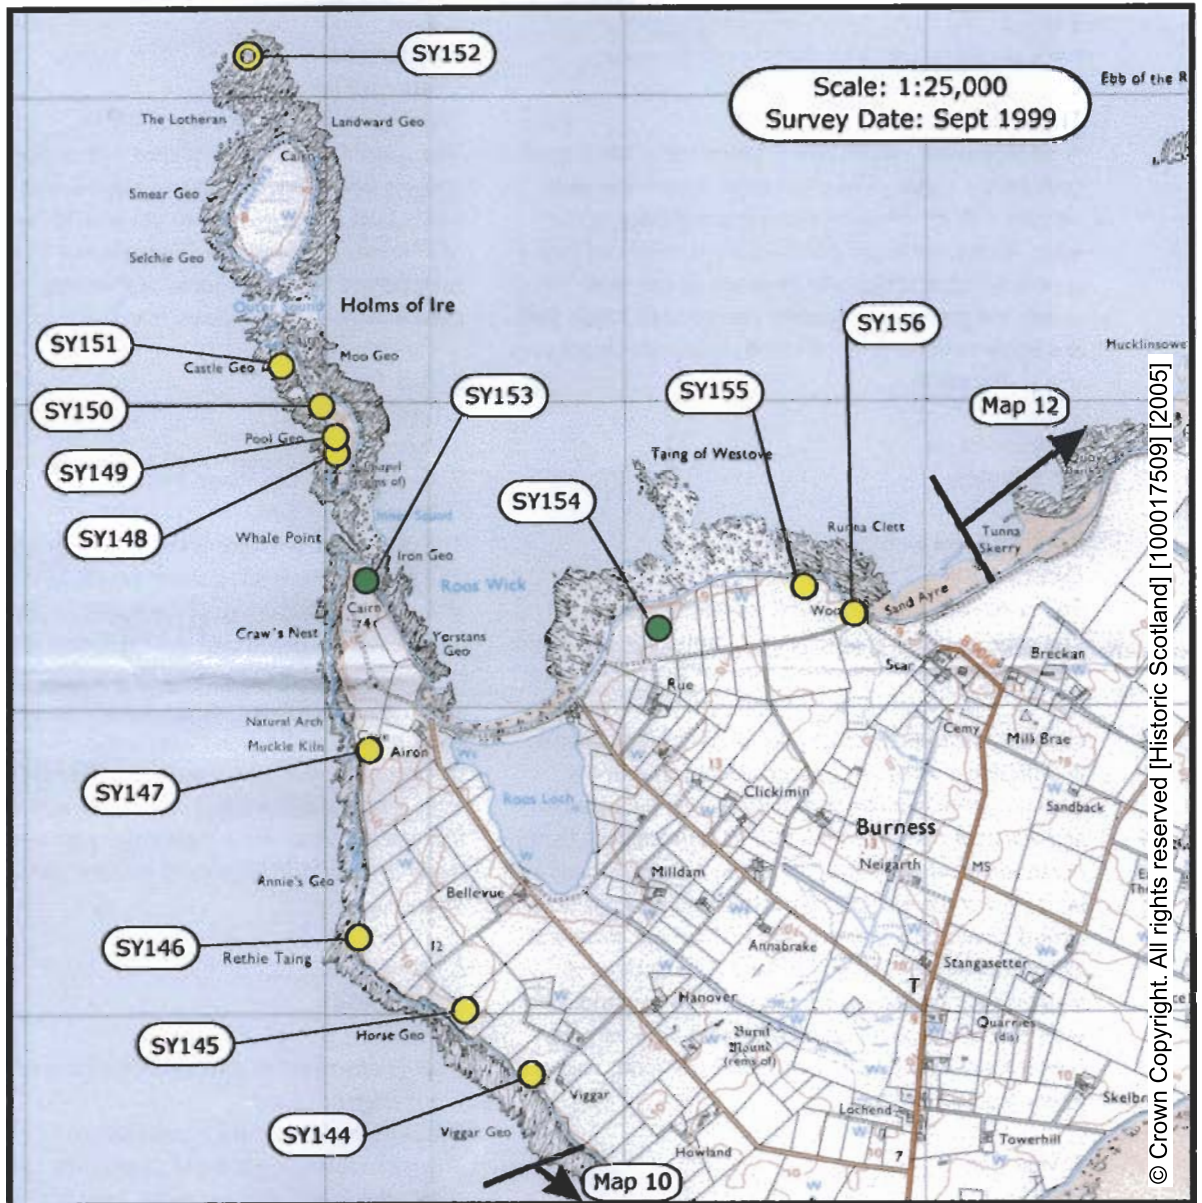
A dispersed group of probable burial mounds lie to the south of this area. The Knowe of Yarrow (SY145) is known only from records, having been destroyed some time before 1928. It is said to have contained a burial in an urn, of which no trace remains. At Rethie Taing (SY146) a chambered cairn lies on the coast edge and is eroding. Part of the entrance passage is visible to the seaward side; the cairn is very vulnerable to destruction from continued erosion. Further to the north, an undistinguished grassy mound at Rue (SY154) may also be a funerary monument; it is situated over 50m from the coast and is not currently at risk.

A low mound close to the coast edge at Runna Clett (SY153) has been recorded as the site of a broch. Coastal erosion to the seaward side of the mound has exposed archaeological deposits, but while some large stone blocks and midden-type deposits are present in the section, there is little to indicate the presence of such a substantial structure. In another coastal exposure at Woo (SY156), shell midden is revealed in close association with a relict soil. these deposits may be suggestive of an early prehistoric settlement. They derive from a long, low mound which is being eroded by the sea.

Two churches have been reported here; one at Kirk Geo (SY144) may be based merely on place name evidence, but the other (SY148) is located on the inner Holm of Ire and can still be seen. Said to be dedicated to St. Colm, this small and presumably early chapel has been damaged both by coast erosion and impromptu investigations. Situated close to a storm beach, the interior is now covered by quantities of loose stone, which although obscuring it may serve to protect the remains to some degree.

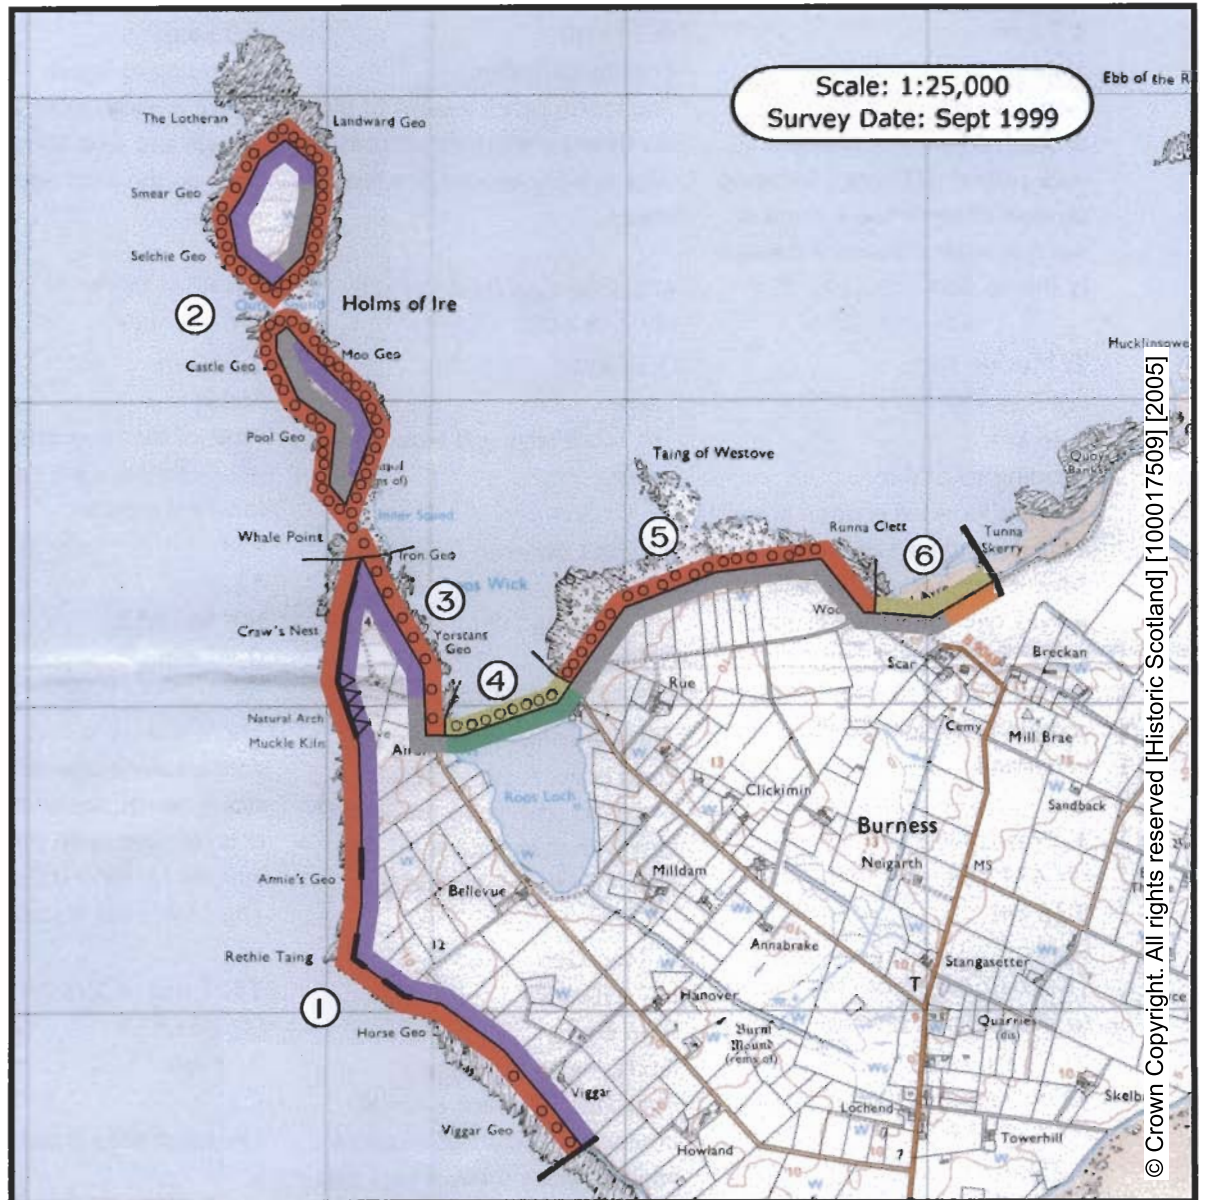
A small discrete cobble storm beach lies within a small cove below Viggar. The coast edge is generally well defined with a stone wall running along close to the edge. To the north the promontory is unfenced with a quarry which appears to be in use of the time. The slopes are generally moderate with grassed fields. Soils are freely to imperfectly drained podzol which are very thin to the north.

The main feature of the coast line are the large storm beaches mainly composed of boulders with some cobbles. Most of the coast edge is covered by cobbles and boulders along the eastern sides. Some of the boulders have been thrown > 40 m into the hinterland and are now overgrown. A buff till is prominent on the north island where it is > 1 m deep. An old sea wall also lies to the south east of the north island which is now almost covered by storm beach with an old coast wall almost obliterated. The hinterland is fairly clear of thrown rock on the west side of the north island. The west side of the south island has much boulder and cobble thrown over 20 m into the hinterland. Soils are freely drained podzol.

The rock platform has intermittent cobble cover with up to 40% cover mainly along the upper foreshore. The coast edge is well defined with a moderate to steeply sloping hinterland. Fields are grassed with stone walls and an underlying freely drained podzol.

The upper foreshore is covered with a storm beach of cobbles which extends up to a ridge with a track. A newly built stone wall lies to the east of the bay in front of a house. The hinterland drops down to Roos Loch lying behind the ridge. Some of the ridge may well have been enhanced and appears man made in areas.

The rock platform has a storm beach to the west grading to cobble cover of the upper foreshore with another storm beach past the first point which then grades to cobble cover of the upper foreshore again which grades to more shingle further to the east. The coast edge is well defined with some overgrown cobble throw on the east side. Further to the east the coast edge is better defined and may be up to 3 m high in a few places. Generally the soils of the hinterland are freely drained podzol with more sand content towards Woo.

The rock platform has more sand cover to the east. The coast edge is well defined to the west with some farm waste in front of Woo to help slow down erosion. A berm of sand grades into cobble along the upper foreshore over the sand with a sandy ridge along the coast edge to the east of Woo. The cobble increases along the upper foreshore and coast edge to the east of this section. A small dumping area of farm waste lies on the coast edge to the west of Woo. The hinterland has a freely drained podzol to the west of Woo with a wet area behind the buildings and sand dune ridge to the east.
