Map 11: Howland to Scar

Landscape, Built Heritage & Archaeology

Sanday Map 11

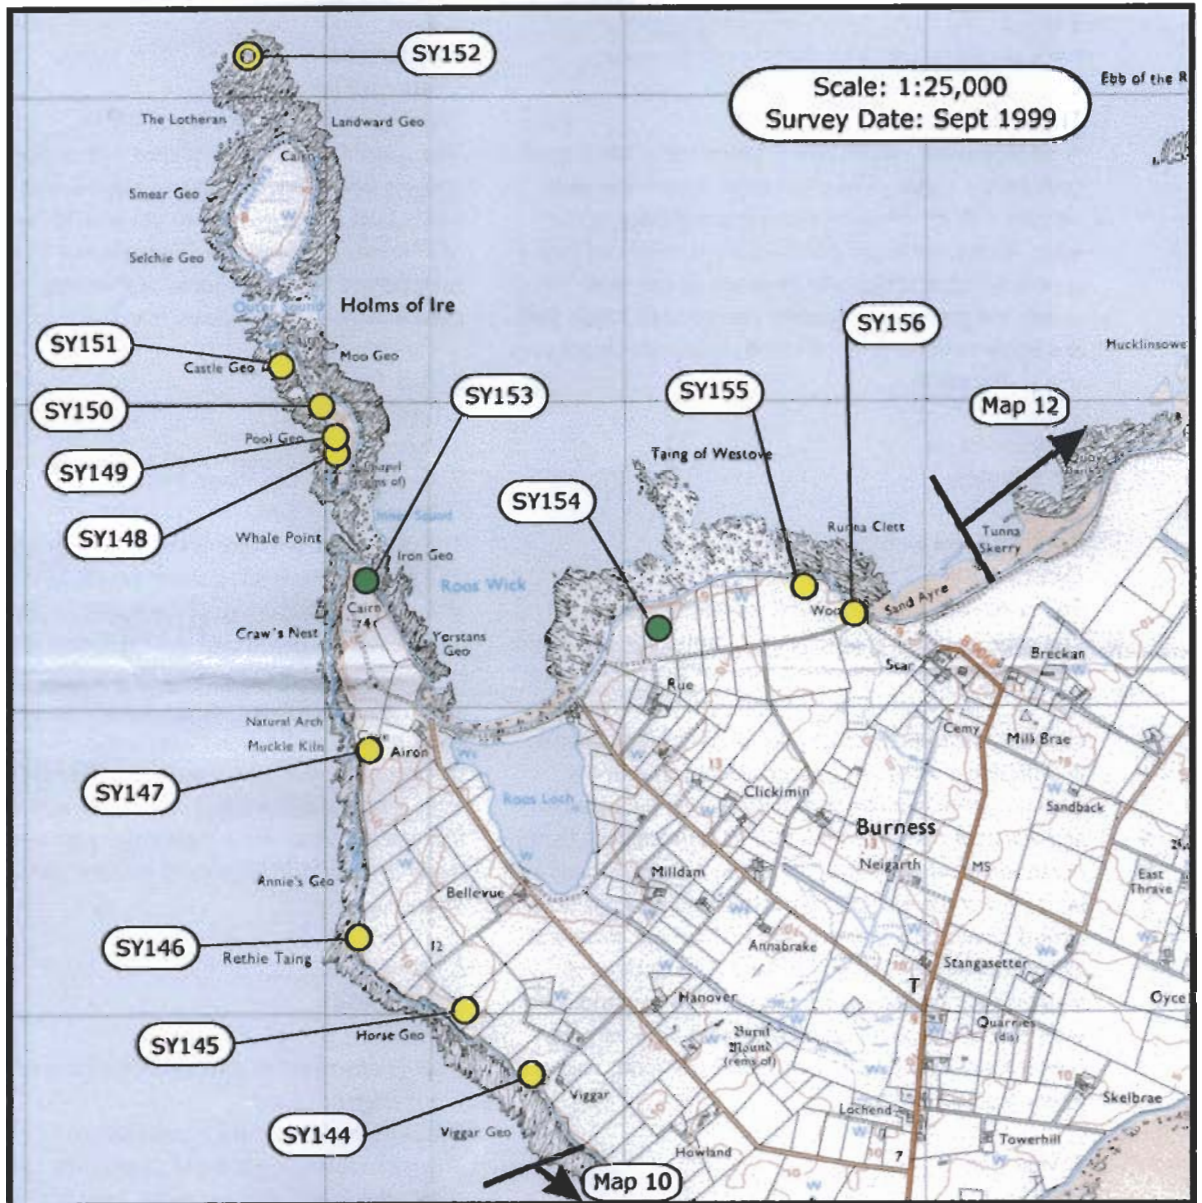
A dispersed group of probable burial mounds lie to the south of this area. The Knowe of Yarrow (SY145) is known only from records, having been destroyed some time before 1928. It is said to have contained a burial in an urn, of which no trace remains. At Rethie Taing (SY146) a chambered cairn lies on the coast edge and is eroding. Part of the entrance passage is visible to the seaward side; the cairn is very vulnerable to destruction from continued erosion. Further to the north, an undistinguished grassy mound at Rue (SY154) may also be a funerary monument; it is situated over 50m from the coast and is not currently at risk.

A low mound close to the coast edge at Runna Clett (SY153) has been recorded as the site of a broch. Coastal erosion to the seaward side of the mound has exposed archaeological deposits, but while some large stone blocks and midden-type deposits are present in the section, there is little to indicate the presence of such a substantial structure. In another coastal exposure at Woo (SY156), shell midden is revealed in close association with a relict soil. these deposits may be suggestive of an early prehistoric settlement. They derive from a long, low mound which is being eroded by the sea.

Two churches have been reported here; one at Kirk Geo (SY144) may be based merely on place name evidence, but the other (SY148) is located on the inner Holm of Ire and can still be seen. Said to be dedicated to St. Colm, this small and presumably early chapel has been damaged both by coast erosion and impromptu investigations. Situated close to a storm beach, the interior is now covered by quantities of loose stone, which although obscuring it may serve to protect the remains to some degree.
