Map 15: Westayre Loch to Tofts Ness

Landscape, Built Heritage & Archaeology

Geology and Geomorphology

Erosion

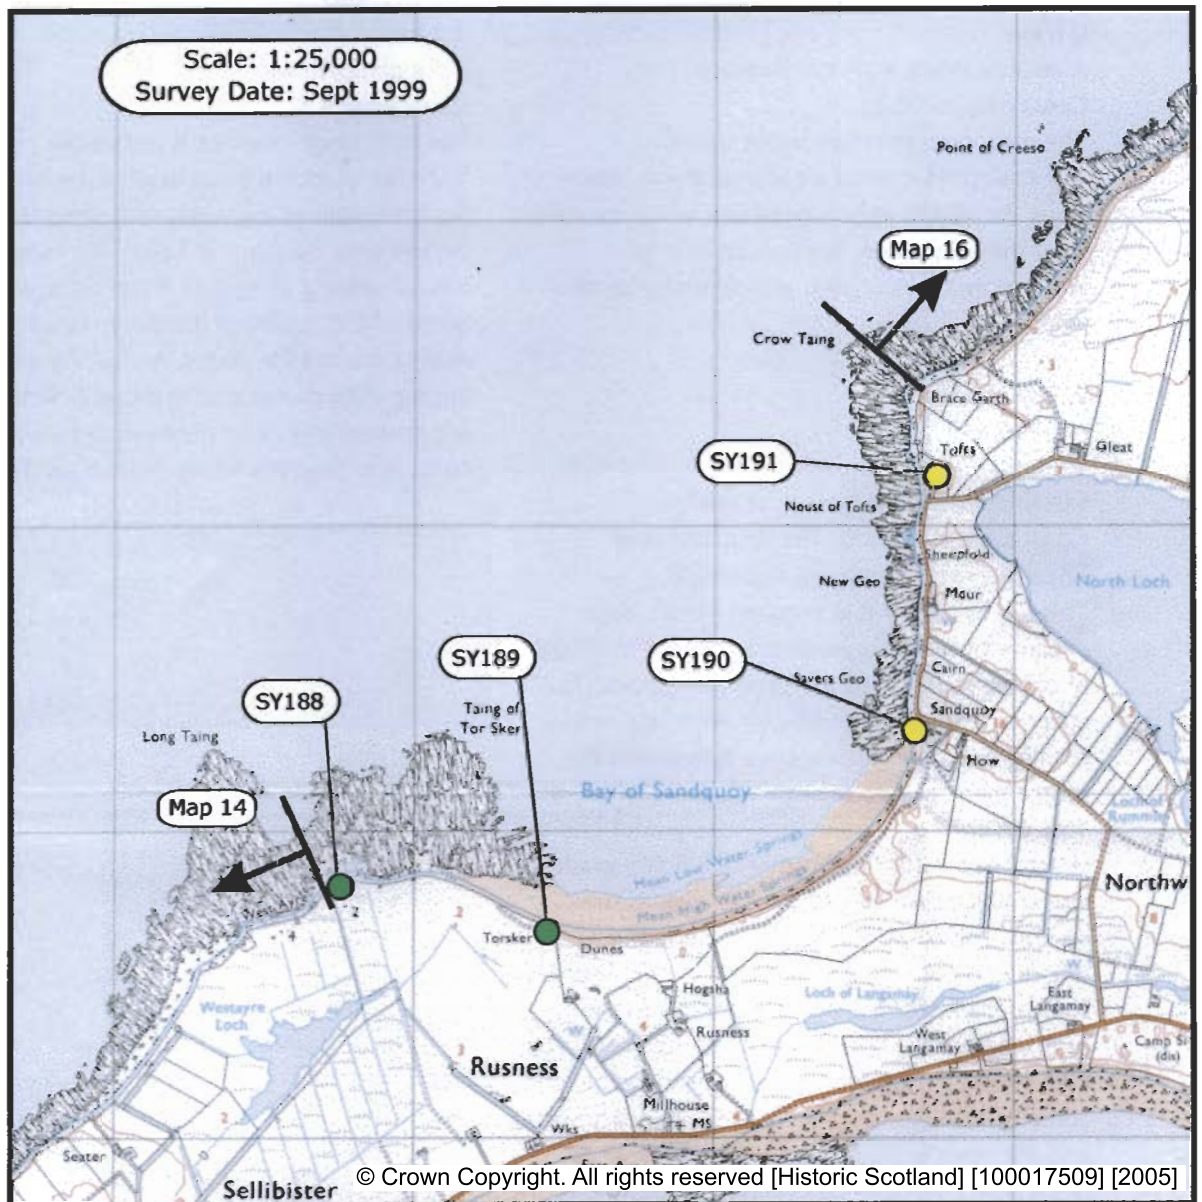
This map section commences at a sharp headland which lies to the north of Westayre Loch. It extends into the Bay of Sandquoy, where the long sandy beach is bordered by dunes and there are quantities of unconsolidated, drifting sand. Along the east side of the bay to Tofts and beyond, the coast becomes progressively more rugged and less sandy. Over most of this area, the hinterland comprises large open areas of pasture land which are prone to sporadic blow-outs and coverage by drifting sand. From How, on the east side of the Bay of Sand Quoy onwards to Tofts, there are smaller more regular fields in the hinterland and bordering North Loch. The little modern settlement present within this section lies to the northeast of the area.

At Taing of Tor Sker, a pool set into the shingle bar in the intertidal area may have been artificially deepened for use as a fish trap (SY188). It lies close to the 19th C farm buildings at Torsker (SY189). This abandoned farmstead is slowly being inundated with drifting sand; stonework visible in a short section on the coast is probably a feature of recent date which has become buried beneath the sand rather than evidence of earlier activity.

Stonework exposed in the coast section at Sandquoy (SY190) may be part of a prehistoric burial mound or house. Old records describe how a structure which was opened and demolished in this area had three compartments and contained human skulls. While it has been classified as a possible souterrain, the description is more suitable to a chambered cairn or burial mound with multiple cists. It is unlikely that much of this site survives.

The most substantial indication of earlier activity in this area is provided by the massive farm mound which underlies the present farmstead at Tofts. This mound, which measures at least 100m in diameter extends to the coast edge and is eroding. The exposed deposits, which include many interleaving layers of peatash and highly organic soil with shell, bone and flint, are up to 2m thick. There were few diagnostic finds among the deposits and of those that were seen, all relate to the latest period of deposition, probably in the 19th C.

SY188

HY7273 4484
Taing of Tor Sker
Possible fish trap
Unknown
Fair
Survey

SY189

HY7342 4470
Torsker
Farmstead & coastal exposure
18-20th C
Fair/poor
Nil

SY190 HY74NW3

HY7467 4532
Sandquoy
Coastal exposure & alleged souterrain
?3rd-1st mill BC
Poor
Monitor

SY191 HY74NW5

HY7475 4615
Tofts
Mound and coastal exposure
Unknown: ?prehistoric
Good
Monitor

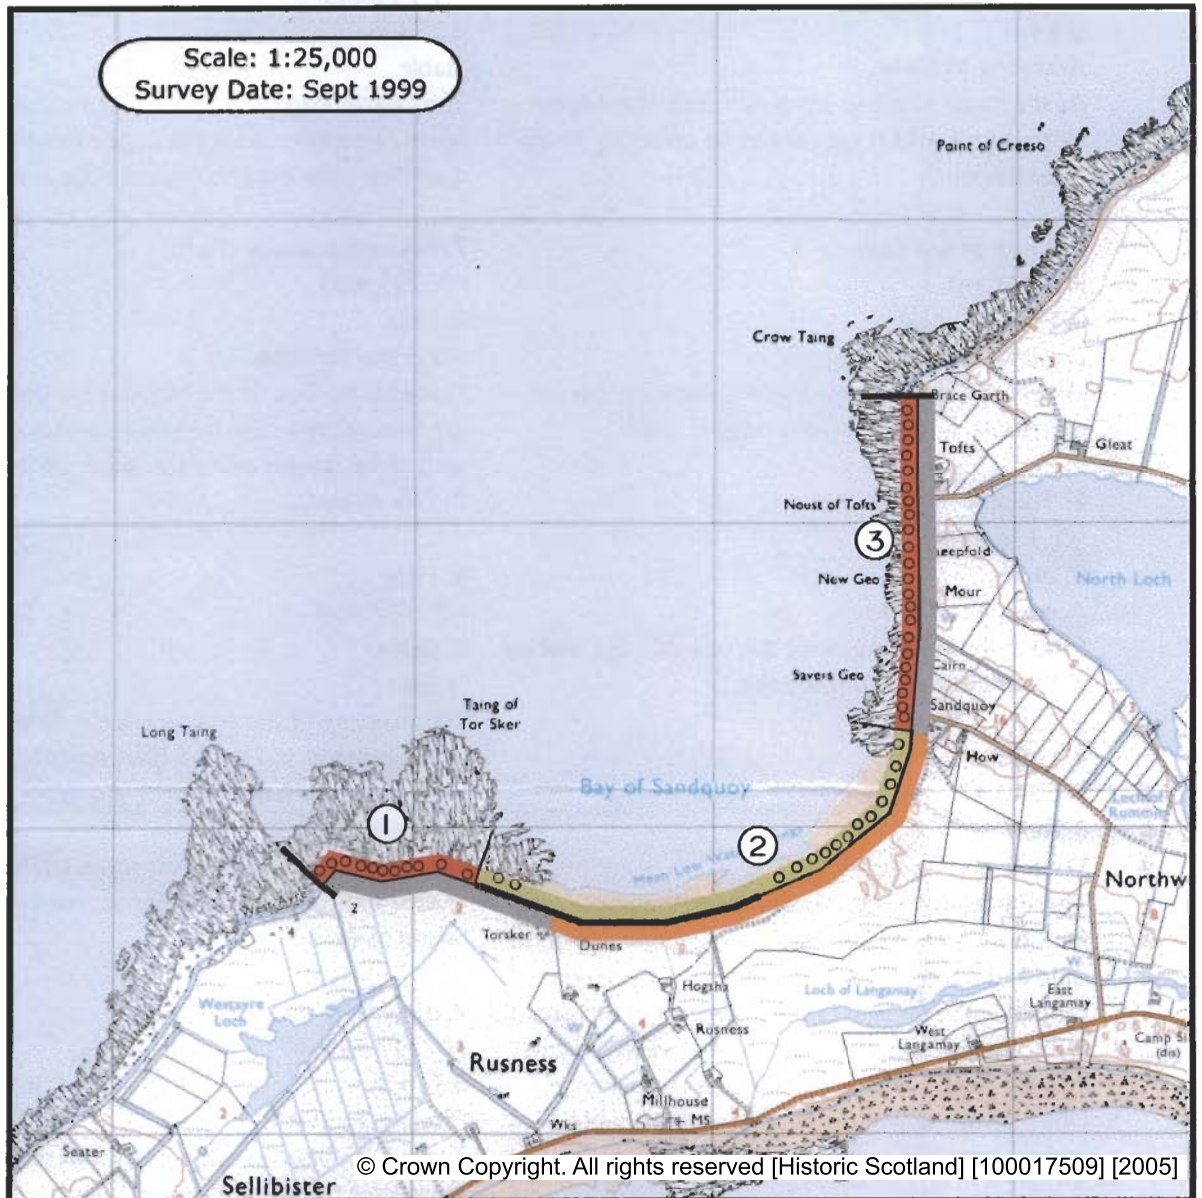
The unit has the large sandy Bay of Sandquoy to the centre with rock platform and storm beaches at either end. The hinterland has fenced grass fields with sand dunes behind the bay. Much of the soils are poorly drained gleys and water logged sandy soils to the far hinterland behind the dunes. The dune ridge is vegetated overlying freely drained skeletal sands.

1. Long Taing

A rock platform with storm beach.

The rock platform has a cobbled storm beach along the mid to upper foreshore which forms a lip at the coast edge. Soils are poorly to imperfectly drained gleys with fenced grassed fields.

2. Bay of Sandquoy

Sandy foreshore with areas of cobble.

This sweeping bay is dominated by the large expanse of sandy foreshore. There are small areas of cobble cover along the upper foreshore. This cover extends 100 m from the west side before grading out and reappears briefly towards the centre then again to the east of centre where a 40% cover of the upper foreshore grades into a storm beach with one berm which finally grades into cobble cover before the east side of this section. The coast edge is > 5 m along the west side due to the height of the sand dunes. There is some deflation of the dunes especially to the centre where the coast edge drops to < 5 m. The dunes form a ridge with a level hinterland beyond. Some of the dune ridge is fenced and incorporated into the fields beyond. Soils are freely drained sands with some gleys and waterlogged soils to the far hinterland. A small mound lies close to Sandquoy and then a stone wall lies around the house.

3. Sandquoy

Rock platform with storm beach.

The rock platform has a large storm beach which lies the length of this section. A berm is more evident past the farm at Tofts. The coast edge has a road running along side from Sandquoy to Tofts. Some of the cobble of the storm beach lies up against the road in places. At Tofts there is some tipping of farm waste used as sea defence. Fields are grassed and generally have stone walls to the coast side. Soils are freely drained sandy podzol.
