Map 2: Lop Ness to Sellibister

Landscape, Built Heritage & Archaeology

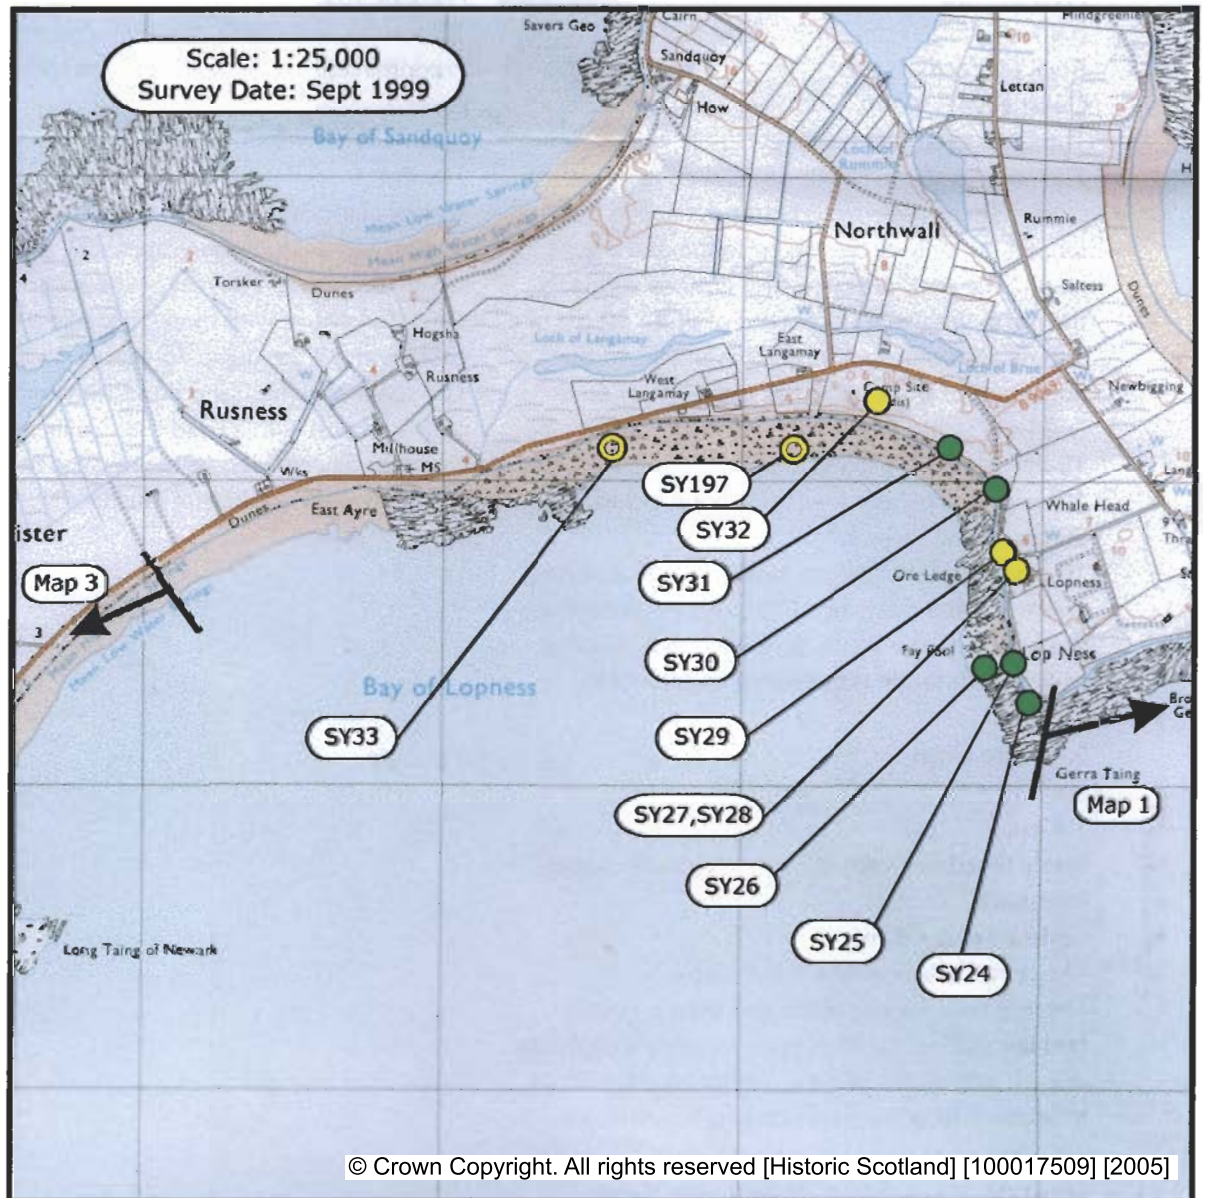
Sea erosion to the northeast side of the Bay of Lopness has exposed archaeological deposits in the coast section in several places. At Lopness (SY27), part of a probable prehistoric stone structure, which has a flagstone floor, and midden-type deposits associated with it are exposed in section. Topographical features in the surrounding hinterland suggest that further buried remains may lie inland.

More enigmatic remains exposed in section at Stackald Brae (SY30) include columns of coursed masonry and anthropogenic soils; it is possible that these remains may be associated with a church (SY29) recorded in this area, the location of which is currently unknown.

In the northern corner of the bay, eroding deposits are revealed in a 15m long coast section. These include soils rich in bird, fish and mammal bone, shell and organic content. The deposits are eroding from the peripheries of a very large, grassy mound, which is more than likely a 'farm mound' or multi-period settlement of extended duration.

Military remains are represented in this area by the wreck of a WWI German destroyer, the B98, which lies just off-shore (SY33). It was grounded here while under tow to Scapa Flow for salvage in 1919, and although it has been divested of much of its metal, it is clearly visible from the shore. In contrast, very little remains of the WWII accommodation camp (SY32) which served the radar station (map 1) and which stood near the centre of the bay. This is because most of the camp would have comprised nissan huts and temporary structures which could be easily dissembled, leaving only the concrete bases behind.

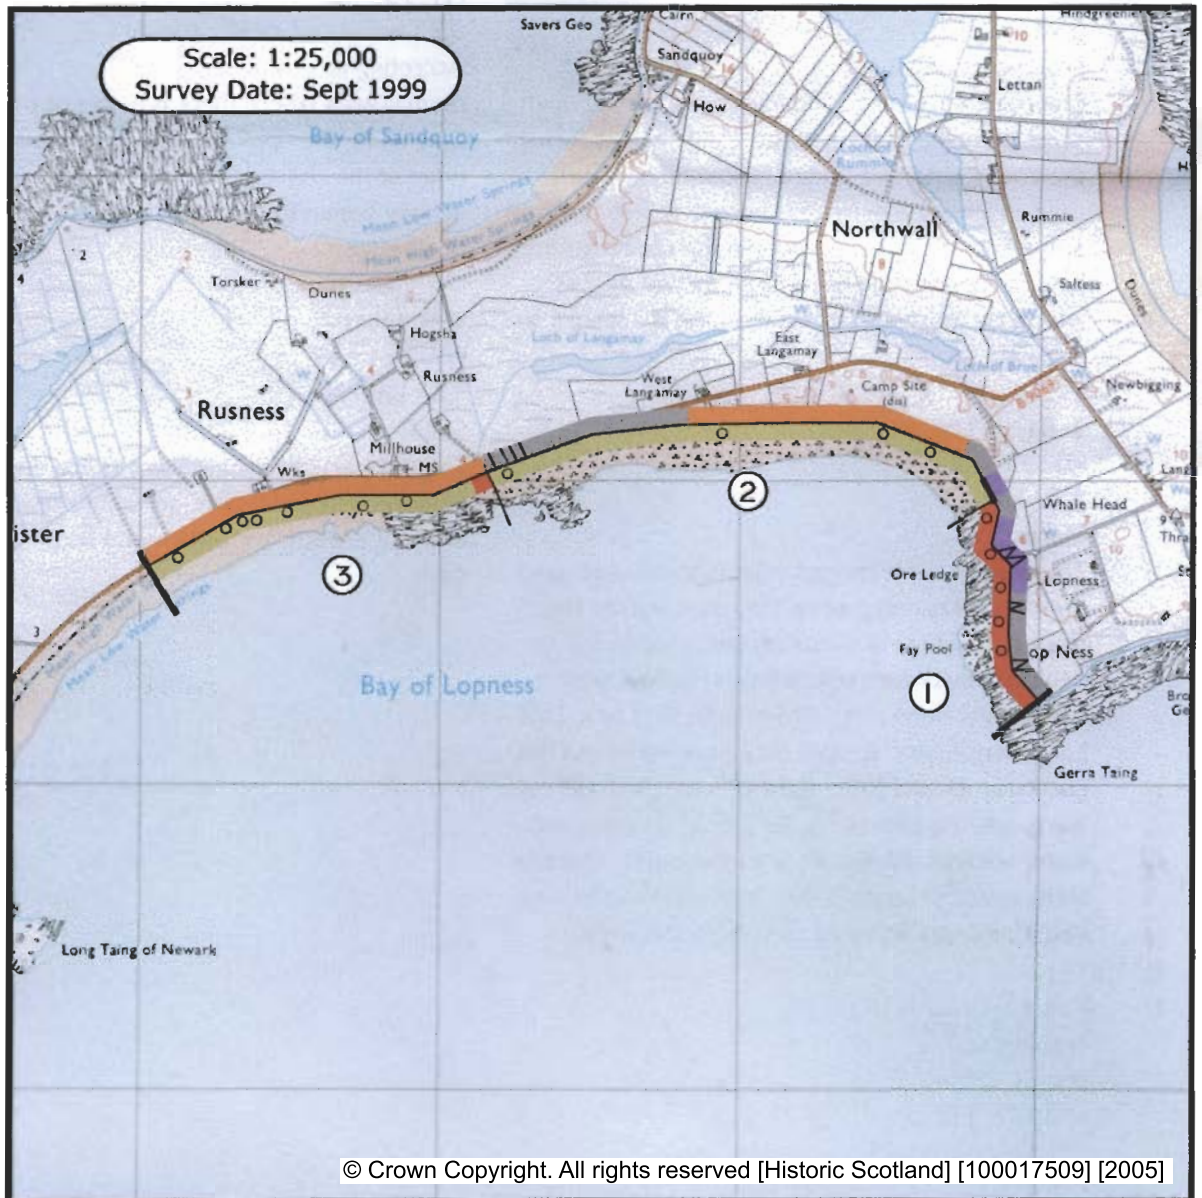
Sanday Map 2

Rock platform.

The rock platform has up to 30% cobble cover in places. The coast edge is better defined in this section but only exceeds 5 m to the extreme north. The rock drift interface is more visible to the north with some exposure of up to 40 cm of a buff till and some colluvium. The profile to the north end of this section has over 1 m of sand overlying :-

Sandy foreshore with some cover on the upper foreshore.

There is only minor cobble and shingle cover, perhaps 30% along the upper foreshore especially at each side of this section. The coast edge drops to under 5 m at the east side and becomes less well defined as it runs into a sand dune ridge. The sand ridge has a slightly levelled appearance towards the centre. At the centre of this section there is a car park by the coast edge where the road runs along the top with a small sea defence wall running along part of the road. As regards the hinterland, grassed fields lie behind the vegetated sand dune ridge along the eastern side as far as West Langamay. There is at least one large deflation hollow within a field on the hinterland. A small sand ridge then runs between the road and the coast edge on the west side of this section.

A rock platform is evident at the beginning of this section and is much more apparent along the lower foreshore. The rest of the section has a sandy foreshore with more sporadic areas of cobbles along the upper foreshore to the west. The coast edge has sand dunes running the length of this section with a road lying behind the ridge. Grassed, fenced fields lie beyond the road. Soils are freely drained skeletal sands.
