Map 4: Plain of Fidge to Cata Sand

Landscape, Built Heritage & Archaeology

Hinterland Geology & Coastal Geomorphology

Sanday Map 4

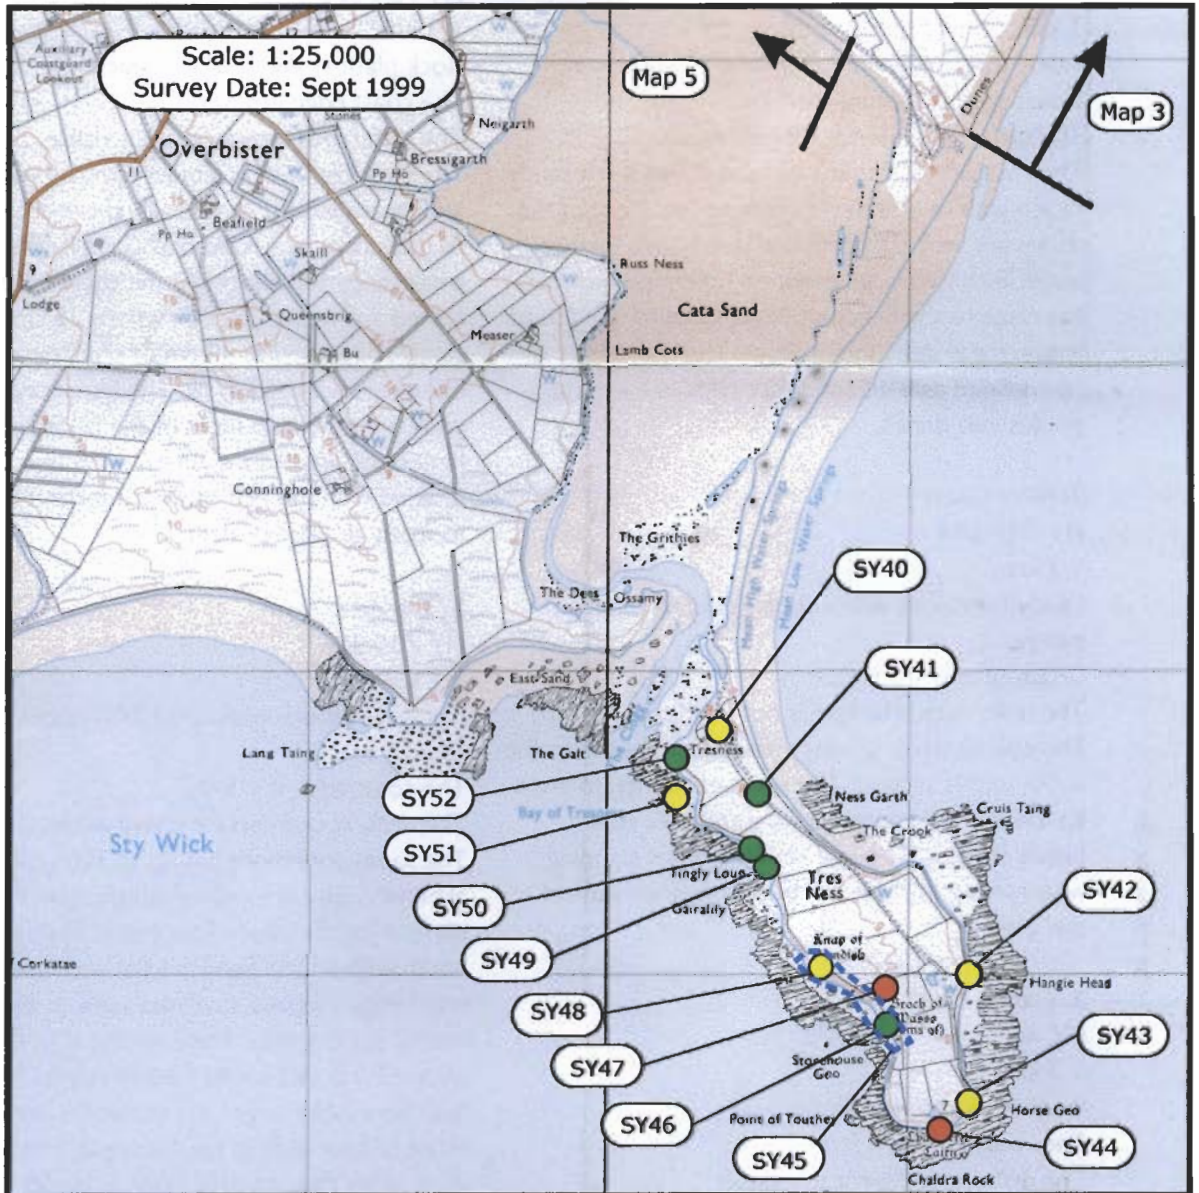
Tres Ness is rich in archaeological sites. One of the most impressive sites is located in an elevated position at the tip of the ness. Here a large chambered cairn (SY44) has been damaged by coastal erosion. Recent investigations at the site indicate that the cairn may comprise up to three separate phases of construction. It has been scheduled as an ancient monument but remains at risk from continued sea erosion.

Several other mounds recorded in this area (SY41-43, 48, 49, 52) may also be burial monuments. These mounds extend along the western coast and may be part of a more extensive concentration of burial mounds, similar to Els Ness (Map 6) which lies directly opposite on the other side of the bay and Tofts Ness (Map 16), further north. Of interest, is a mound conjoined with an earthwork (SY42), which shares similarities with examples at Tofts Ness. Another mound (SY48) at Knap of Grindish is partly surrounded by what may either be a bank or a series of smaller mounds; this may have parallels with burial mounds at both Tofts Ness and Els Ness.

The Broch of Wasso forms a massive grassy mound in which very little detail is apparent. The surrounding defences remain visible and there are strong hints of further, extra-broch settlement in the immediate area. Antiquarian investigations in the 19th C were not well recorded, but do not appear to have been extensive or particularly destructive. The broch lies in an area of marshy land, close to a loch and this factor may hold potential for the preservation of materials in waterlogged deposits.

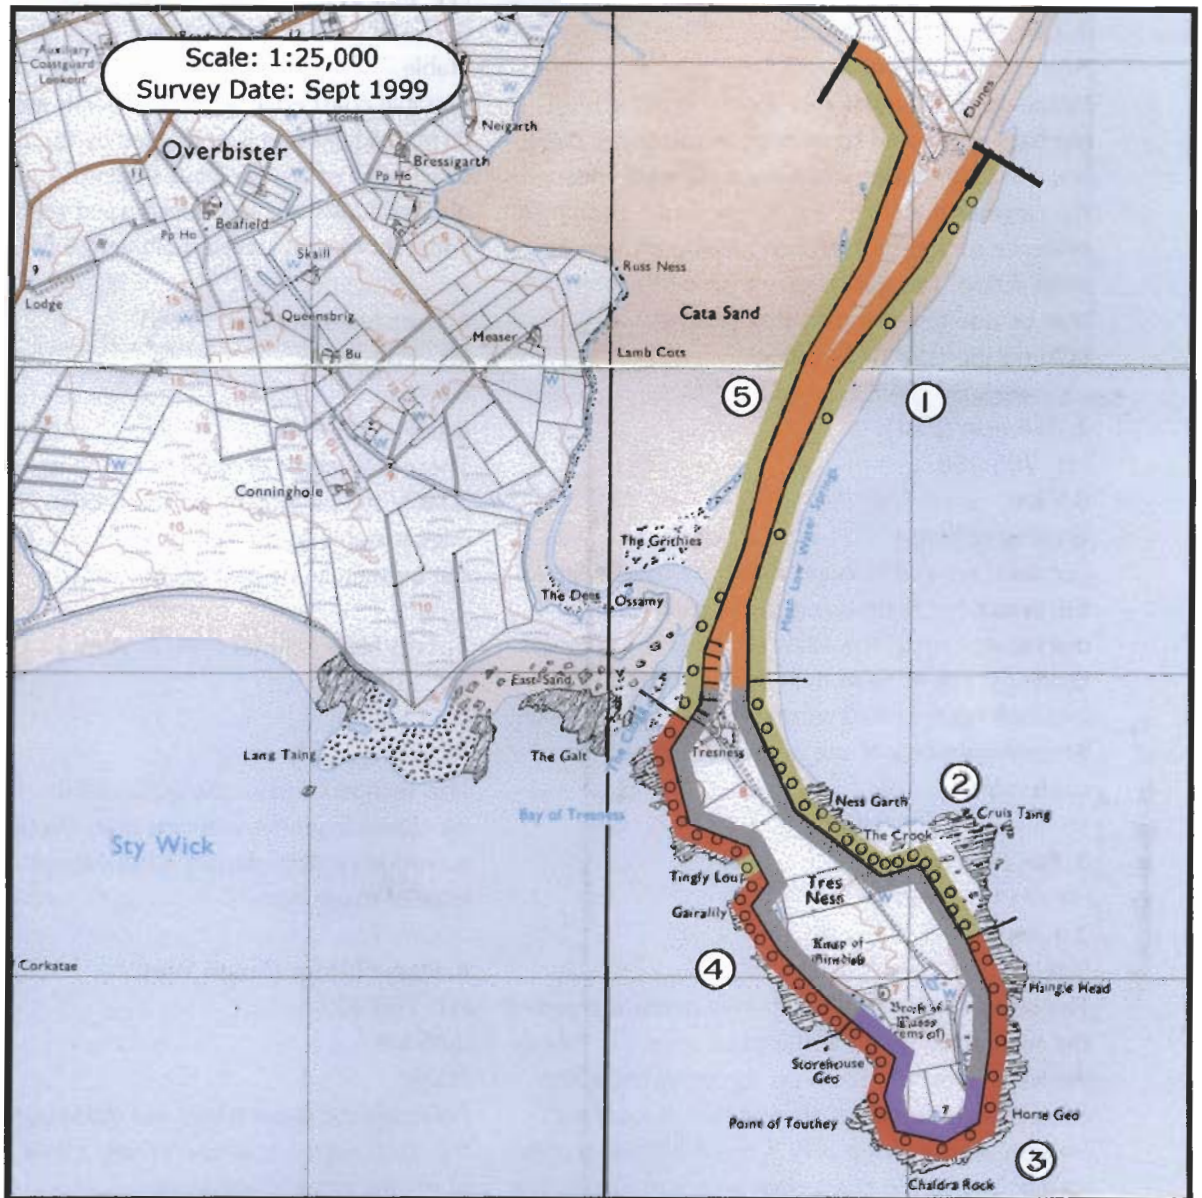
The east side of this line of sand dunes has a sandy beach with only limited cobble cover. Most of the dunes are well over 5 m and over 10 m further south with two large deflation hollows which cut the ridge to the far coast edge. Cobbles are found within these deflation hollows. The coast edge is not definite as the back shore rises as the sand grades into dunes.

The cobble cover grades into a storm beach to the south of this section. The coast edge then forms a lip made up of contemporary and relic storm beach cobbles. The low hinterland has standing water in places. Soils are poorly drained podzol and gleys.

The rock platform has storm beach to the east and west of Tres Ness with up to 70% cobble cover around the head. The drift to rock interface is visible with some till and saprolite evident at Hangie Head. Around Chaldra Rock the coast edge has a scalloped appearance. The till is almost absent from the southern head but up to 1 m is evident at Storehouse Geo. The soils are imperfectly to poorly drained podzol and gleys. Stone walls lie around the fields although most fields are set back 4 - 5 m from the coast edge.

The rock platform is almost covered with cobbles and storm beach. At Gairailly there are two berms to the storm beach. Also at Gairailly there is a small sandy foreshore. At the coast edge there is a buried soil seen in section where 25 cm of dark sandy soil underlies 30 cm of sand and stones. The soil overlies a reddish till. The hinterland is grassed with stone walls to most of the fields. The hinterland around the Broch of Wasso is poorly drained with the rest of the hinterland imperfectly to freely drained podzol.

The sandy foreshore has up to 70% cobble cover around Tresness much of which makes up a hard surface for the upper foreshore. The sands to the north within Cata Sand are flat and fairly firm. The coast edge has two small sea walls to the south, one to the north of Tresness and a further one within the dunes a little further north. The sea wall may have been larger as remnants now stand three to four metres on the upper foreshore. The dune ridge rises to over 10 m in places with the two same breached areas from the east side obvious on this Cata Sand side. The dunes fade out to sandy soil in the north with some fencing. Dunes and soils are freely drained.
