## Map 5: Cata Sand to Els Ness

### Landscape, Built Heritage & Archaeology

### Geomorphology

### Erosion

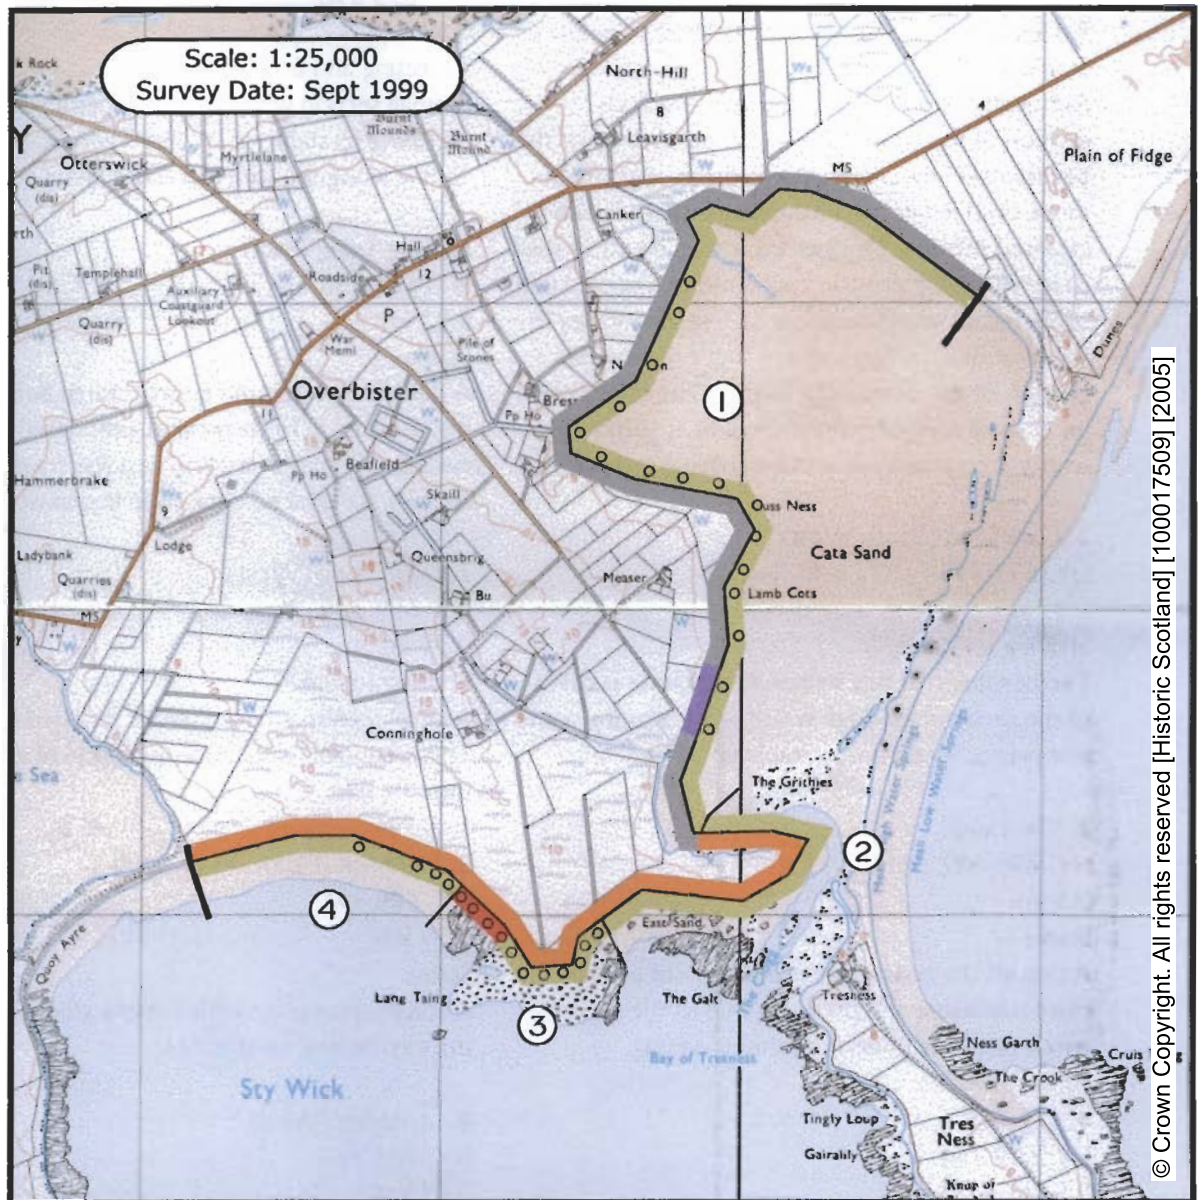
A relatively level hinterland faces Cata Sand, which is itself is very flat. The seaward facing coast edge is generally lined with sand dunes. These have small slopes of moderate gradient. A large area of cobbles and boulders lies around Lang Taing. Within the confines of Cata Sand, most of the hinterland is fenced but is generally unfenced along the seaward facing side.

The foreshore within Cata Sand is very flat with very little distinction between upper and lower foreshores. The coast edge is generally well defined with an edge of 20 to 50 cm. A small buried soil, over 15 cm, is evident at the very beginning of this section which lies below 30 cm of sand and extends to below the upper foreshore sand. The coast edge resembles saltings to the north west corner with small talards and some tipped rubble along the coast edge. More cobbles are found along the eastern upper foreshore.

A sandy foreshore runs around this small promontory with varying amounts of cobble cover. Most of the patchy cover lies to the east and south of this section. The dunes rise to over 3 m and have a well defined coast edge. A great deal of shell also lies to the east by the neck of Cata Sand. The dunes are vegetated and are freely draining.

The sandy foreshore to the east increases in cobble cover towards the point. Between the point and Lang Taing there is a large area of boulder and cobble cover extending from upper to lower foreshore as an ayre. A relic storm beach lies along the coast edge as a lip, much of which is vegetated. At one point the drift to rock interface is visible in section over 10 m. The hinterland is moderately sloping, grassed and unfenced with much ragwort in evidence. Soils are freely draining sands.

The cobbles grade out from the east side with negligible amounts to the centre. The coast edge is fairly well defined against the sand dunes. There are some deflation hollows within the dune ridge with some dumping of waste materials within one of these hollows to the centre of the section. The hinterland is moderately sloping and slightly hummock like in appearance from the centre to the west of the section. A fence runs behind the dune ridge with grassed fields beyond infested with ragwort. Soils are freely drained sands.
