Map 6: Els Ness to Backaskaill Bay

Landscape, Built Heritage & Archaeology

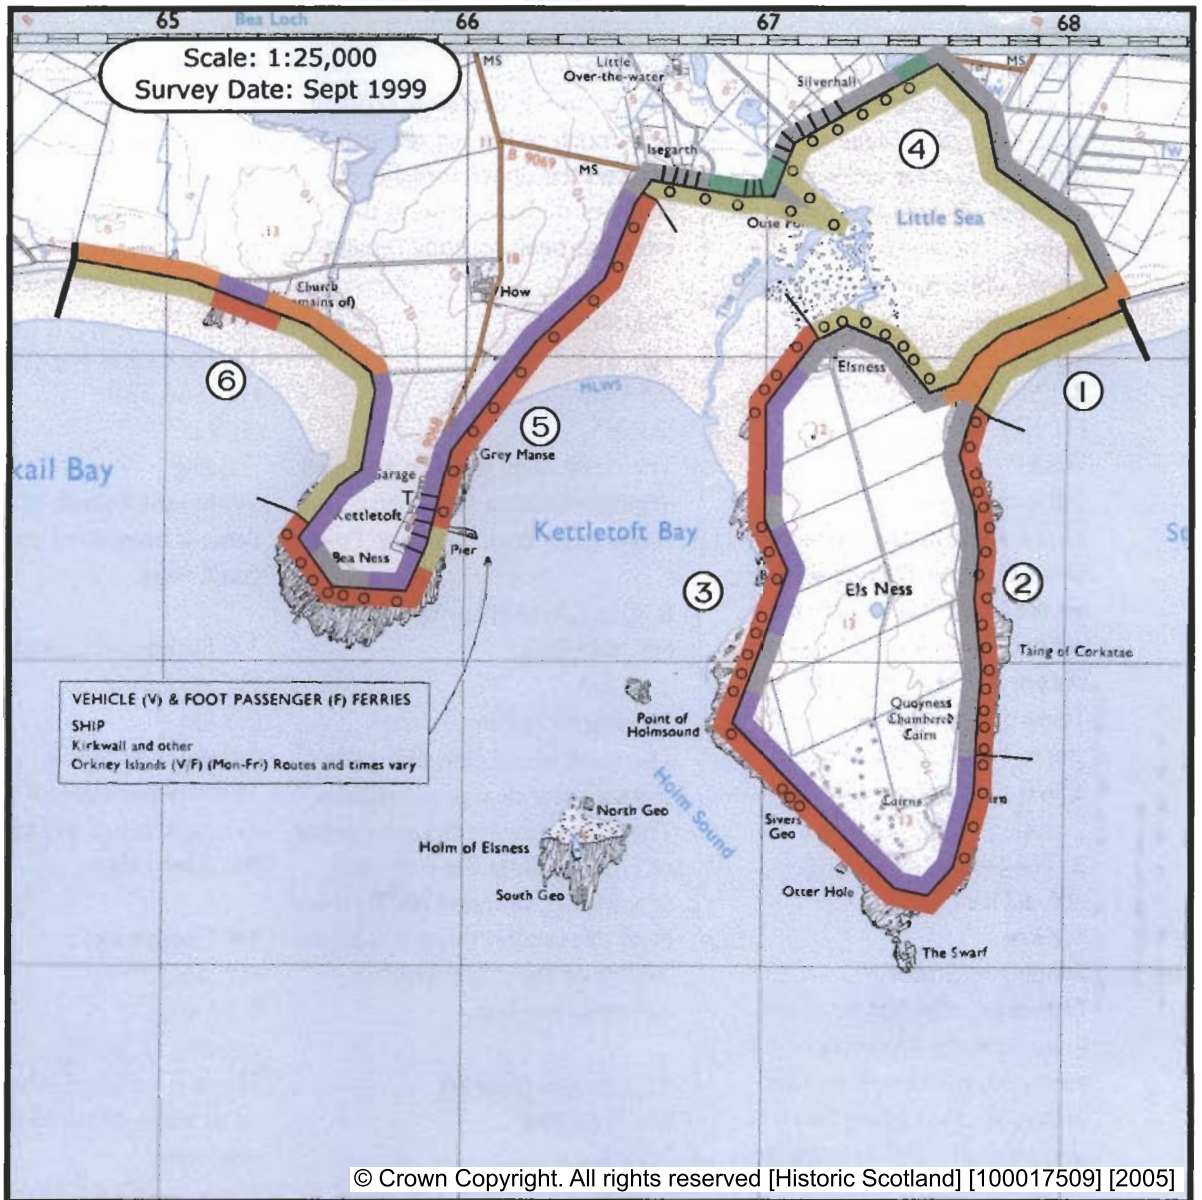
1. Sty Wick
HY 678 390
0.7 km

Sandy foreshore with negligible cobble cover.
Coast edge is < 5 m.

This section is the south facing shore of Quoy Ayre and is made up of sand dunes with a road on the north side. There are very few cobbles along this section. The dune ridge is vegetated with more deflation evident to the extreme eastern side.

Rock platform with storm beach of cobbles and small boulders.

The storm beach covers most of the rock platform right up to the coast edge forming a small lip of stones. There are many stones thrown back into the hinterland and are now grassed in. A small sea wall lies in front of Quoyness chambered cairn. The stone walls of the fields are set back from 4 m to 10 m from the coast edge. A deep loam of 40 cm lies in the corner at the north of this section. Soils are imperfectly to freely draining podzol.

Rock platform with up to 70% cobble cover.

The storm beach fades out at the beginning of this section revealing the rock to drift interface. The cobble cover becomes greater again along the west coast with a small storm beach within Siver's Geo. There are remnants of sea wall along the north west of Els Ness with intact sea wall closer to the farm of Elsness. Soils are imperfectly to freely drained podzol. The field stone walls are set back from the coast edge from 5 m to 10 m.

The sandy foreshore has up to 70% cobble cover along the eastern side of Little Sea. An almost continuous ayre is apparent at low tide running from Elsness to Ouse Point almost as a barrier to Little Sea. Along the west side of Little Sea the coast edge is well defined with a small sea wall running along the north east coast of Little Sea and again to the west of Ouse Point where gabions are also in place. The sand dunes run along Quoy Ayre and sandy soils grading into imperfectly drained podzol along the east and north sides. Some of these soils are sandy loams and up to 50 cm deep. There is standing water east of Silverhall and saltings behind the sea walls and bridge by Ouse Point. The road runs along the northern edge of this section.

The rock platform has up to 50% cover in places and a well defined coast edge. There is a small area of sand to the south of the pier. A storm beach made up of cobbles and small boulders lies around the point of Bea Ness. The deep reddish loams of 40-50 cm lie over till. The buildings of Kettletoft have sea walls at the coast edge. The fields are fenced, well maintained with moderate or gentle slopes. Soils are imperfectly to freely draining podzol.

The sands grade over the rock platform at the beginning of the unit and lie against a well defined coast edge with a visible drift to rock interface. The beach at Backaskail Bay runs up against vegetated sand dunes and the coast edge is not so well defined. A small rock platform lies in front of the church. The hinterland has moderately sloping fenced fields with some stone walls to the south east of the section which run into vegetated sand dunes around the bay. Soils are imperfectly drained podzol running into freely draining sands.

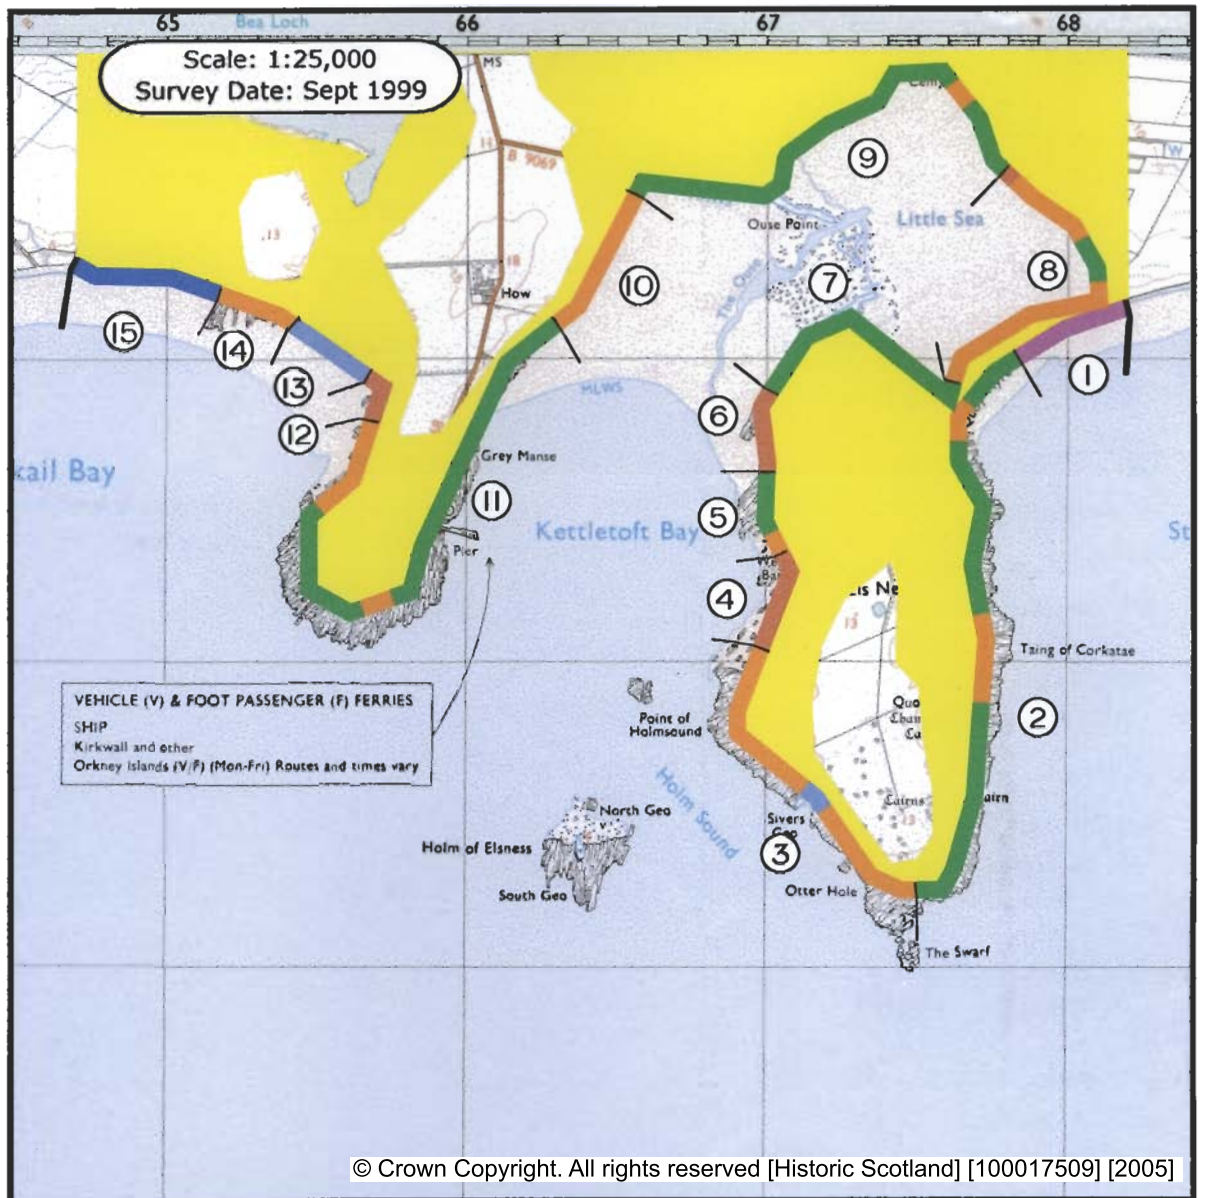
- 1. Sty Wick**
HY 680 391
0.3 km
Accreting and Eroding.
There is localised erosion of the dune ridge coast edge due mainly to marine action with accretion of sand due to aeolian activity. The accreting sands lie on the upper foreshore and coast edge.

- 2. Quoy Ayre (South)**
HY 677 379
Stable
1.8 km
There are only two, localised, areas of erosion along this section, both due to marine action. These are at the western corner of Quoy Ayre and at Taing of Corkatae, where the storm beach appears to be active and migrating landwards.

- 3. The Swarf**
HY 671 375
1.2 km
Eroding to Stable
The coast edge has localised erosion along this section. All the erosion is due to marine action. At Sivers Geo there is accretion of cobbles in the geo.

- 4. Els Ness (West)**
HY 670 382
0.21 km
Eroding
A section of coast edge is definitely eroding where there is exposed till.
- 5. Weelan Bank**
HY 670 384
0.32 km
Eroding to Stable
The coast edge has localised erosion which is fairly stable to the centre. An old sea wall has been eroded out in a few places.

- 6. Els Ness (North West)**
HY 670 387
0.21 km
Eroding
This section is definitely eroding with much of the old sea wall now on the upper foreshore. Some of the wall close to the edge has been recently repaired.

- 7. Elsness**
HY 672 391
0.94 km
Stable
The coast edge is stable and well vegetated with a stable ayre running out towards Ouse Point.
- 8. Quoy Ayre (North)**
HY 681 392

1.13 km
Eroding to Stable
The road which runs alongside gives a great deal of protection. There are more substantial areas of erosion along the E of Little Sea, of soft sand and till. To the N of this section there is a 30 m stretch of coast line which is definitely eroding.

- 9. Little Sea (North)**
HY 673 398
2.29 km
Stable
Most of the coastline is stable along the north edge due to the sea wall defences. There is some localised erosion outside the cemetery walls.

- 10. Isegarth**
HY 664 393
0.55 km
Eroding to Stable
The coast edge has localised erosion due to some undercutting of the soft till.
- 11. How**
HY 657 382
1.85 km
Stable
There are two small areas where erosion is occurring. On the point of Bea Ness a storm beach is eroding small areas of coast line. On the west side of the ness there is localised erosion.

- 12. Backaskail Bay (East)**
HY 656 388
0.09 km
Eroding
Within the corner of the bay there is erosion of the sandy coast edge.
- 13. Backaskail Church (East)**
HY 655 390

0.4 km
Accreting to Stable
There is accretion of sands along the back shore and coast edge of the dune ridge.
- 14. Cross Kirk**
HY 652 391
0.17 km
Eroding to Stable
There is localised erosion of the coast edge. Much of this edge is vegetated.

- 15. Backaskail Bay (West)**
HY 649 392
0.45 km
Accreting
One of the few areas where there is evidence of accretion in the form of sands covering vegetation. Although the survey took place almost at the end the growing season there was little evidence of new vegetation colonising the accreted sands.
