Map 9: Loth to Scuthi Head

Landscape, Built Heritage & Archaeology

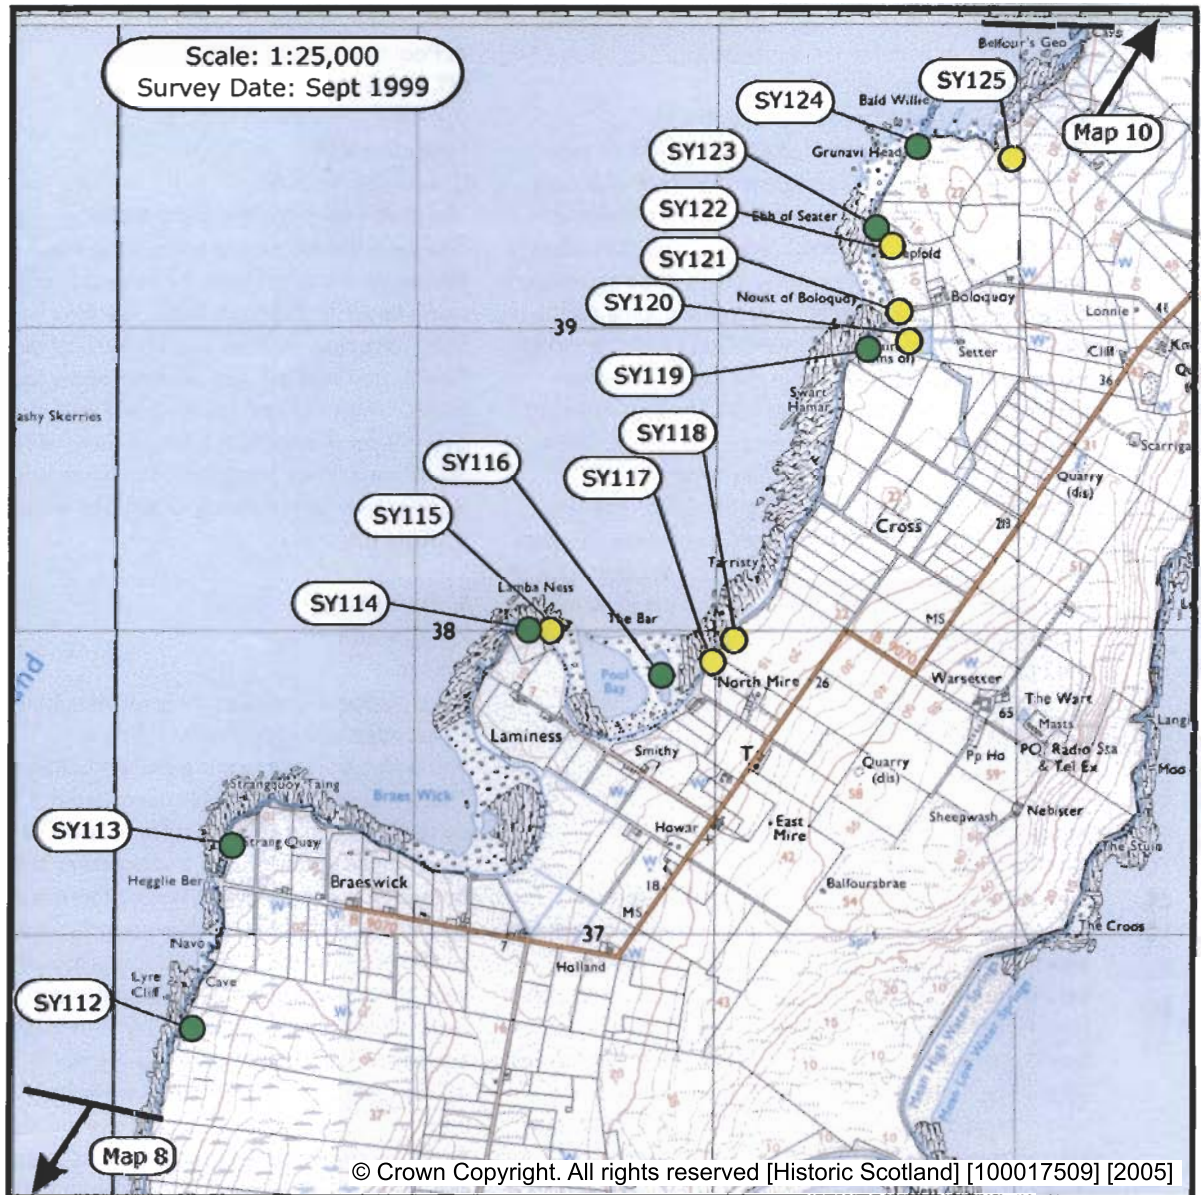
From Loth, this map section extends along the southwest coast of the Island, over high rugged ground with fine views over to the neighbouring island of Eday. At Braeswick, a small bay marks a lowering in the cliff edge and from here the landscape becomes progressively more gentle, even and green.

Between Boloquoy and Mires, at the end of the section, there are further areas of rough ground, but here the coast edge is low-lying. Modern settlement in this area is concentrated around Braeswick and along the roadside to North Mire; but it is set back from the coast edge. The hinterland is divided in a pattern of regular small fields, most of which support grazing.

A site (SY117) which formed the subject of intensive recent investigations is located to the centre of this section, on the east side of Pool Bay. The extensive multi-period settlement was first noted in a coast exposure; excavation revealed a series of buildings and deposits dating from the Neolithic period to the Norse period. This is the only such 'farm mound' site to have been investigated in depth and thus the results of excavation are eagerly awaited. The site remains visible as a series of substantial organic soil deposits in the eroding coast section.

Further along the coast at North Mire, a probable cairn (SY118) is eroding over rocky cliffs. Part of a small chamber or cist-like structure is visible to the centre of the section and further structural elements can also be identified. The cairn extends inland and may be more substantial than it appears.

At Boloquoy, archaeological deposits revealed in a coast exposure may mark an early settlement (SY119). This exposure has not been recorded before and it may be that this site has only begun to erode. Finds recovered from the section include fragments of struck flint and coarse pot of Neolithic/Bronze Age type. The exposure flanks an overgrown mounded area, which may represent further buried remains. It is very vulnerable to continued erosion.

Early activity in this area is further indicated by a cairn at Boloquoy Farm (SY120). The cairn has been dug into in the past and little of it now remains. A second mound in an adjacent field (SY122) may also be a burial site; this also appears to have been investigated in the past. At Ebb of Seater a grassy mound which lies close to exposed layers of ashy deposits and a patch of burnt, reddened ground surface (SY123) may be comparable to the burials and pyre settings recently identified at Hermisgarth (Map 10).

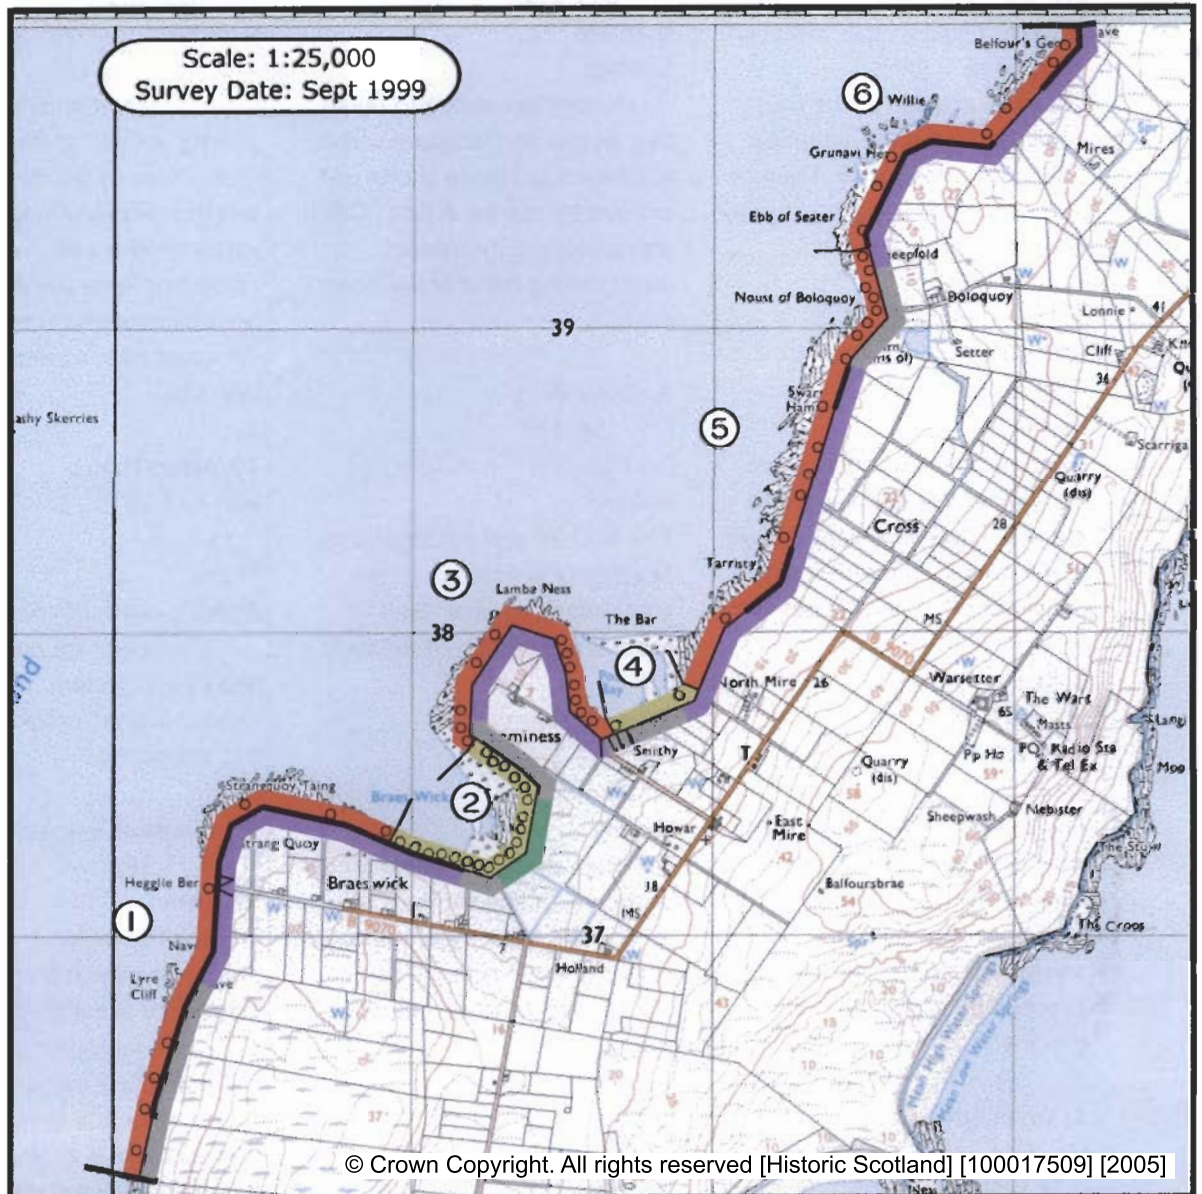
The hinterland slopes become more moderate to the north of this unit. There are two well defined storm beaches within coves in this area and an impressively carved coast edge along North Mire. The coast edge is over five metres at the beginning and end of the unit, but in between these points it is generally lower.

Rock platform with intermittent cover. Coast edge is generally > 5 m. The drift/rock interface is visible to the N. Cobbles and small boulders grade out to the N with some more cobble cover beginning to the E of Strang Quoy. The drift to rock interface becomes visible at Lyre Cliff. The till thins to < 1 m by Heggli Bar. Here there is a small quay like platform with steps cut into a conglomerate rock. There is also some tipping on the hinterland. At the point of Strang Quoy there is a large exposed section of saprolite in the form of a yellow marl bed > 5 m thick which appears to be an excellent source of pottery clay. The harder sandstones which overlie this bed are collapsing. The hinterland is moderately sloping with fenced grass fields. The area around the clay exposure is rather hummocky, perhaps due to erosion of the soft marl bed or past quarrying of this resource. Soils are imperfectly drained gleys at Spaney Geo becoming freely drained podzol towards the N.

Sandy foreshore with up to 100% cover. Coast edge is predominantly < 5 m. The drift/rock interface is not generally visible. The sandy/shale foreshore is almost covered by a storm beach made up of cobbles and boulders. These lie below the cliff at Braeswick but form a lip of relic storm beach where the coast edge drops to < 5 m. The storm beach grades out to rock platform on the NW of Braes Wick. The hinterland has grassed fields with a more water-logged area around the centre of the cove with iris and reeds. On the N side there are fenced fields down to grass although there is a headland of perhaps 5 to 7 m which has vegetated relic storm beach. Soils are freely drained podzols with a poorly drained peaty alluvium to the centre.

Rock platform with varying cover. Coast edge is generally < 5 m. The drift/rock interface is visible. There are small areas of cobbles almost making up small storm beaches in two areas on the west of this promontory. There is a more typical storm beach, of cobbles and small boulders, along the N shore. The coast edge is well defined by small cliffs with a drift to rock interface showing up to 1.5 m of buff till to the S and a more reddish brown till to the N. The hinterland

Sandy foreshore. Coast edge is < 5 m. The drift/rock interface is not visible. The sandy foreshore has some shingle and a few cobbles to the edges with the remnants of a vegetated storm beach at the coast edge. Gabions lie along the coast edge next to a sea wall on the S of the section. Two buried soils are also evident below the relic storm beach. Under top soil lies 40 cm of relic storm beach, over 30 cm of dark loam, over 2-5 cm of sand, over 30-40 cm of black peaty soil. The hinterland is gently sloping/level with a poorly drained to waterlogged area of peaty gley.

Rock platform with discrete areas of cobbles. Coast edge is predominantly < 5 m. The drift/rock interface is generally visible. There is boulder and cobble cover around Tarristy with up to 60% cobble cover further N and a large storm beach made up of cobbles and boulders at Noust of Boloquoy. Just N of Swart Hamar there is an unusually clear black buried soil, perhaps only 5 cm thick and up to 50 cm below the soil. It truncates the subsoil in a very horizontal fashion with sharp horizon boundaries and is likely to be a cultivation layer. A further two buried soil horizons lie closer to the storm beach, each 10 cm thick separated by a thin stone layer. Further into the Noust of Bolonquoy the storm beach runs over the coast edge. The cobbles grade out as the coast edge rises to the N. Soils are freely drained brown soils running to podzols with poorly drained gley behind Noust of Bolonquoy.

Rock platform with varying cover. Coast edge is > 5 m. The drift/rock interface is visible. There are a few small areas of cobbles along the rock platform with a storm beach made up of boulders and cobbles at Grunavi Head. The cliff edge is over 5 m high with > 1 m of till at Grunavi Head, otherwise the dark red till thickness ranges from 30 cm to negligible amounts. The hinterland is gently to moderately sloping with fenced fields underlain by freely drained podzol to the S and imperfectly drained gley and podzol to the N.

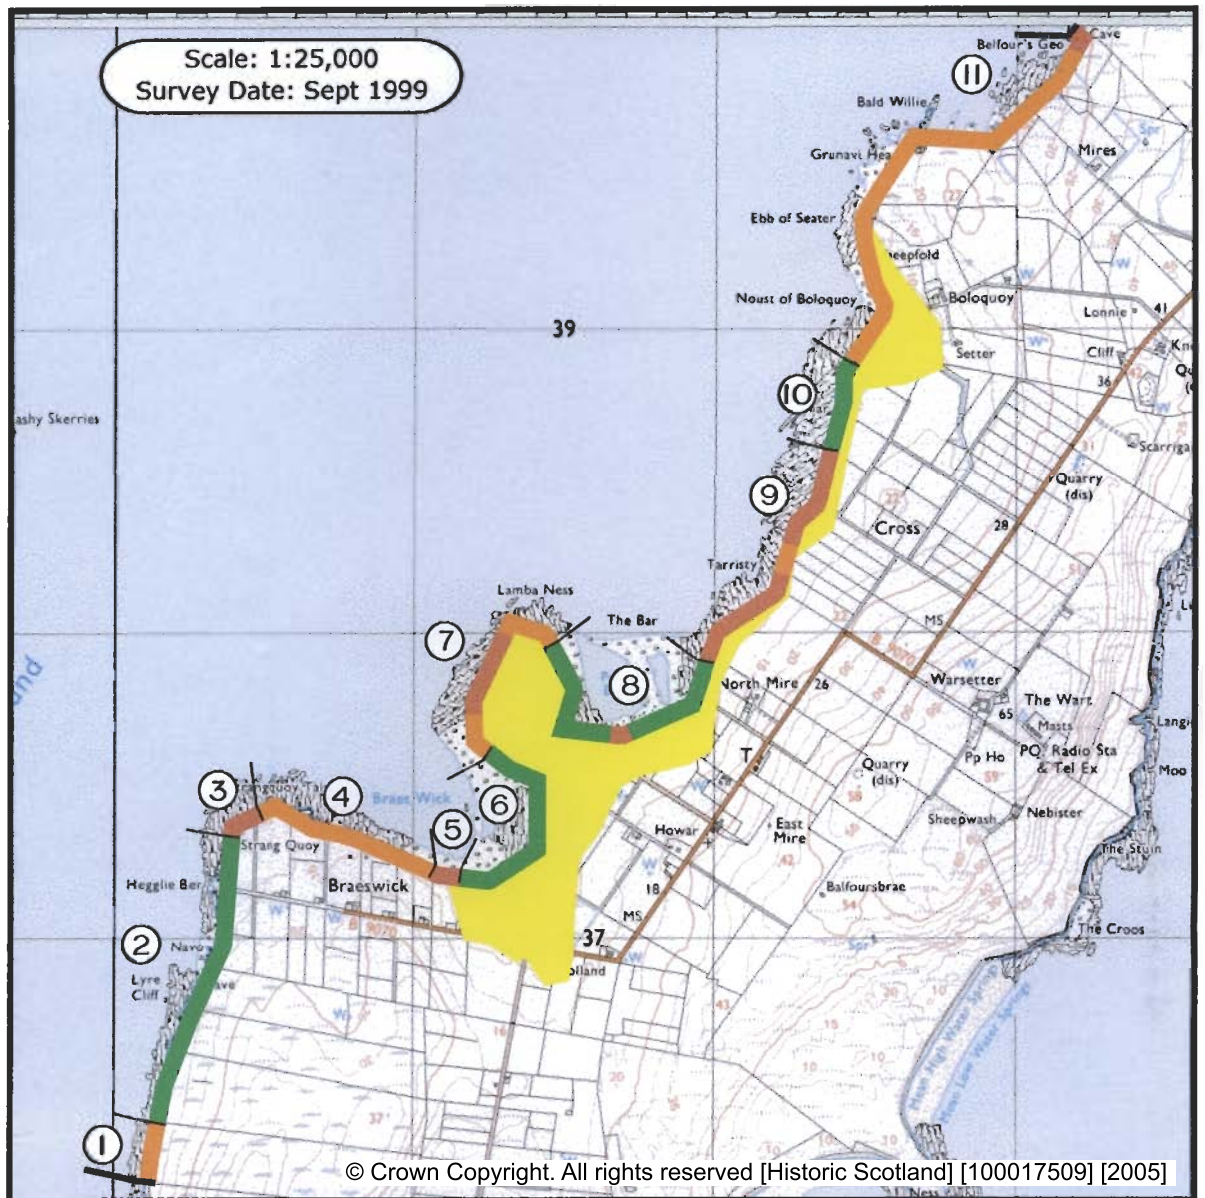
The unit contains a number of sections which are eroding. The most significant is the coast edge from North Mire to Swart Hamar, where the softer shale layers of the Eday Sandstone are eroding. Other erosion sections are also due to the exposure of softer Eday Sandstone seams.

- 1. Spanney Geo**
HY 601 362
0.2 km
Eroding to Stable
Localised erosion of the coast edge due to marine action on the softer exposed till. There is also minor sub-aerial erosion by water run off.

- 2. Lyre Cliff**
HY 603 368
0.93 km
Stable
Much of the coast edge is over 5 m, and has less till exposed to the sea. There is a slight change in the rock layers with some conglomerate bands appearing.

- 3. Strang Quoy**
HY 604 373
0.13 km
Eroding
The softer laminations of the Eday Beds are evident with a thick, soft yellow clay or marl lying beneath a harder sandstone. Where this is exposed the coast edge is eroding.

- 4. Strangquoy Taing**
HY 607 373
0.58 km
Eroding to Stable
Although the clay layer is not exposed in this section the overlying sandstones are soft and easily eroded. There is localised erosion along this cliff edge.

- 5. Braeswick**
HY 611 372
0.14 km
Eroding
As the cliff face drops to under five metres so the upper soft sediments are more prone to erosion by marine action. This is also enhanced by cobbles undercutting parts of the coast edge.

- 6. Breas Wick**
HY 614 373
0.51 km
Stable
The boulder and cobble storm beach give protection to the coast edge and hinterland around this section of the bay.

- 7. Lamba Ness**
HY 612 379
0.59 km
Eroding
Although there are stable areas to the north and south of this section the majority of the coast edge has some active erosion due to marine action alone. The storm beach to the south may be migrating landwards.

- 8. Pool Bay**
HY 615 377
0.7 km
Stable
The majority of this section is stable. There is localised erosion on each side of a sea wall and gabions close to the road.

- 9. North Mire**
HY 622 383
0.91 km
Eroding
Most all of this section is being actively eroded at the present time. Much of the rock strata of sandstone is overlying soft laminations of shales with the result that large pieces of rock are undercut and break off from the coast edge as small areas of land slip.

- 10. Swart Hamar**
HY 624 387
0.33 km
Stable
A short length of coastline is stable as there are no soft shales exposed in section. There is only minor localised erosion of the top sediments.

- 11. Noust of Boloquoy**
HY 625 395
1.56 km
Eroding to Stable
The coast edge is being eroded in localised areas throughout the section. A large storm beach within the first bay is definitely migrating on the north side. Overall there is an impression of less erosion to the north because of the higher cliffs. However there is substantial erosion at Grunavi Head on the two north facing points. At Belfour's Geo, and running to Scuthi Head in the next unit, the softer beds of shale run closer to the surface and dip to the west. This has caused some landslip and soil creep with large gullies running coastward. Most of the gullies are vegetated but further north they are being eroded by sub-aerial action mainly due to stream action.
