Map 2: West Burra, Southerhouse to Papil, Steina to Coast Guard Lookout

Built Heritage and Archaeology

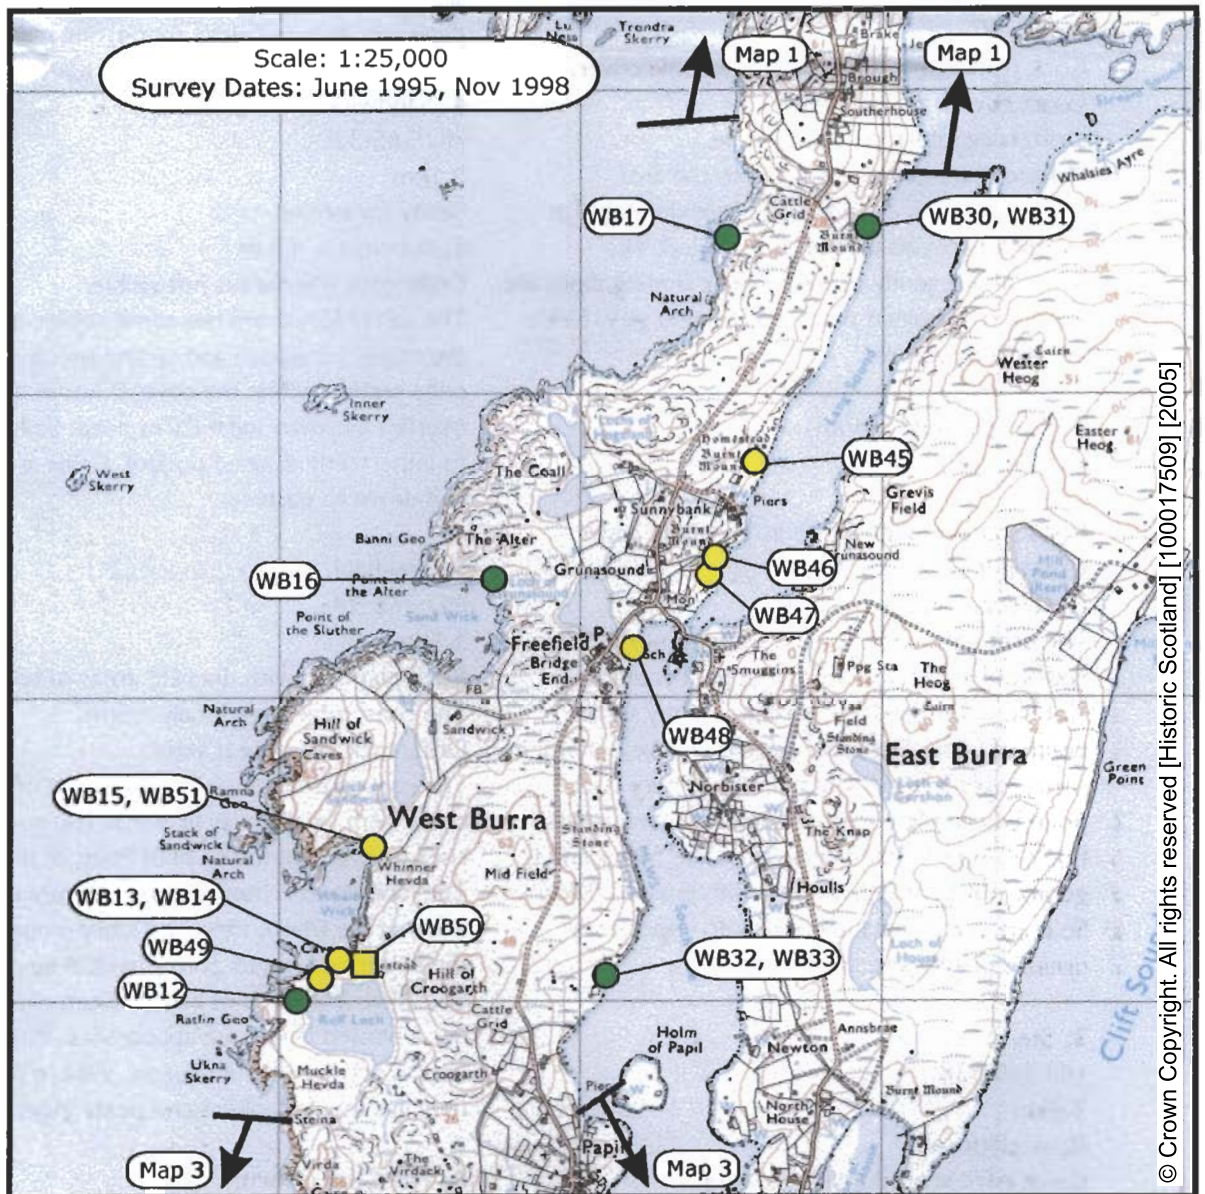
The area covered by this map section takes in the central part of the island. There is no modern or recent settlement on the west coast and settlement on the east coast is confined to the area around Sunnybank. The west coast is rugged and exposed; the east coast is more sheltered but the better land occurs in small pockets close to the coast.

A total of 17 sites are recorded in this area, of which seven sites are new discoveries. Sites of the period 3rd-1st millennium BC predominate; accounting for nine sites in all. They include at least four settlements with field systems, four burial mounds or cairns and two burnt mounds. Four sites lie on the west coast and five are on the east coast.

There are four sites of 18th - 20th C date. These include five click mills and an enclosure. Sites of unknown date account for the remainder of entries within this area. These include a structure, a mound, a crop mark and an enclosure.

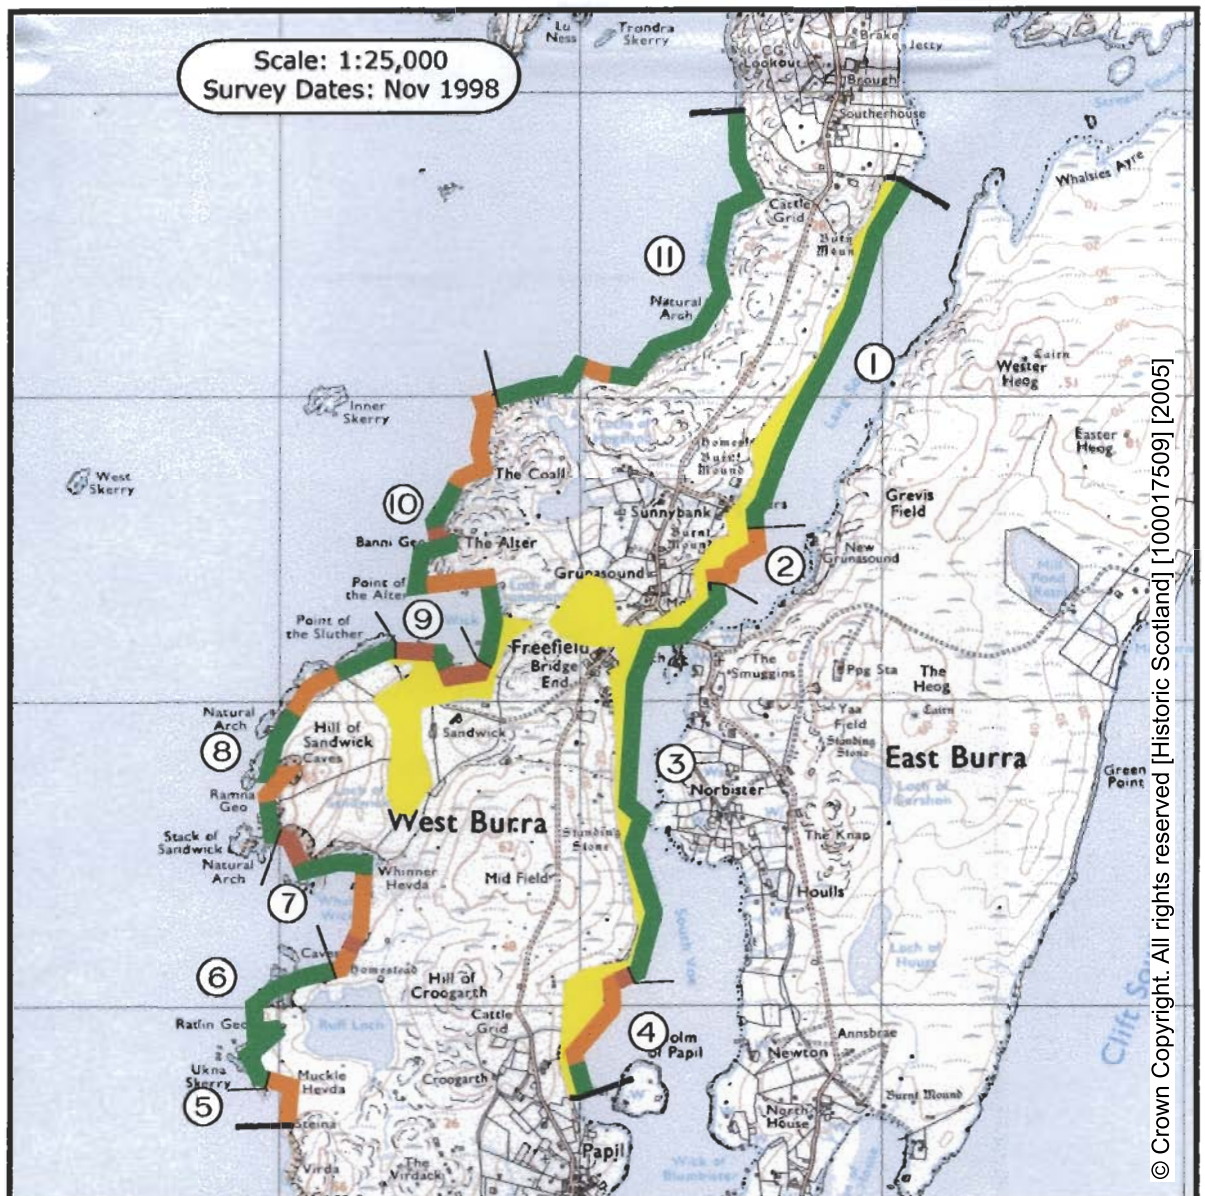
Stable

There is no marine erosion.

Eroding to Stable

There are small areas of erosion where the coast edge is being eaten away by marine action.

To the extreme N there are a few areas where man-made fill has stabilised coast edge erosion. Otherwise the coast edge is naturally stable. There is one very small point of erosion to the S of the promontory S of the Standing Stone.

There is erosion in the cove at the start of this section which then runs into localised erosion only of the coast edge. The coast edge has some scalloped indents.

Some of the coast edge rocks have been shattered by wave action and there is erosion of the hinterland soil by water flow.

Although the coast edge rocks are stripped of soil, as normal for this environment, the coast edge is stable.

To the South of the cove there is erosion of the cliff face by marine action. The hinterland also has erosion due to water flow. Some of the rock faces have been hollowed out by wind and wave action. The coast edge is stable to the N corner of the bay and then more erosion to the W where there has been a recent rock fall and landslip.

There is some localised erosion around Ramna Geo and further N although, generally, the coast edge and hinterland are stable.

Eroding

There is one small portion of stable rock outcrop to the centre of the section.

The area to the S is stable with more coast edge erosion in the mid section. The rock is stripped back of vegetation and soil on the head S of Banni Geo although the coastal edge appears stable. There is definite erosion to the N of this head, by The Alter. By the Coall the rocks are stripped back up to 100m into the hinterland.

N of The Coall the coast edge is stable with only a few minor areas where fresh erosion has taken place. There is however some erosion of the hinterland soils in a small area to the E of the section start and is due to water run off and exposure.
