## Map 14: LAGGAN CAMP TO ROCK OF PROVIDENCE

**LAGGAN CAMP TO ROCK OF PROVIDENCE**  
**NGR: NX 40-44/33-38**

**MAP CLASS: EROSION**

**MAP CLASS: Built Heritage and Archaeology**

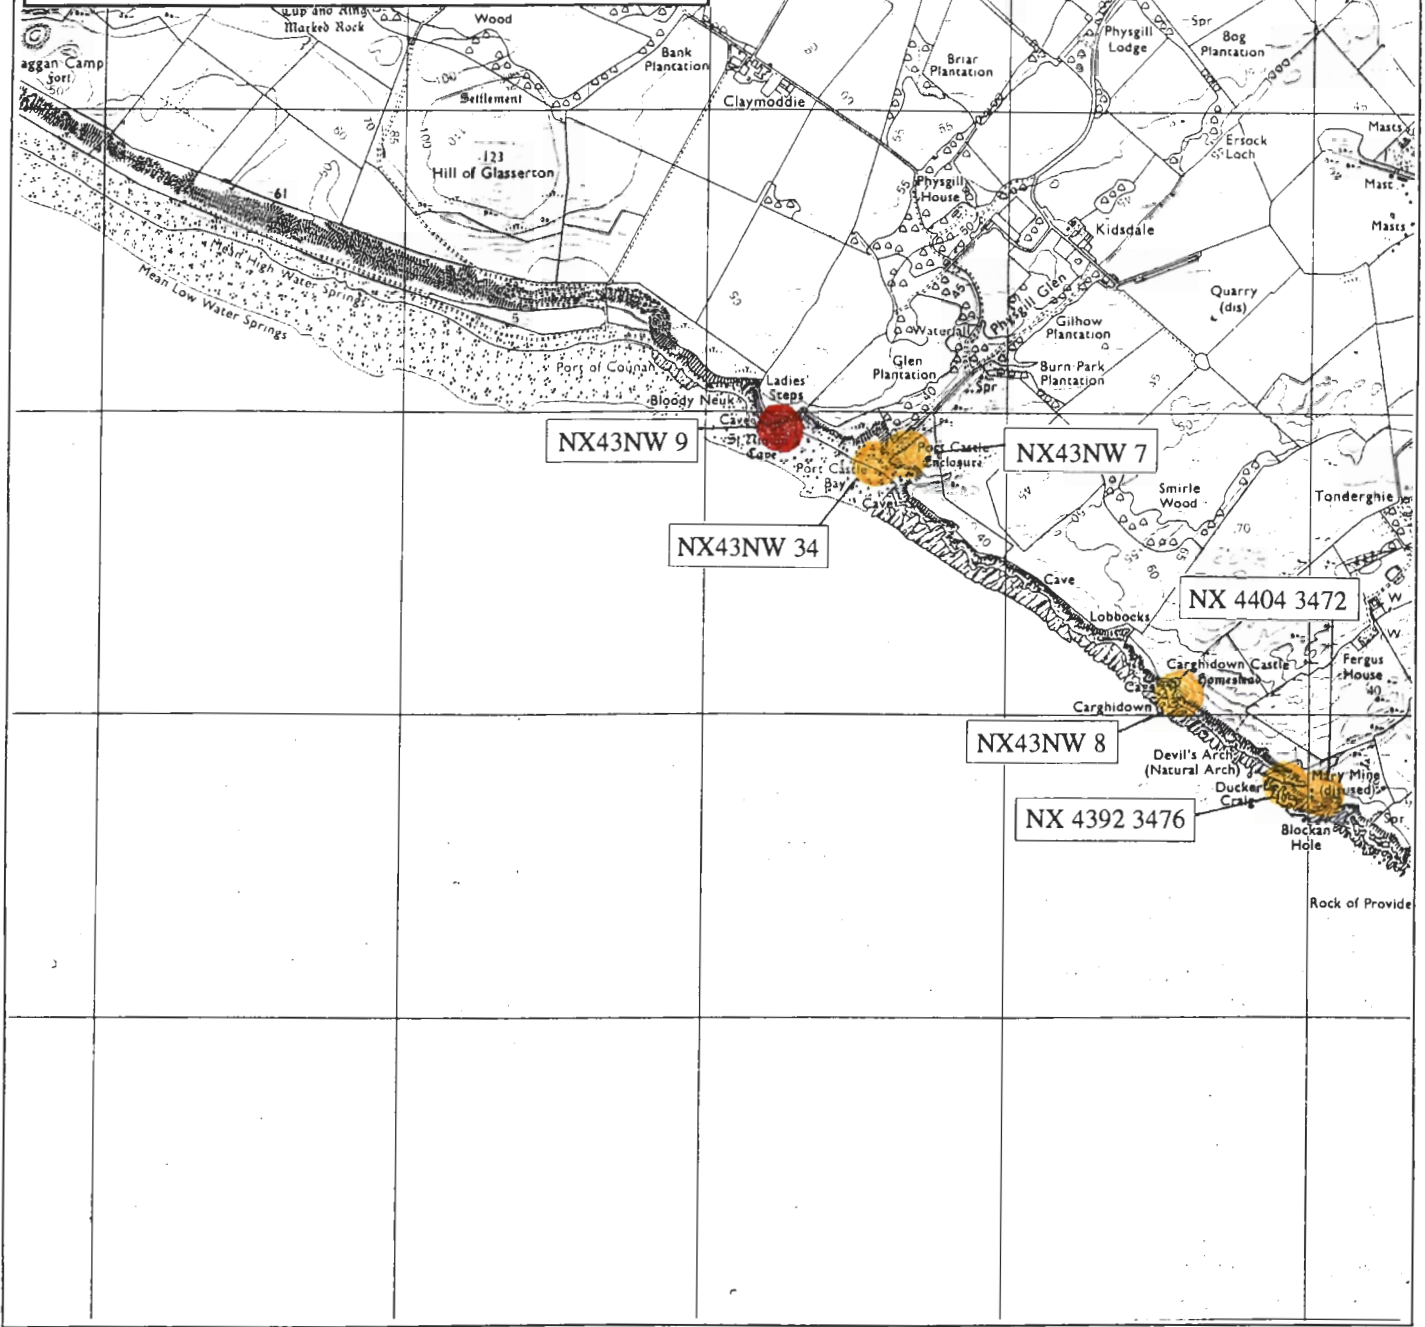
**NX43NW 9**  
NX 4224 3595  
ST NINIAN'S CAVE  
Cave & Incised Crosses  
Scheduled Ancient Monument  
5 to 11th centuries AD  
Fair  
Monitor

**NX43NW 34**  
NX 4256 3582  
PORT CASTLE  
Landing Place  
Uncertain  
Uncertain; not located  
Nil

**NX43NW 8**  
NX 4356 3507  
CARGHIDOWN  
Promontory Fort  
1<sup>ST</sup> Mill BC/AD  
Poor  
Survey & Monitor

**NX 4392 3476**  
MARY MINE  
Disused mine shaft  
18/19<sup>th</sup> century  
Fair  
Nil

**NX43NW 7**  
NX 4266 3584  
PORT CASTLE  
Castle / Enclosure  
Uncertain  
Good  
Nil

**NX 4404 3472**  
MARY MINE  
Disused mine shaft  
18/19<sup>th</sup> century  
Good  
Nil
