MAP 34: MULLOCK BAY TO PORT MARY

MAP CLASS: Hinterland Geology and Foreshore Geomorphology

MAP 34: EROSION

34: BUILT HERITAGE AND ARCHAEOLOGY

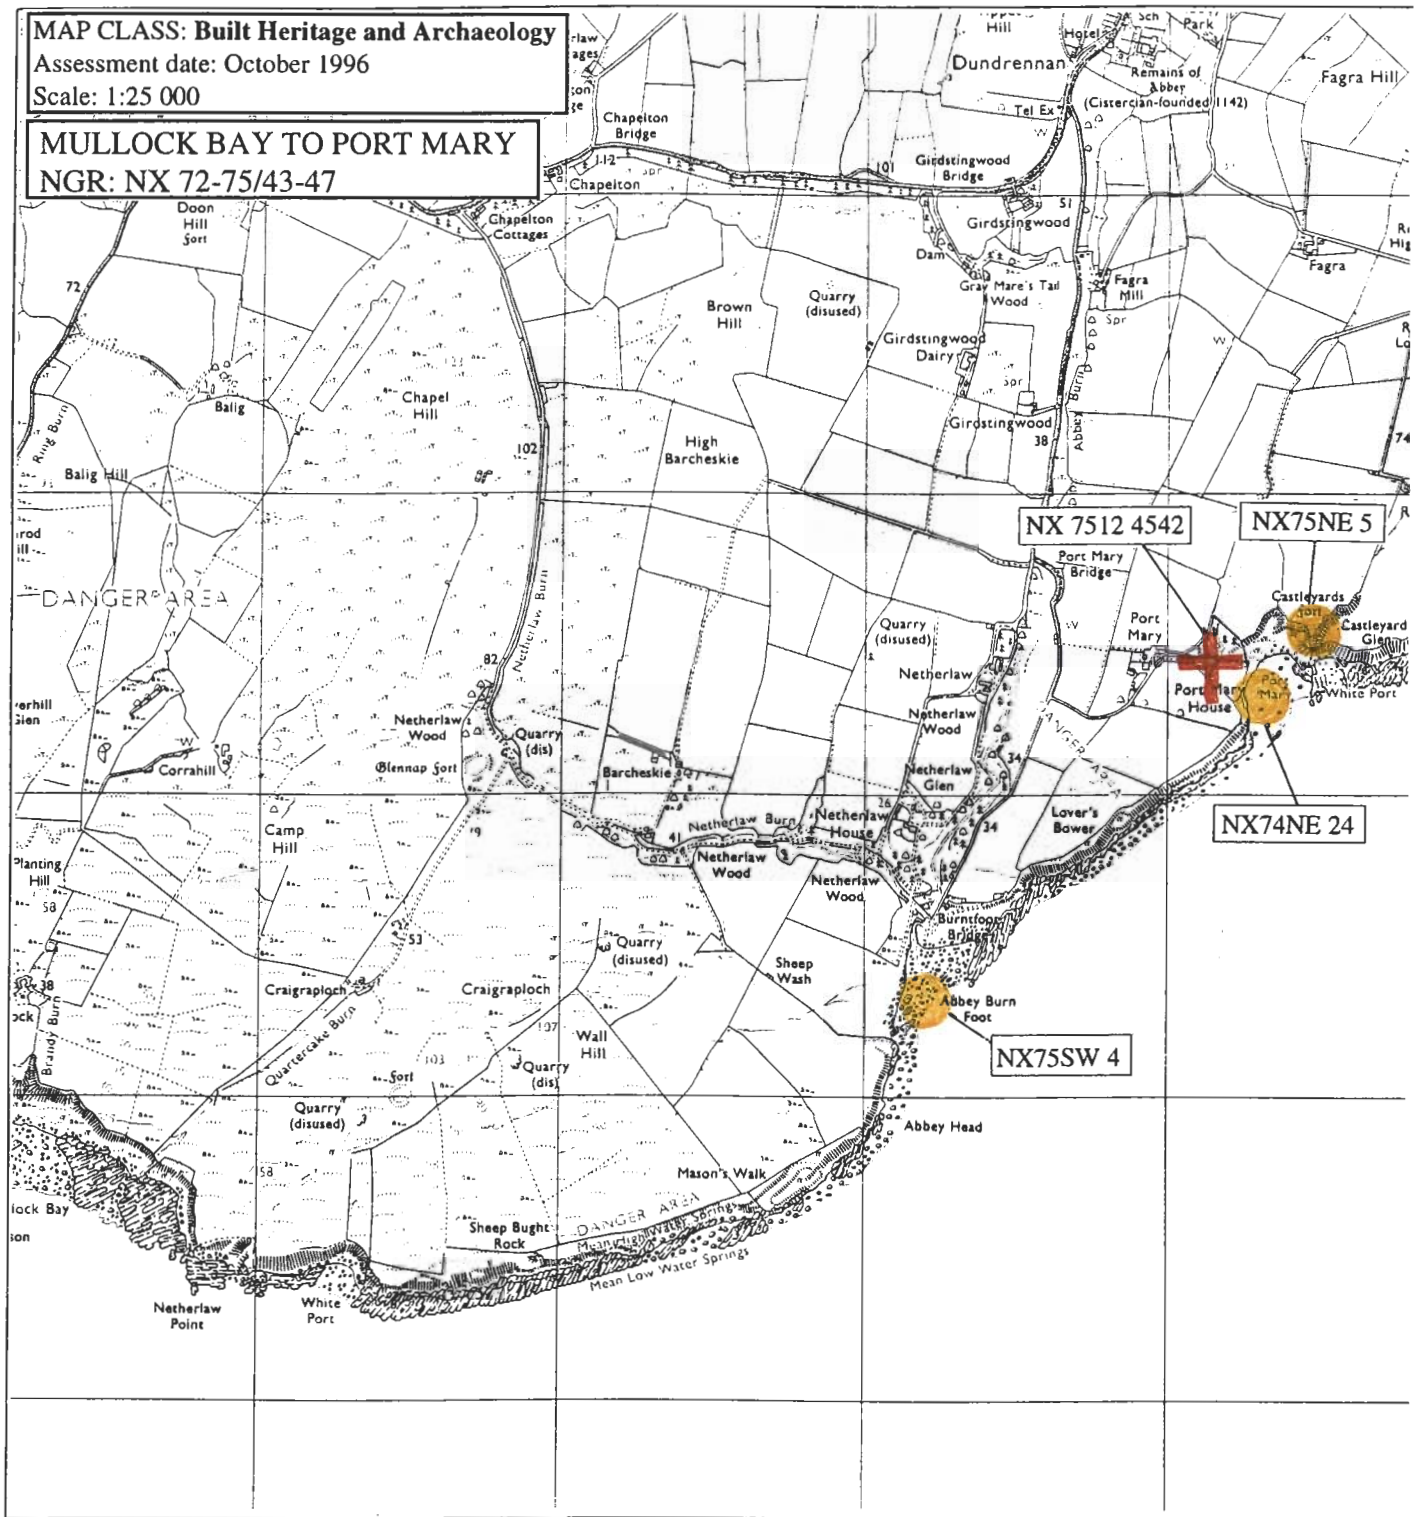
NX74SW 4
NX 742 443
ABBAY BURN FOOT
Natural Harbour
Uncertain
Good
Nil

NX74NE 24
NX 753 453
PORT MARY
Landing Place
Uncertain
Uncertain; not located
Nil

NX 7512 4542
PORT MARY HOUSE
House
Statutory Listed Building
Late 18th century
Good
Nil

NX75NE 5
NX 7548 4552
CASTLEYARDS
Promontory Fort
1st Mill BC/AD
Good
Nil

Built Heritage & Archaeology: The archaeology of this section of the coast is dominated by the small cluster of monuments at Port Mary, comprising a natural landing place, on the coastal edge, and a promontory fort and listed building in the immediate hinterland. Coastal erosion does not affect any of the sites. Of much greater significance to the condition of the promontory fort of Castleyards is the occurrence of a pit containing dead sheep and calves immediately within the interior of the rampart. A survey and monitoring programme is strongly recommended.
