MAP 55: EASTRIGGS TO RIG

MAP CLASS: EROSION
 Assessment date: 07.10.96
 Scale 1:25 000

EASTRIGGS TO RIGG

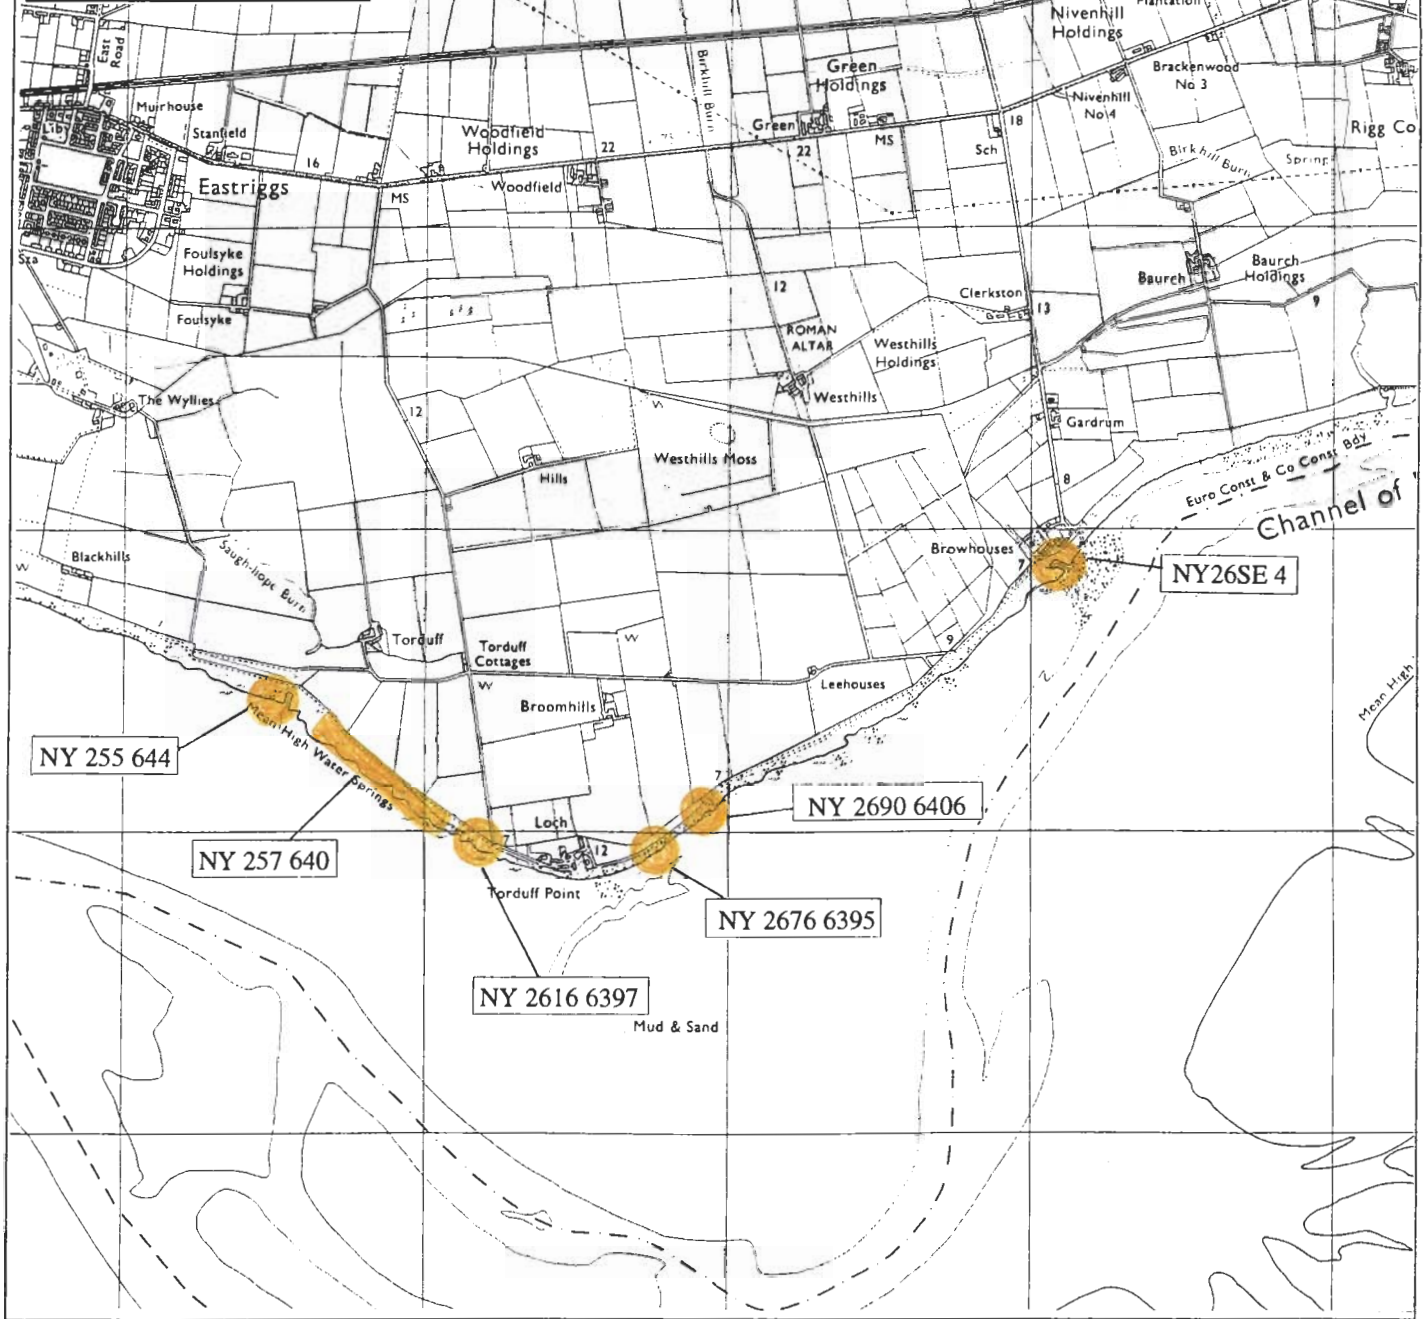
MAP 55: BUILT HERITAGE AND ARCHAEOLOGY

Built Heritage & Archaeology: This stretch of the coastline again contains a scattered distribution of fisheries, generally surviving in poor condition. A monitoring programme is strongly recommended for the surviving fisheries of the Solway coast east of the river Annan. A World War 2 pillbox surviving in poor condition on the coastal edge at Torduff Point relates to the munitions factories established around Eastriggs and Gretna in the middle of the Twentieth century. Surveying and monitoring is recommended in regard to this monument.

NY 255 644
TORDUFF
FISH TRAPS
Uncertain
Poor
Monitor

NY 257 640
TORDUFF
Fish Traps
Uncertain
Poor
Monitor

NY 2616 6397
TORDUFF POINT
WW2 Pillbox
Mid 20th century
Poor
Survey & Monitor

NY 2676 6395
TORDUFF POINT
Fish Trap
Uncertain
Poor
Monitor

NY 2690 6406
TORDUFF POINT
Fish Trap
Uncertain
Poor
Monitor

NY26SE 4
NY 2810 6486
BROWHOUSES
Landing Place
Uncertain
Poor
Monitor
