MAP 55: EASTRIGGS TO RIG

Map 55: Hinterland Geology and Coastal Geomorphology

MAP 55: EROSION

MAP 55: BUILT HERITAGE AND ARCHAEOLOGY

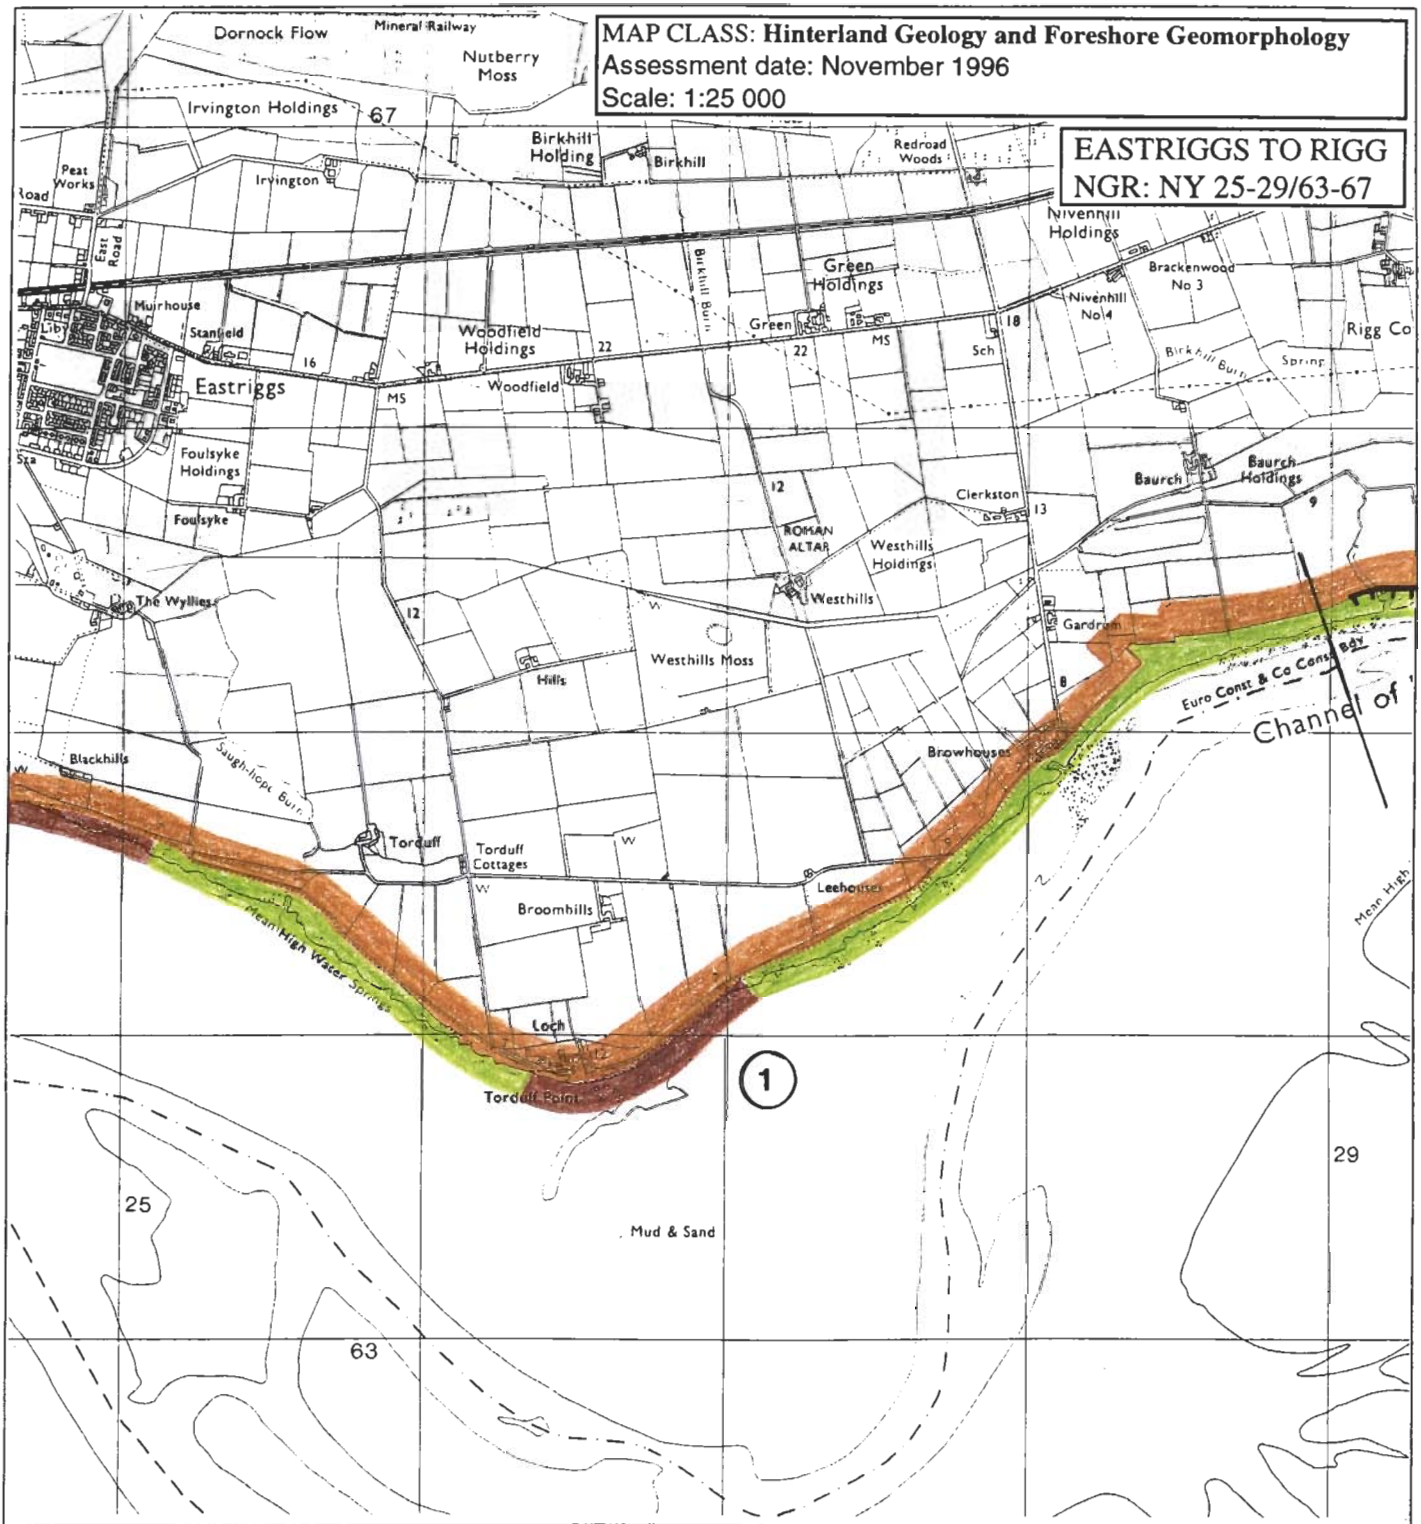
Hinterland Geology and Coastal Geomorphology: This section of the coast is dominated by marine sands and gravels over carse clays. The shoreline has been shaped by the channel of the River Esk. Estuary mud and salt-marsh are common along the steep river-edge. The hinterland is extremely flat and lies below 10m O.D.

Marine sands and gravels overlie carse clays. The shoreline is bounded by salt-marsh which overlooks the wide tidal mud-flats of the River Eden.
