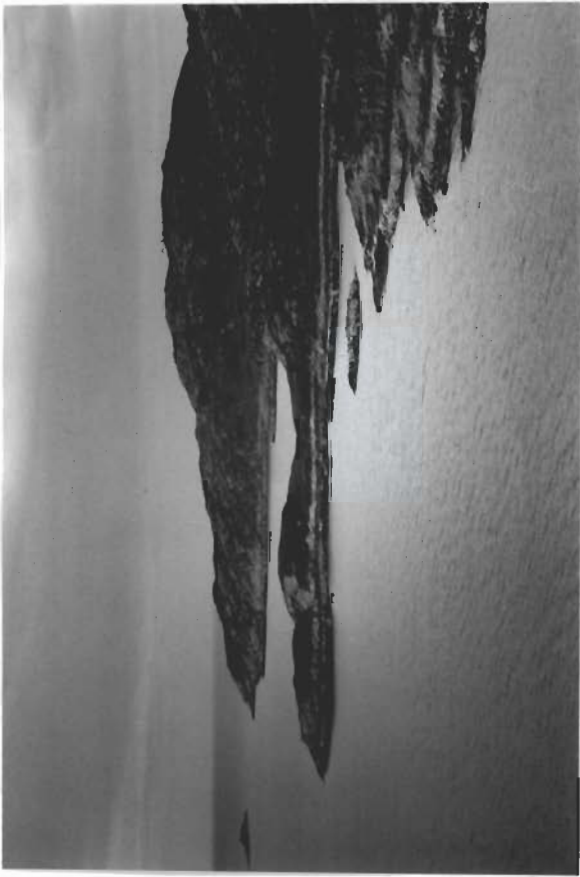
Plate 1: A typical stretch of 'skerry' coastline, looking north west to Rubha na Brèige from Rubh' a Brochaire (Map 10).

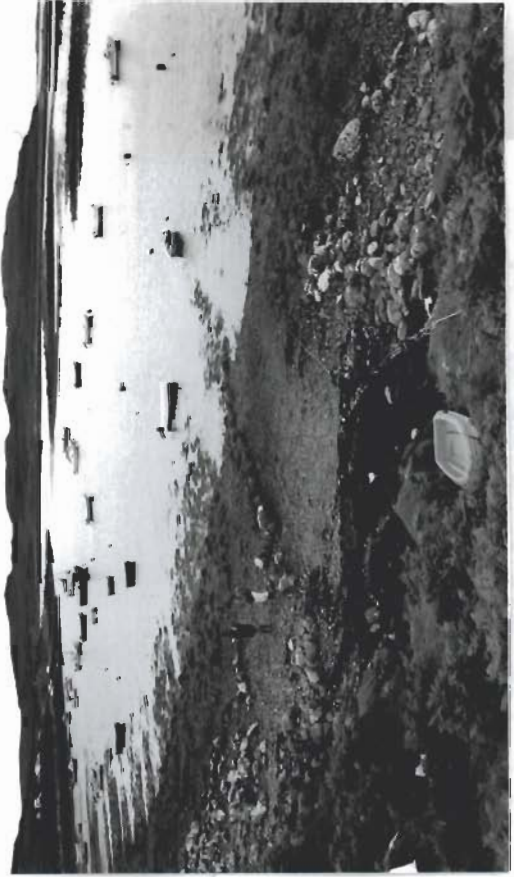
Plate 3: The sheltered harbour of Old Dornie Bay (NB 1985 9113), with several slipways and a boat naust visible in the foreground. Looking towards Isle Ristol.

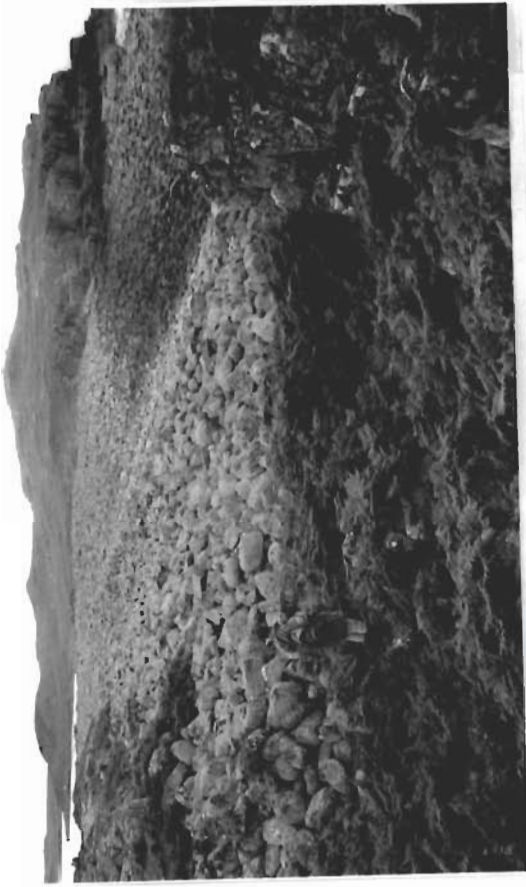
Plate 2: Storm bar composed of massive boulders, defining the head of Loch of Reiff (Map 7).

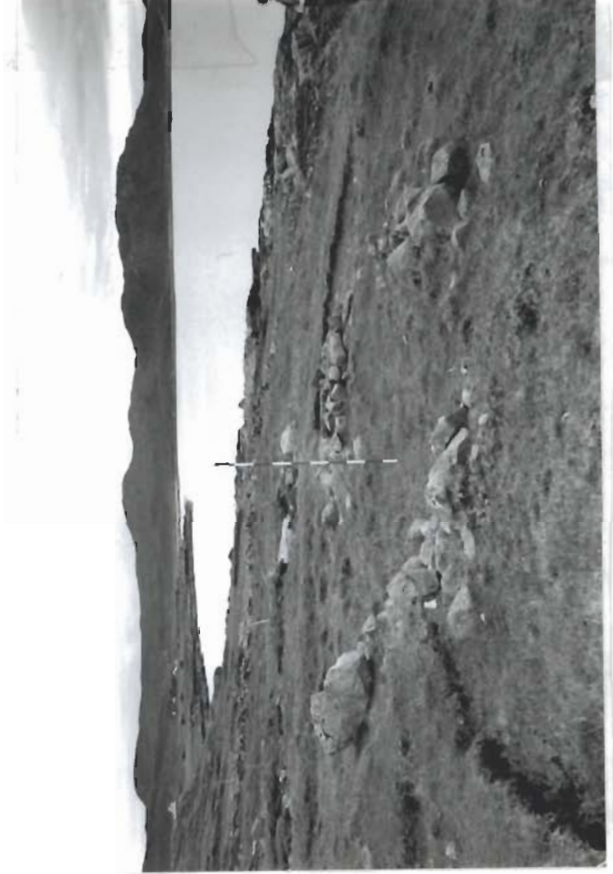
Plate 4: Subcircular structure near Allian Dubh, (NB 1975 9131) revealed through peat cutting.

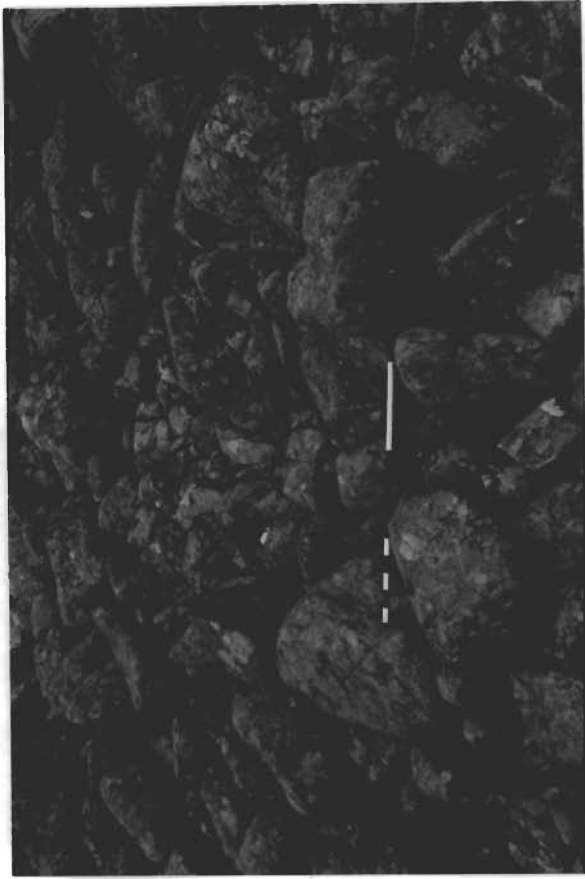
Plate 5: Remains of circular kelp kiln at Rubh' a' Choin (NC 2033 9148); note heat shattered rocks inside boulder arrangement on storm beach

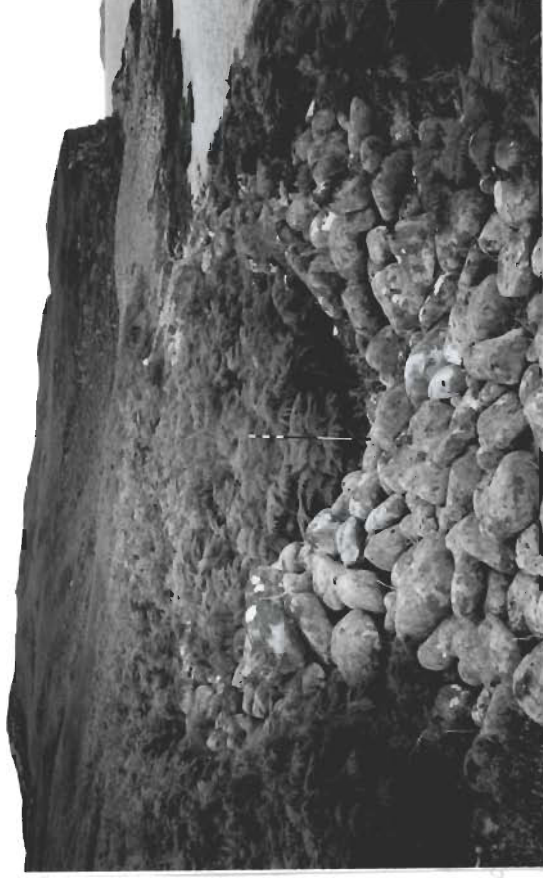
Plate 6: Enclosure composed of piled boulders on a storm beach, Garvie Bay (NC 2038 9141).

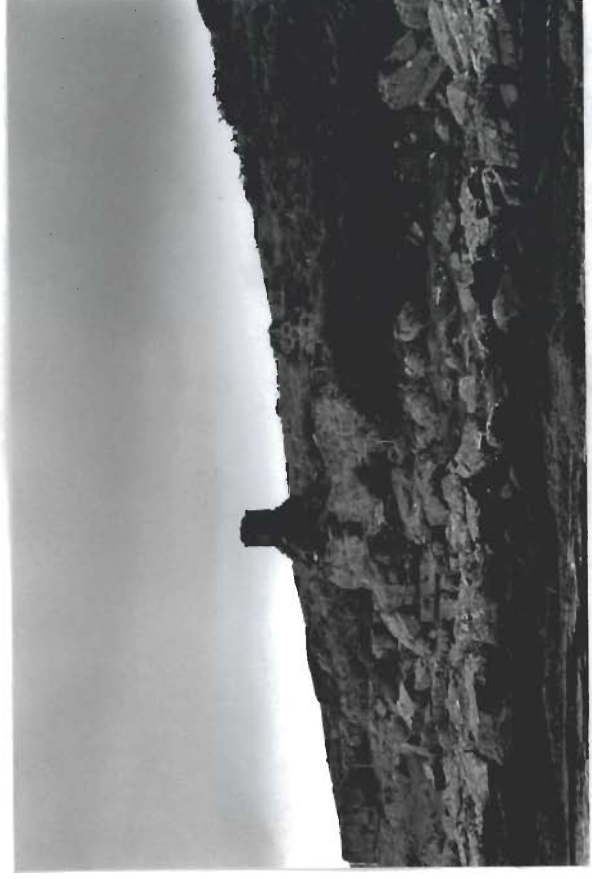
Plate 7: Abandoned croft at Badenscallie (NC 00 NW 56). Reputedly built below HWM to avoid eviction, this building was flooded several times while in occupation.

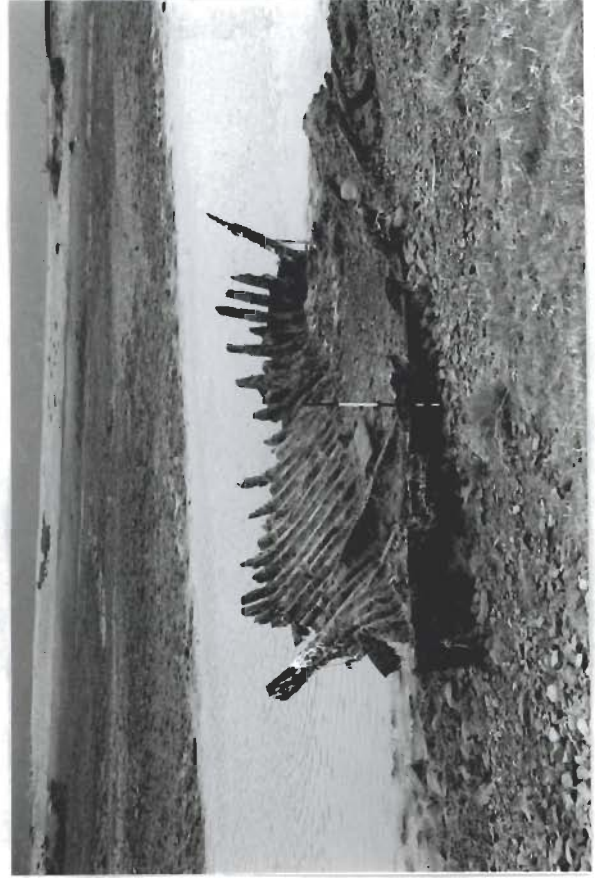
Plate 8: Hulk stranded in a tidal stretch of the Ullapool River (NH 2123 8947).

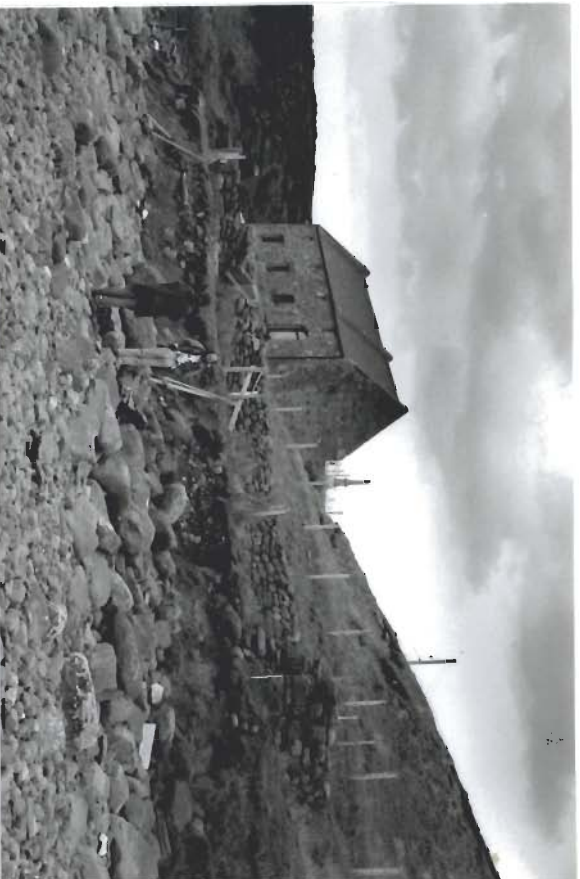
Plate 9: Evidence of wave erosion to a structure at Achitibwic (NC 2019 9090). Achitibwic Mill (NC 00 NW 27) is in the background

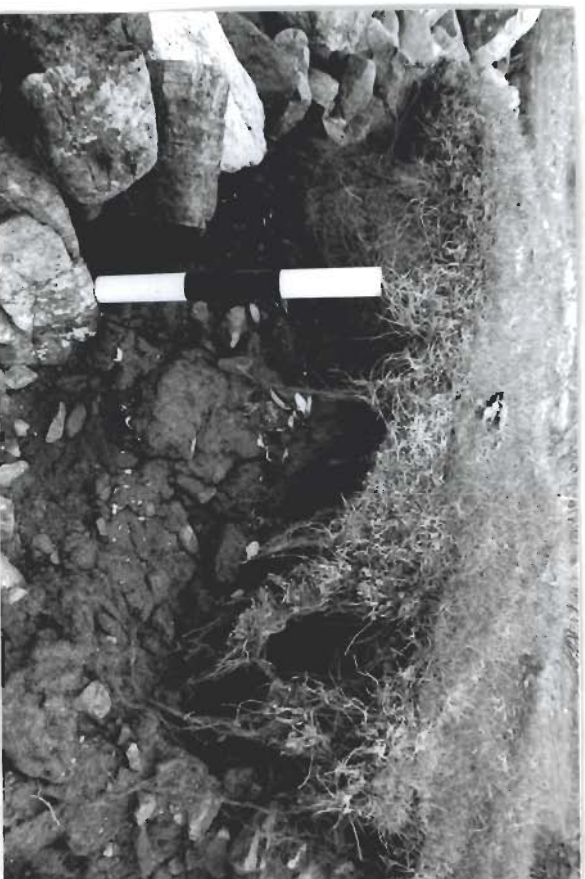
Plate 10: Evidence of wave erosion at the edge of a historic midden at Port na Ba, Inverkirkraig (NC 2074 9198)
