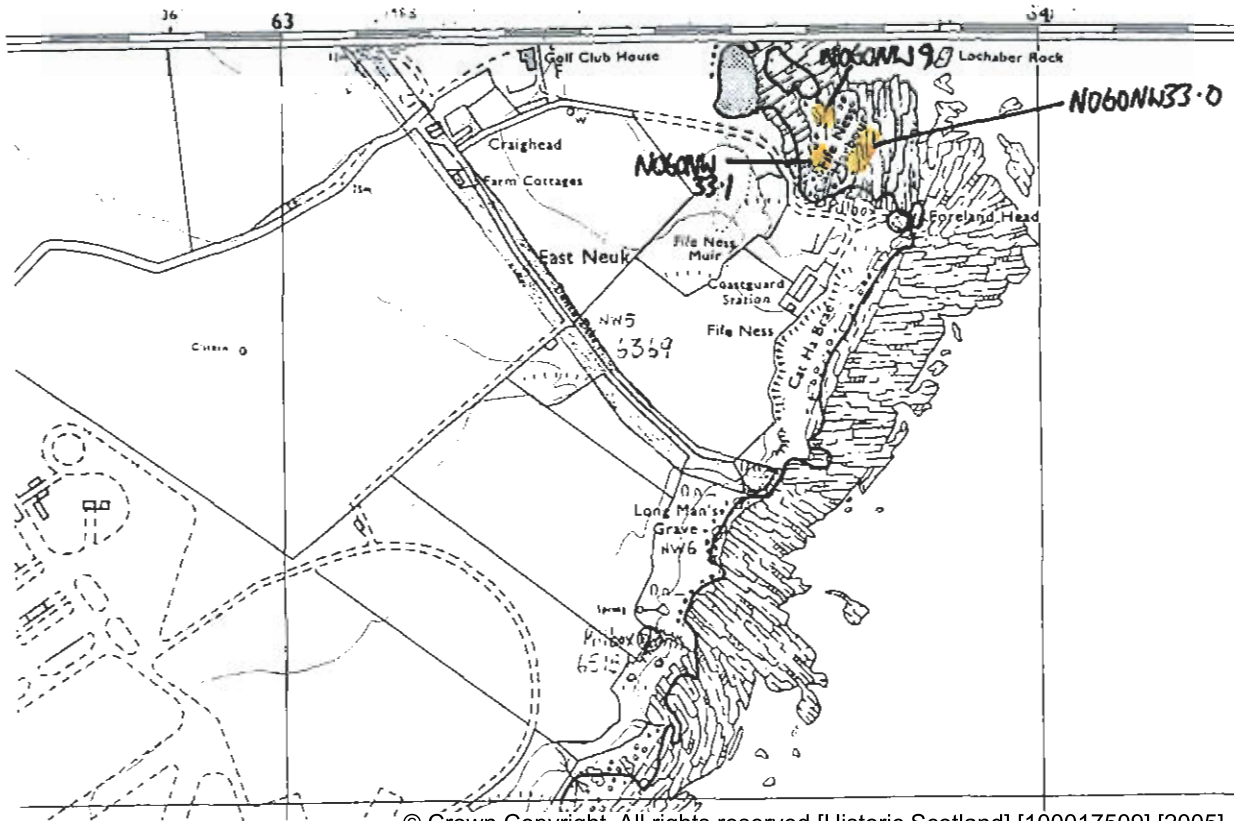
Fig 3: Fife Ness harbour and Lighthouse Construction site.  
 (NO60NW33.0;NO60NW33.1)  
 Sheet NO60NW Scale: 1:10,000

The early 19th Century sandstone quay which can be seen at Fife Ness Harbour is almost completely collapsed, with the height of the quay now some way below the level of Mean High Water and with an extensive debris field of scattered boulders from the quay. Collapse has been caused by wave damage caused by easterly gales and high tides, and through lack of maintenance since the harbour fell into disuse. The existence of the tramway fittings nearby is also of interest, but the iron fittings will not last much longer due to corrosion in sea water, and the holes for these fittings are being gradually eroded by shingle scour.

**Lighthouse Construction Site (NO60NW33.1)** The indentations marking the base of the lighthouse construction site are heavily eroded at the edges and in some places are not visible. This has been caused by shingle scouring and other marine action.

Given the state of collapse of the stone quay, and the ongoing erosion to the tramway fittings and lighthouse construction site, it is recommended that the existing monuments be compared with the baseline surveys carried out by RCAHMS in 1990 to establish whether any changes have occurred in the recent past and to assess what can be done to mitigate any decline.

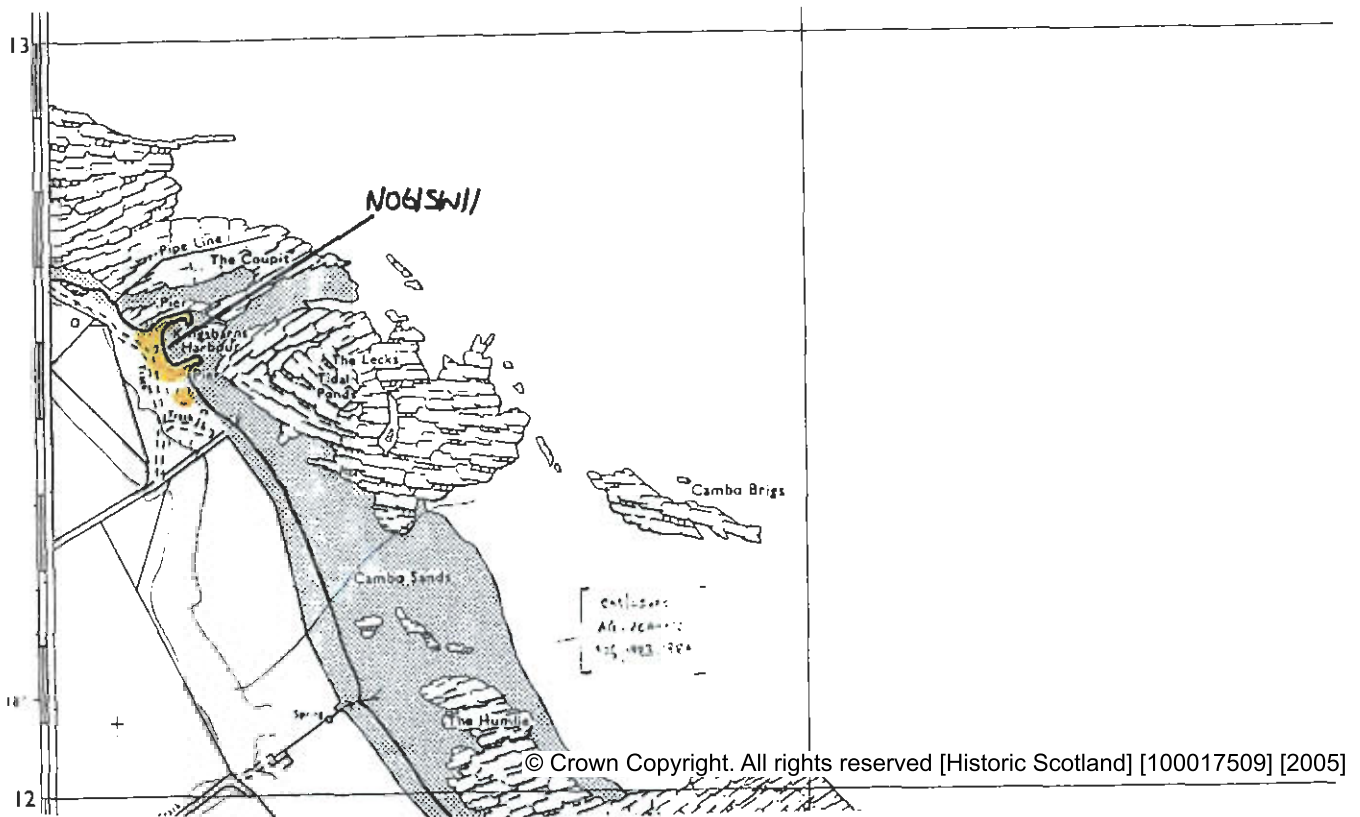
Fig 5: Kingsbarns Harbour and Limekiln (NO61SW11)  
 Sheet NO61SW Scale 1:10,000

The principal threat to Kingsbarns harbour is from erosion. Throughout history, the harbour has suffered from sea damage which brought about its downfall at the end of the 19th Century. Since then, only a small part of the northern sea-wall remains intact, while the foundation courses are also intact along the length of the southern sea-wall where it appears to be protected by accreting sand deposits, and at the foundation layers of the outer wall. Sand can be seen to be breaching the northern quay at the landward side where the quay line is no longer visible. The survey team testified to substantial deterioration since a measured survey was carried out by the Scottish Institute of Maritime Studies in the 1990's. This indicates that the rate of erosion may be rapid.

The nearby limekilns appear to be fairly stable and lie behind the coast edge. The only evidence of erosion was from footpath damage caused by access to the beach from the car-park behind.

A further survey of this site would be desirable to confirm whether the harbour has deteriorated since the 1990's survey carried out by S.I.M.S. If there has been deterioration, then the site should be frequently monitored with additional recording work carried out in the event of imminent collapse of the harbour and its associated features, and, if required an assessment made of what can be done to mitigate the effects of erosion. In addition, monitoring of sand movement along the coastline as well as dune stabilisation work to trap sand in the vicinity of the monuments might help to protect the harbour wall structure and limekilns in the longer term.

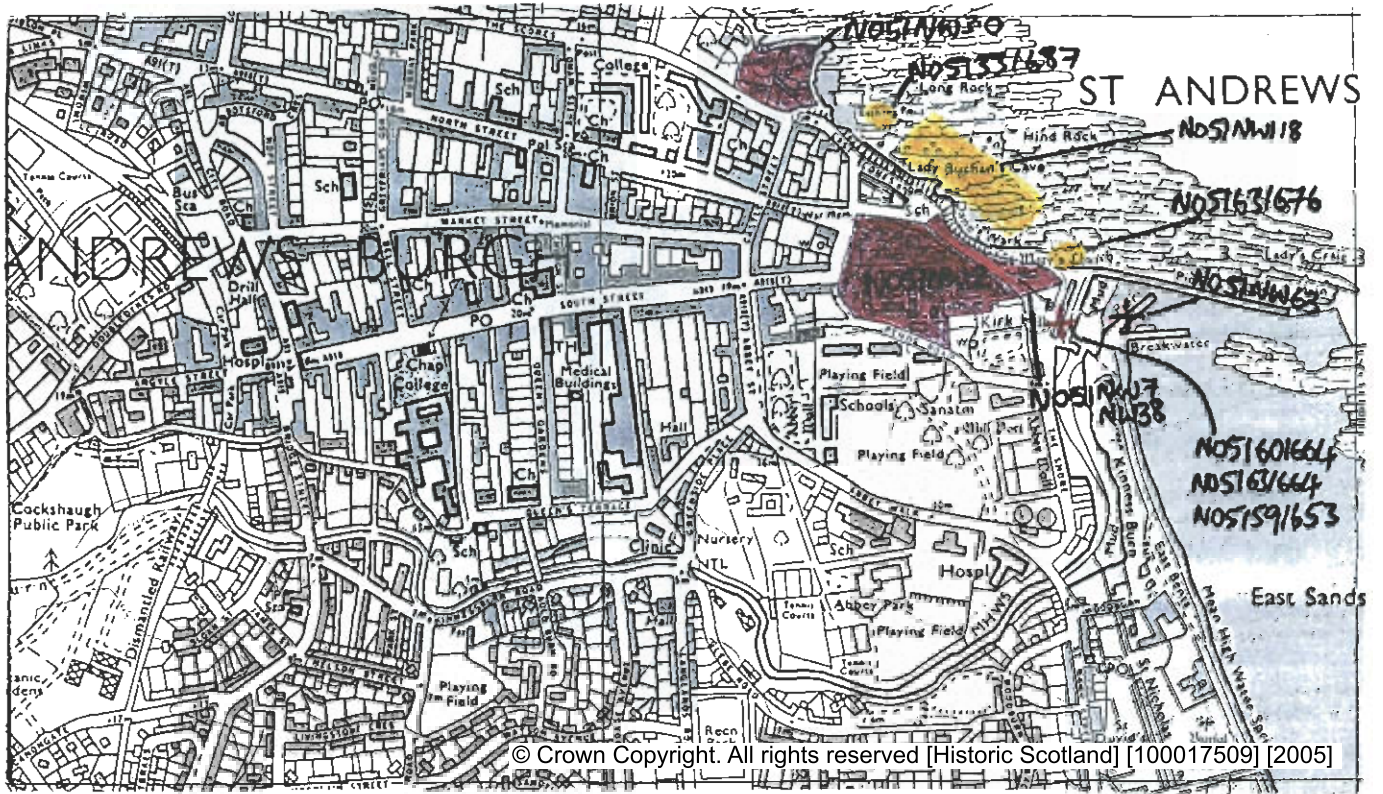
Fig. 7: St Andrews Castle piers (NO51NW118)  
Sheet NO51NW ; Scale 1:10,000

**Threat:** *These features have been inadequately recorded to date. Although the geology of the foreshore at this point will insure that the natural rock inlets remain stable for the foreseeable future, the enhanced features will soon disappear. Only a few iron fittings remain due to the corrosion of iron in sea-water and the other post footings, visible as cuts and drill holes into the littoral rocks are gradually eroding as a result of shingle scour.*

**Recommendations:** A thorough survey of these features is required, including an E.D.M measured survey of the entire area including St. Andrews Castle, all identifiable inlets, post footings, steps, cart ways, and other features as far as the west sea wall of St. Andrews harbour.

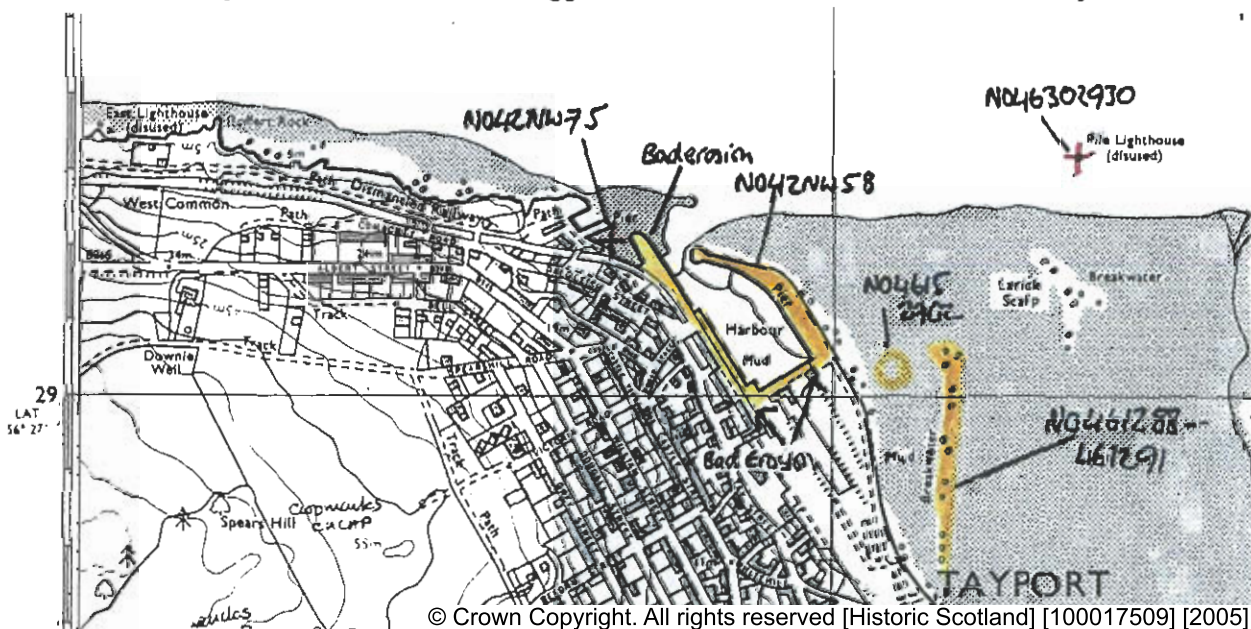
Fig. 9 : Tayport harbour (NO42NW58) - Sheet NO42NE ; Scale 1:10,000

**Threat:** There is evidence of serious erosion to the harbour walls at Tayport Harbour (NO42NW58). The sloping cobble wall at the southern end of the main basin is collapsing probably because of faulty drainage causing water run-off to undermine the ground behind the wall. There has been a recent housing development in the land adjacent to this section but it was unclear whether pavement works could be connected to the deterioration of the wall. Further damage of a similar nature was evident on the topstones of the main quay of the northern harbour complex. Again drainage is probably the cause of this collapse. However, erosion to the northernmost harbour feature has probably been caused by marine action. Land-fill has been dumped at this point in an effort to mitigate the effects of erosion. Since the Pile lighthouse (NO46302930) fell into disuse, its condition has deteriorated but its structure appears to be fairly sound. However, given its exposed location, this attractive feature will quickly deteriorate. The old harbour breakwater (NO461288-461291) has almost entirely collapsed and the wide scatter of debris building material indicate the erosive effects of the sea on this feature. Although the small wreck (NO46152902) is buried in mud, it will deteriorate fairly quickly once its iron fittings have corroded and rusted away.

Tayport Harbour (NO42NW58)

-*Survey and monitor*

Old Harbour breakwater

(NO461288-461291) -*Survey*

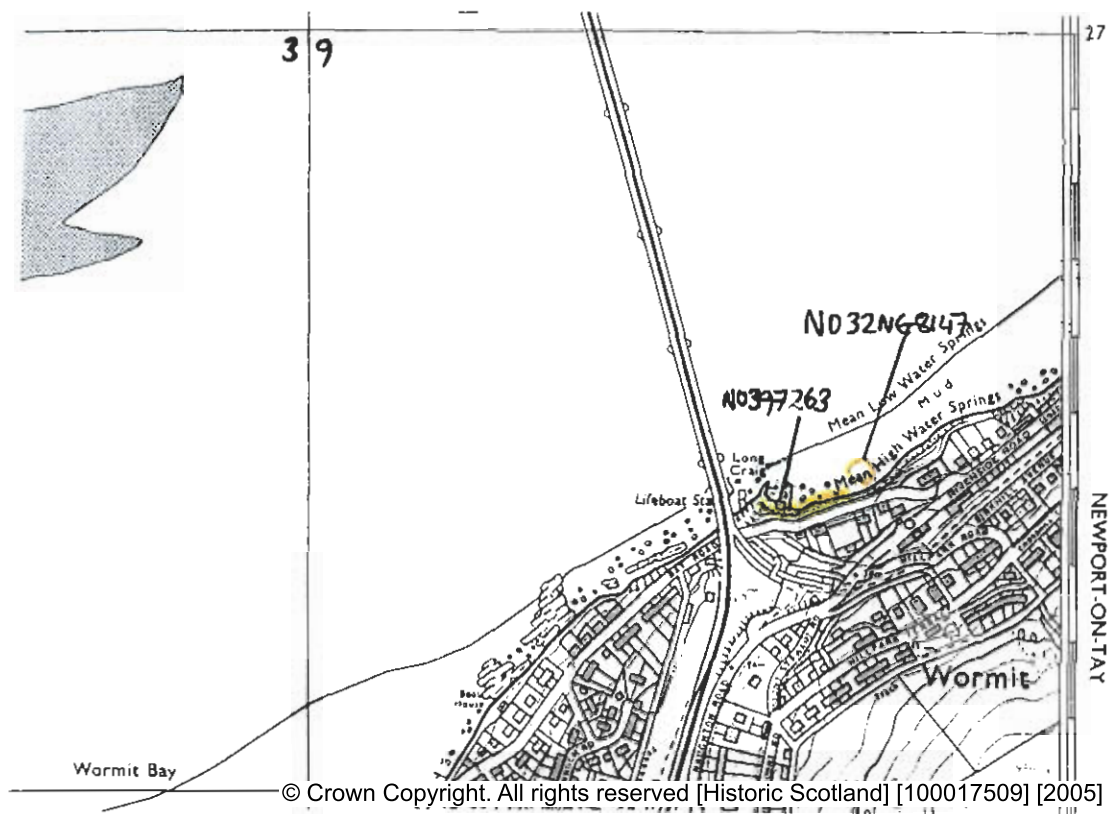
Fig. 11: Wharf remains and wreck  
(NO397263;NO32NE8147).  
Sheet NO32NE; Scale: 1:10,000

**Threat:** Heavy growth of seaweed over the wreck and wharf remains suggest that the site is stable and will if anything, be protected by the accretion of mud evident along this part of the Tay estuary. However, this interesting collection of industrial remains has been inadequately recorded to date and deserves further attention.

Unknown wharf and harbour remains (NO397263): *Survey*

Wreck (NO32NE8147): *Survey.*

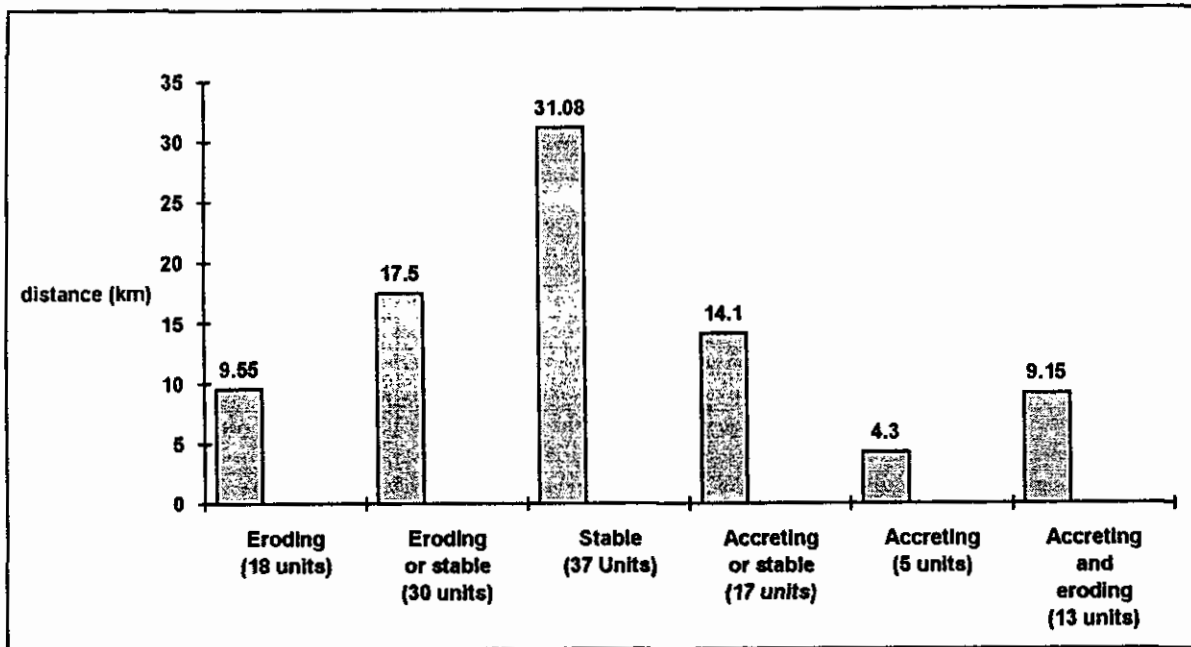
Fig. 19: Erosion units (%) by total length ( km)

By calculation of the lengths of erosion units, observed during the survey, it appears that approximately 9.55 km (11%) of the coastal survey area is definitely experiencing erosion and that there may be erosion occurring along approximately a further 17.5 km (20%) of the coast (see fig.19). Although erosion rates were seen to vary substantially, even between adjacent sections of coastline, it was possible to identify the following trends in coastal erosion along the survey section.
