Map 1: South Gravity to Hollandstoun

Landscape, Built Heritage & Archaeology

North Ronaldsay Map 1

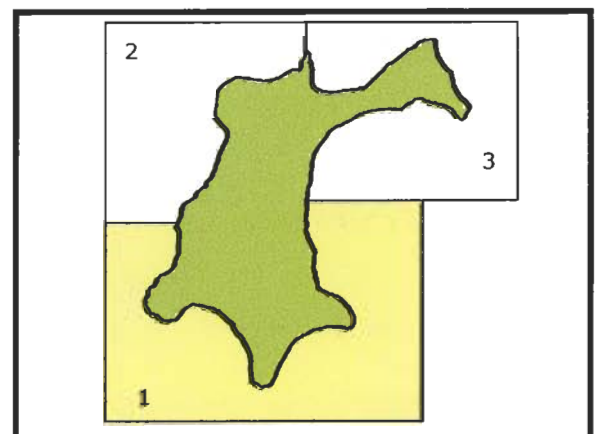
The foreshore is sandy with a small amount of patchy cobble cover. Around Hooking/Haskie

Taing the bedrock is exposed and has some cobble cover. There is a concrete sea wall in front of Hooking farm. The hinterland is grassed, with dunes towards the southern end of the unit.

There is some cobble throw throughout this unit. A storm beach lies to the west of Brides Ness. It is large with a flat top and some vegetation. It extends c. 20 m inland. The drift/rock interface can be clearly seen around Strom Ness. The hinterland is mostly grassed and enclosed but it is marshy east of Viggay. There is a gabion wall sea defence in front of Stennabreck farm buildings.

This wide sandy bay has some cobble throw on the upper foreshore, especially towards the centre of the bay. The hinterland comprises dunes, which rise to c. 4 m high towards the east side of the bay.

This unit comprises a coast edge which is well defined and has a prominent rock platform. There is some cobble cover throughout. The land around Nouster is covered in storm thrown stones. The coast edge around the eastern end of the unit has been stabilised by the pier and road, with attendant sea defences. The hinterland is grassed and fenced.

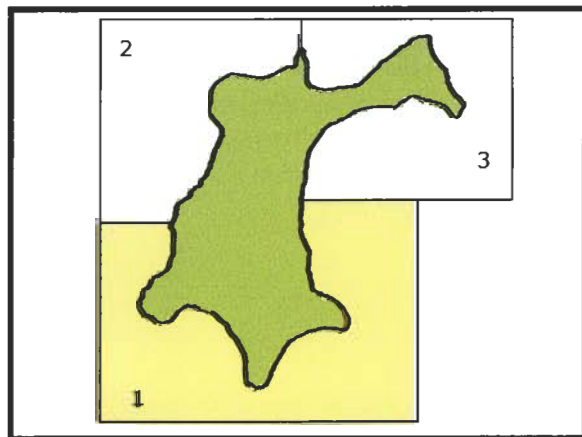
- 1. Galtie Rock**
HY 767 537
0.5 km
Eroding to Stable
A sandy beach leads to a small cliff which measures up to 1.5m high. The hinterland appears stable and well grassed. The small cliff face at the coast edge is clean and appears to be eroding. The hinterland is currently used as a golf course.

- 2. Hooking**
HY 768 529
0.9 km
Stable
This section appears mostly stable. Dunes lie in the hinterland, which are grassed over. There is some erosion at the north end of a concrete sea wall which lies in front of the farm buildings at Hooking.

- 3. Stennabreck**
HY 768 521
2.5 km
Eroding to Stable
There is a gabion wall in front of the farm buildings at Stennabreck. The coast edge to north and south of the wall is eroding in small exposures each no more than a total of 10m long. Elsewhere, the coast edge is mostly stable, with vegetation growing on top of storm beaches, but there is some damage which appears to be caused by sheep. Between South Taing and the Point of Burrian the red till has been exposed in several areas, especially towards the Point of Burrian where the sheep dyke has concentrated sheep activity within a smaller area.

- 4. Strom Ness**
HY 759 517
1 km
Eroding
The sheep dyke lies very close to the coast edge for most of this section, which has had the effect of worsening the effects of sheep erosion. There are many bare sheep trails, and most of the available vegetation has been grazed very flat or entirely eaten, leaving areas of soil with no good cover. The effects of this are most pronounced at the head of Strom Ness, to the west of the broch of Burrian, where a combination of sheep activity and aeolian erosion has rendered a large area unstable. Here, there are signs that adjacent fence lines have been moved inland in the recent past.

- 5. Bustatoun**
HY 754 524
0.9 km
Accreting and Eroding
This section comprises the inner part of South Bay. The hinterland consists of dunes, which are mostly stable and grass covered however there are areas where the grass cover has been lost, exposing the sand below. This may have been caused by apparent rabbit infestation. The land closer to the shore is eroding badly. Here, on the seaward side of the dyke which encircles the island sheep damage is apparent and is undoubtedly contributing to the erosion. The erosion is evident from the lengths of collapsed dyke and from the large 'lumps' or 'pillars' of sand left standing between hollows to either side. Fence lines have also been moved inland. Sand is accreting

- beyond the foreshore around collapsed dykes.
- 6. Nouster**
HY 746 523
1.4 km
Eroding
There are many areas of the coastline within this section which are denuded of vegetation and susceptible to salt spray. The coast edge around the pier area appears more stable, due to consolidation using dumped rubble.

- 7. Loch Gretchen**
HY 749 530
0.5 km
Eroding to Stable
The foreshore over much of this section comprises a storm beach. The coast edge is denuded of vegetation by sheep activity and vulnerable to erosion.

- 8. Holland**
HY 750 535
0.4 km
Eroding
This section is eroding; a new stone wall with concrete foundations has been built c. 2m back from the eroding old one. Sheep and rabbit activity is contributing to the erosion. There is little cobble cover here on the rock platform and this section is very exposed to the effects of the sea.
