## MAP 8: KILFILLAN POINT TO CRAIG LODGE

**KILFILLAN POINT TO CRAIG LODGE**

NGR: NX 20-24/51-55

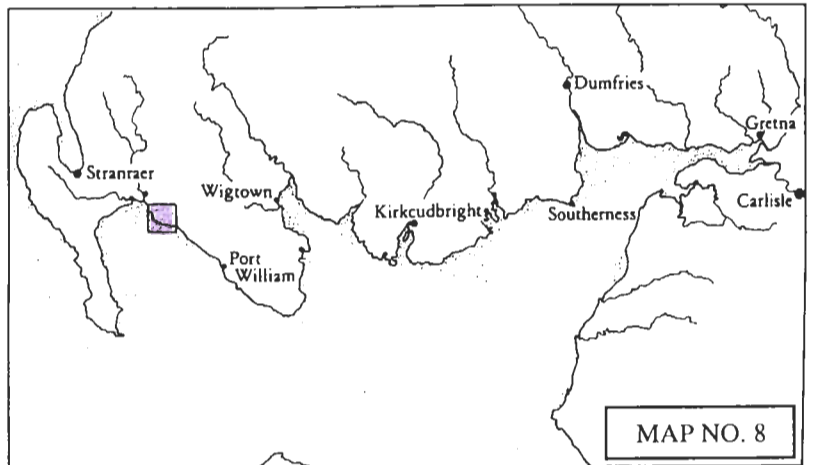
MAP NO. 8

Cliff (> 10m) and low edge (< 5m) at Stairhaven

*Mainly shallow till and drift overlying rock*

Broken rocky coastal edge overlain by *till* and drift deposits. Glacial sands and gravels outcrop at Stairhaven Bay. The intertidal area is wide (c.80m) and consists on boulder and shingle beds intermixed with sand bars.

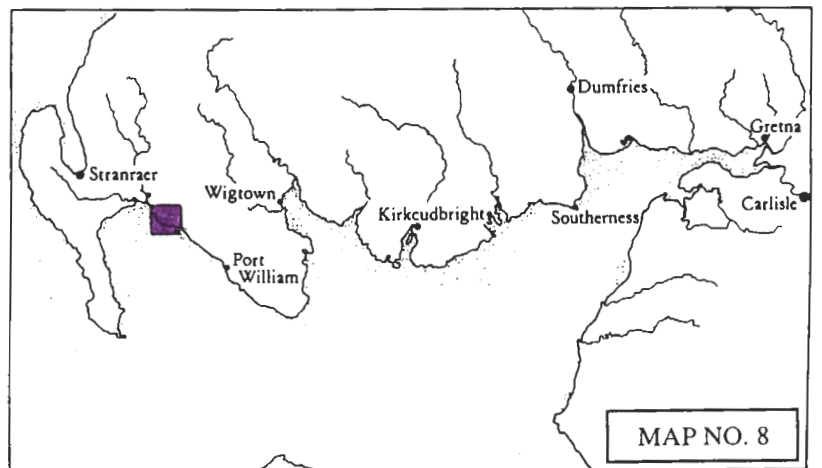
**MAP NO. 8**

*Eroding or stable*

This unit has an exposed south westerly aspect and contains an indented rocky shoreline with shingle at the HWM. This region appears to be eroding only slowly.

*Definitely eroding*

This unit has an irregular cliff edge and an intertidal zone that is extremely wide (current SLWM is c.0.2km) consisting of boulders and sandy bars. Some sand accretion is occurring at the mouth of a small burn that enters the bay. Armour stone and Rip-Rap wall has been used with limited success as erosion is occurring either side of these works. More serious erosion is occurring to the east of a ruined pier. The 1946 vertical aerial photograph shows that the pier was extant. It has since collapsed and wave attack is accelerating erosion immediately east of the pier. Cliff edge retreat now stands in excess of 3m.

This region of coastline consist of irregular indented greywackee cliffs. Erosion is occurring along the deep gullies and especially along faults and fractures. It is difficult to estimate cliff-edge retreat but it is estimated to be slow.

*Accreting or stable*

This bay has a wide intertidal zone consisting of outcropping cleaved greywackee and wide areas of sand and shingle. The exposed promontory headland at Stackmore Point is precipitous and wave abraded rock fall is evident at its base.

Poorly sorted shingle is banking up at the current HWM in the centre of the bay which is defended by a concrete sea wall. The shingle is being deposited by longshore drift on a predominately easterly fetch.

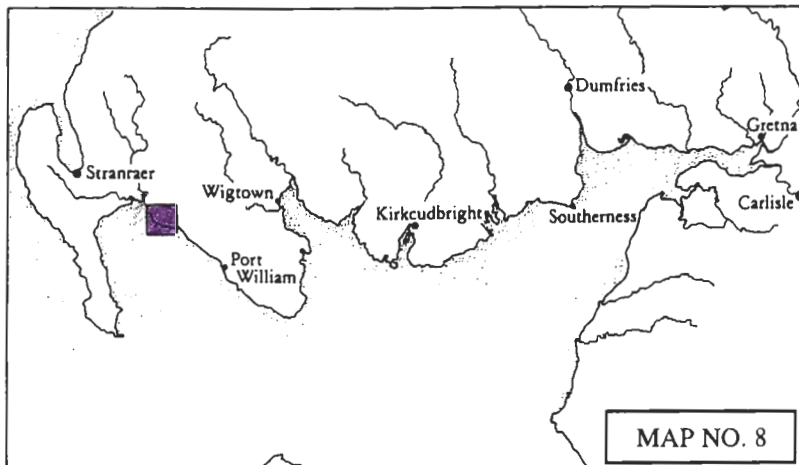
**NX 2084 5358**  
STAIR HAVEN BAY  
Possible Wooden Pier/Fish Rack  
Uncertain  
Poor  
Survey & Monitor

**NX25SW 53**  
NX 2083 5365  
STAIR HAVEN BAY  
Stone & Rubble Pier  
19th century  
Poor  
Survey & Monitor

**NX 2087 5361**  
STAIR HAVEN BAY  
Ruined Harbour House  
19th century  
Fair  
Survey & Monitor

**NX25SW 9**  
NX 2091 5335  
STAIR HAVEN  
Broch  
Scheduled Ancient Monument  
2nd century BC - 2nd century AD  
Fair  
Survey & Monitor

**NX25SW 10**  
NX 2157 5219  
LAIGH SINNINESS  
Promontory Fort  
Scheduled Ancient Monument  
1st Mill. BC/AD  
Fair  
Monitor
