## Coll

### Map 6: Fiskary to Eilean Maol Mor

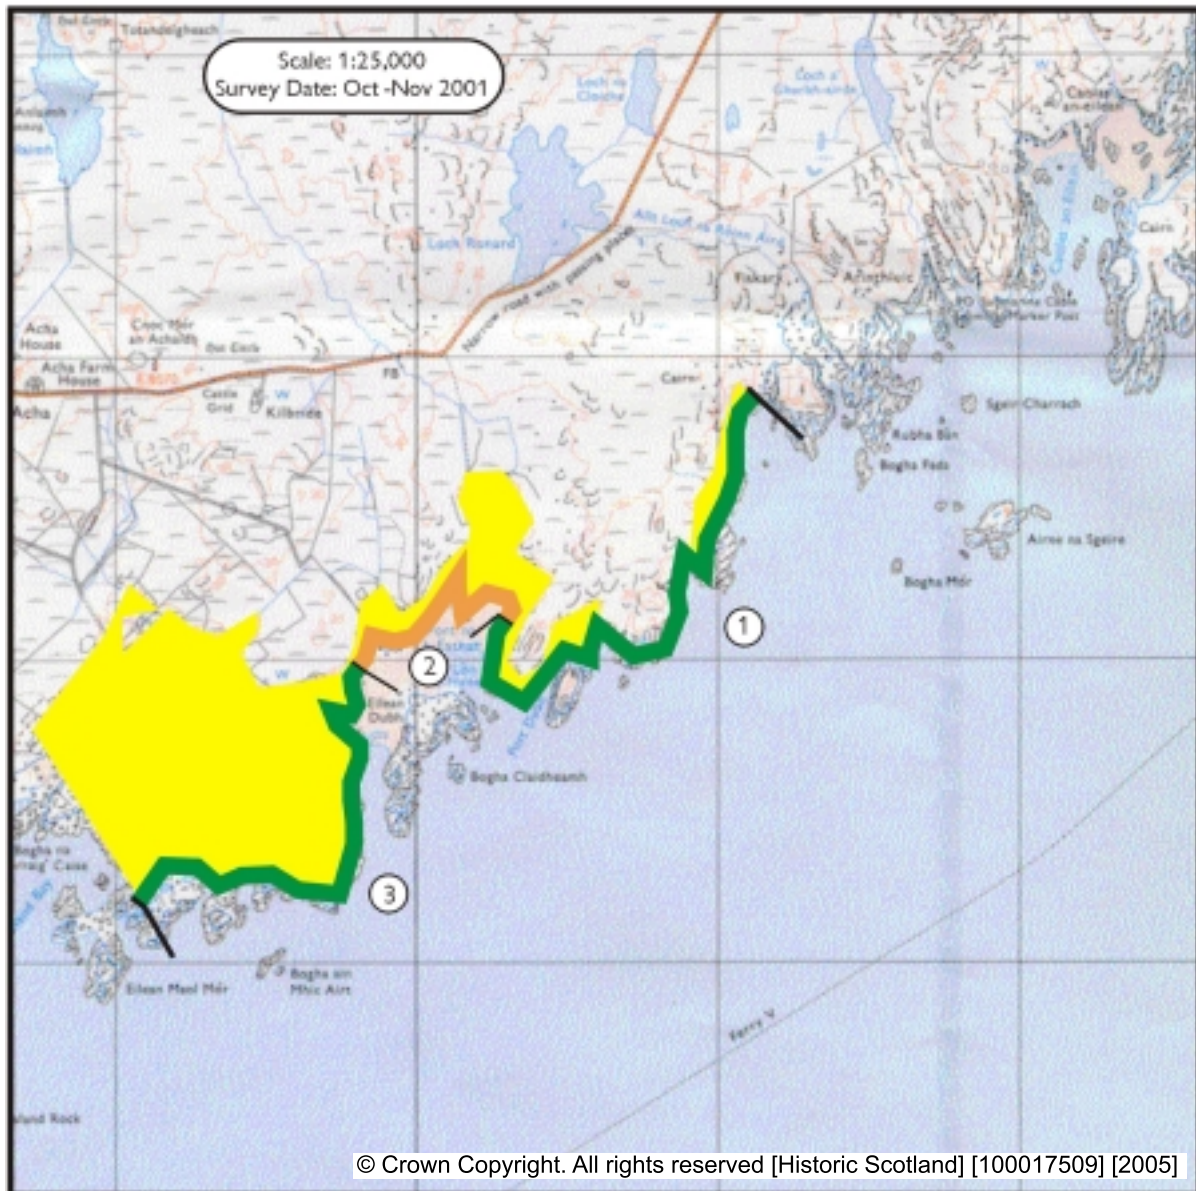
1. Port Dubh NM 208 541 2.4 Km Stable A rocky coast edge with no sign of recent erosion.	3. Creag an Fhithich NM 197 532 1.9 Km Stable A rocky coast edge with no sign of recent erosion.
2. Hyne NM 200 542 1.2 Km Eroding to stable This unit is low lying. The coast edge here is being inundated by the sea at high tide and has been classed as eroding to stable.
