Tiree

Map 11: Rubha Charrastain to Rubha Port Bhiosd

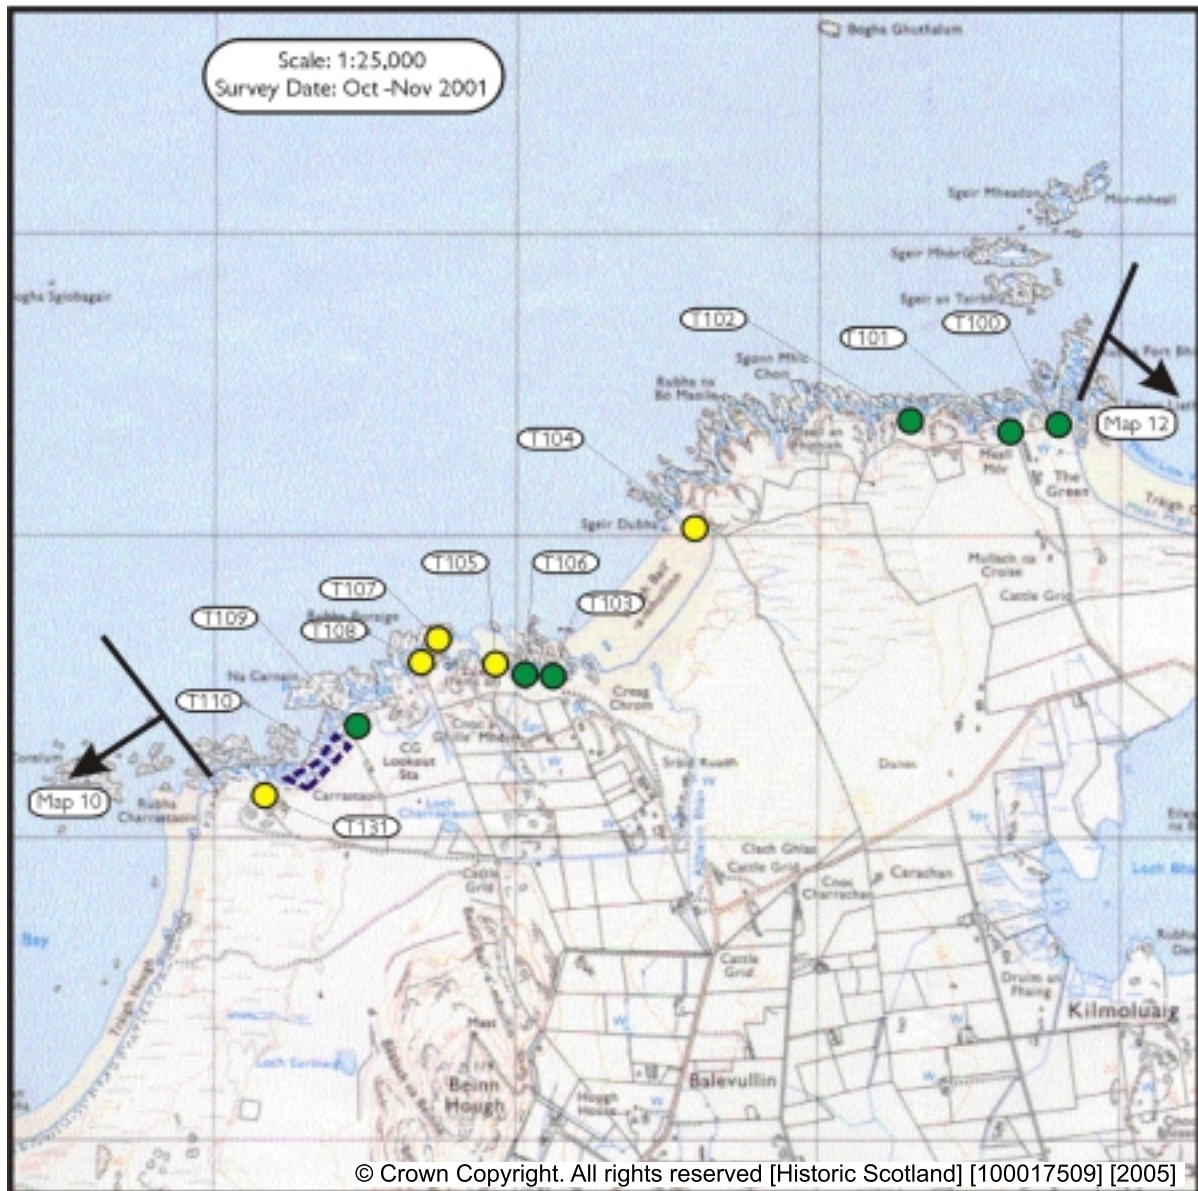
Four defended houses or dun sites have been recorded previously in this area. Of these, no surviving remains could be found at two of the sites (T104, 131). At Dun Boraige Moire (T107) the ruins of a large circular building appear to be those of a broch. The structure is relatively well preserved and may retain traces of its internal layout. Nearby at Dun Boraige Beag (T105), a probable fortified settlement is indicated by traces of walls which appear to define a structure on the summit of a rocky knoll, with outer walls surrounding it. Amongst the sites of 18-20th C date, there are numerous kelp drying walls at Carrastain (T110) and to the SW of Traigh Bail'-a-mhuilinn (T103). There is an abandoned blackhouse settlement at The Green (T101) which has associated boundary walls. There are also slipways and jetties along the coast at Traigh Chornaig (T100) and Traigh Bail'-a-mhuilinn (T106). A disused quarry lies behind The Green (T102).

T100 NL 96821 48390 Traigh Chornaig (W end) Jetty 18-20th C Good Nil	T106 NL 94955 47555 Traigh Bail'-a-mhuilinn Slipway Unknown Fair Nil
T101 NL 96668 48345 The Green Houses, mound, wall 18-20th C Fair/poor Nil	T107 (NL94NW1) NL 94700 47557 Dun Boraige Moire Substantial house/ possible broch 1st mill BC-1st mill AD Fair Monitor
T102 NL 96348 48324 The Green (W of) Quarry 18-20th C Good Nil	T108 (NL94NW6) NL 94661 47482 Carrastaoin (NE of) Enclosure 18-20th C Fair Nil
T103 NL 95232 47520 Traigh Bail'-a-mhuilinn (SW of) Kelp drying walls 18-20th C Fair Nil	T109 NL 94478 47339 Carrastaoin (NE of) Pit 18-20th C Fair Nil
T104 (NL94NE15) NL 9554 4807 Traigh bail'-a-mhuilinn (N of) Alleged site of dun Unknown Poor Nil	T110 NL 94467 47245 Carrastaoin Kelp drying walls 18-20th C Fair Nil
T105 (NL94NW3) NL 94955 47555 Dun Boraige Beag Defended house/ Dun 1st mill BC- 1st mill AD Fair/poor Monitor	T131 (NL94NW4) NL 9422 4710 Cnoc Charrastaoin Dun Unknown Poor Nil

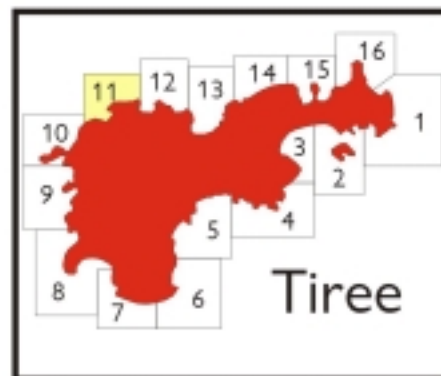
- Built Heritage & Archaeology
- Protected Ancient Monument or area of Designated Wreck
 - Monument formally proposed by Historic Scotland for scheduling or wreck for designation
 - + Listed Historic Building
 - Undesignated wreck
 - Known ancient monument
 - Site found by this survey
 - Site complex

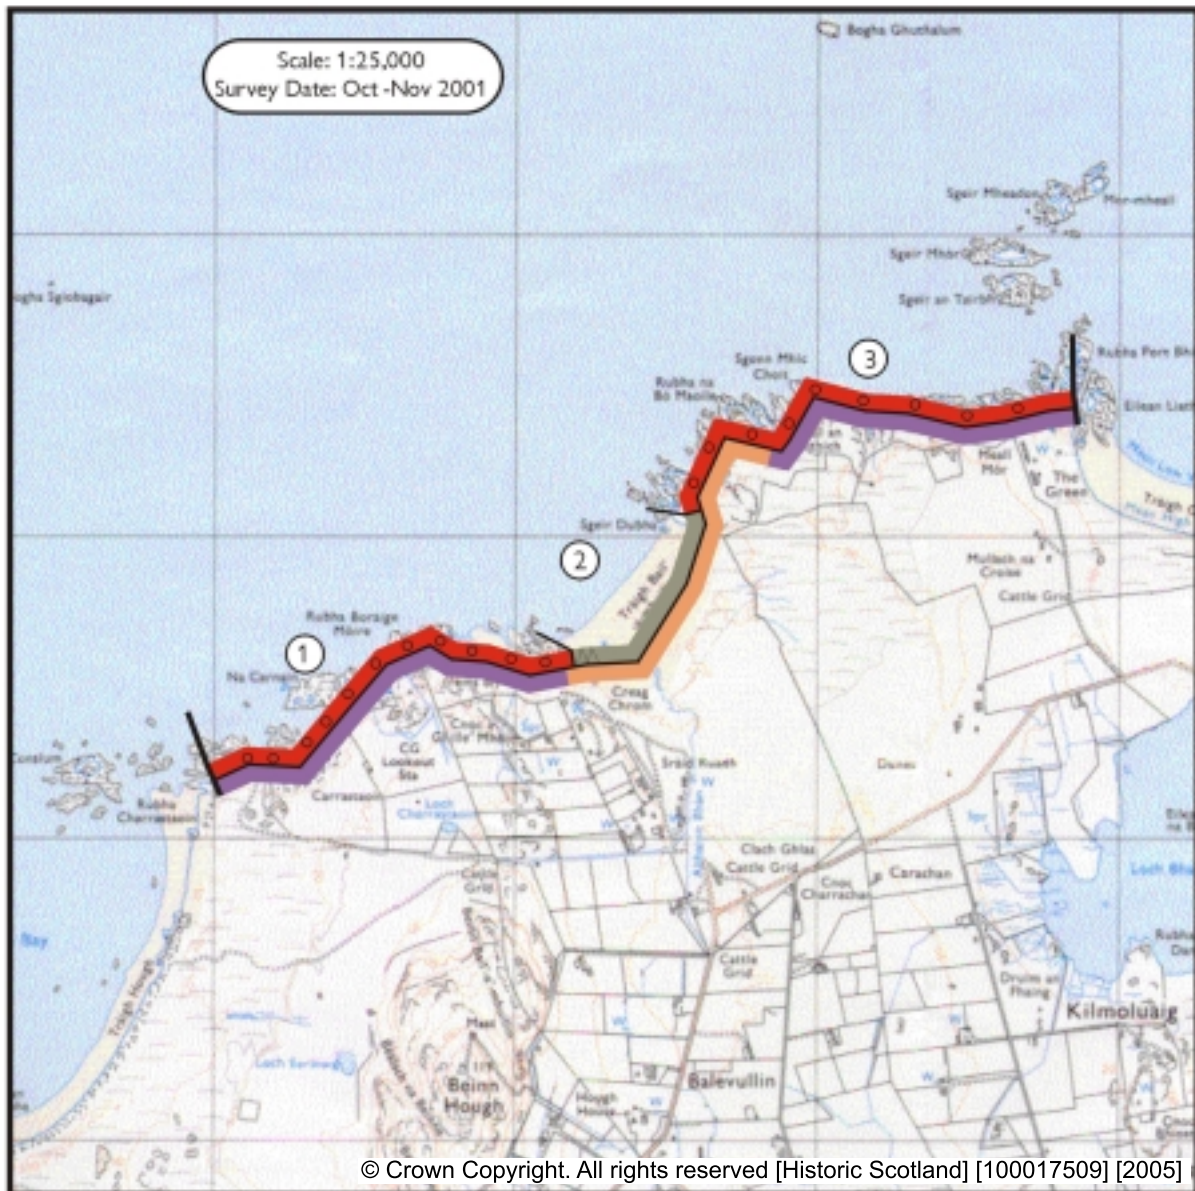
Rocky shoreline sloping steeply to sea. Storm beaches in some sheltered coves, and intermittent cobble and boulder cover elsewhere. This unit includes a short stretch of sandy coast line at Carrastaoin. The hinterland is rough grazing, occasionally poorly drained.

Sandy bay which slopes gently to sea. Large expanse of sand exposed at low tide. There has been some dumping of rubble and refuse at the west end of the beach, this appears to date from c. 1940. The hinterland is dunes.

A rocky shoreline which slopes steeply to the sea. Cobble cover in sheltered coves and on some parts of the upper foreshore. The hinterland is rough grazing, poorly drained in places. From a point c. NL 96104 48358 westwards the hinterland develops more dunes but with many rock outcrops in between.

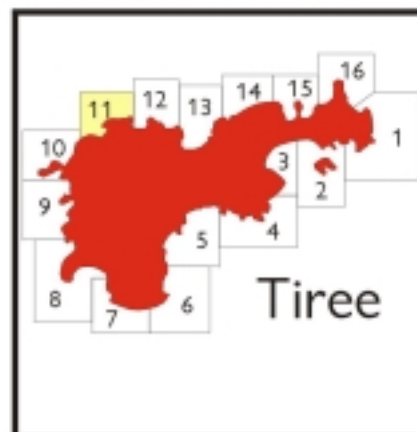
1. Rubha Boraige Moire

Rock platform, some cobble cover

2. Traigh Bail-a-mhuilinn

Sandy foreshore

3. Meall an Fhithich

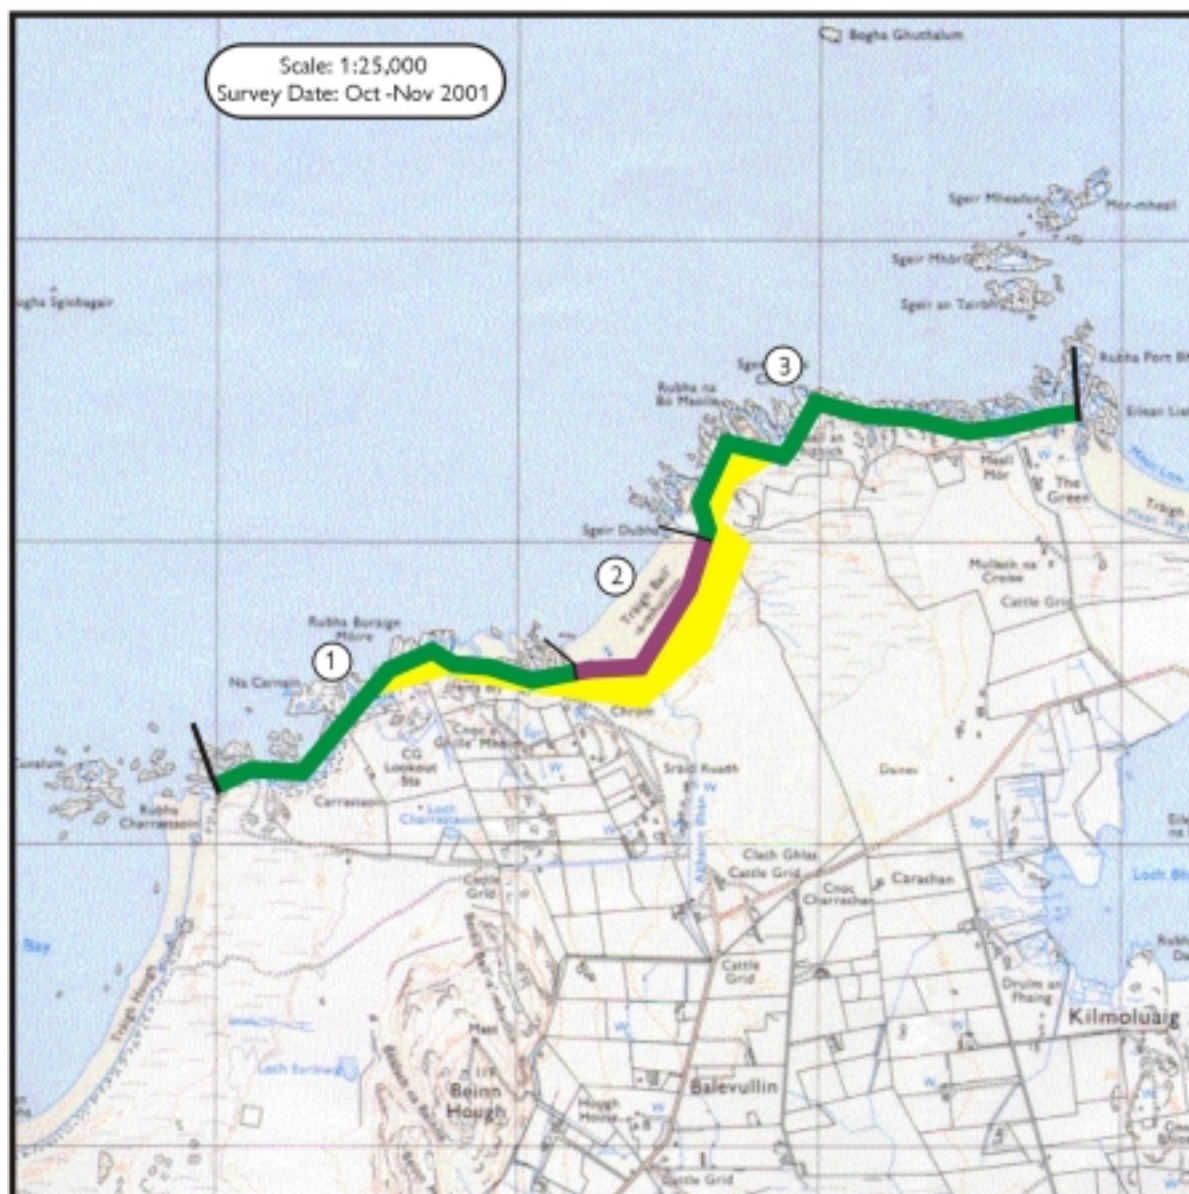
Erosion Class

The coast edge in this unit is rocky and there is no sign of recent erosion

The coast edge in this unit is rocky and there is no sign of recent erosion.

The coast edge in this unit is dunes. The central part of the unit appears to be accreting while to either end the coast edge is visibly eroding, especially so at the northern end where a fence line is dangling in mid air.

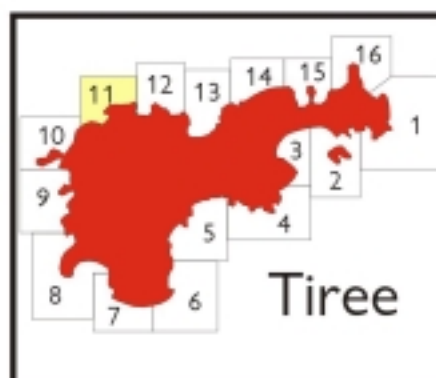
Tiree
Map 11

Stable

Accreting and eroding
