Tiree

Map 14: Rubha Saltaig to Loch an Fhaing

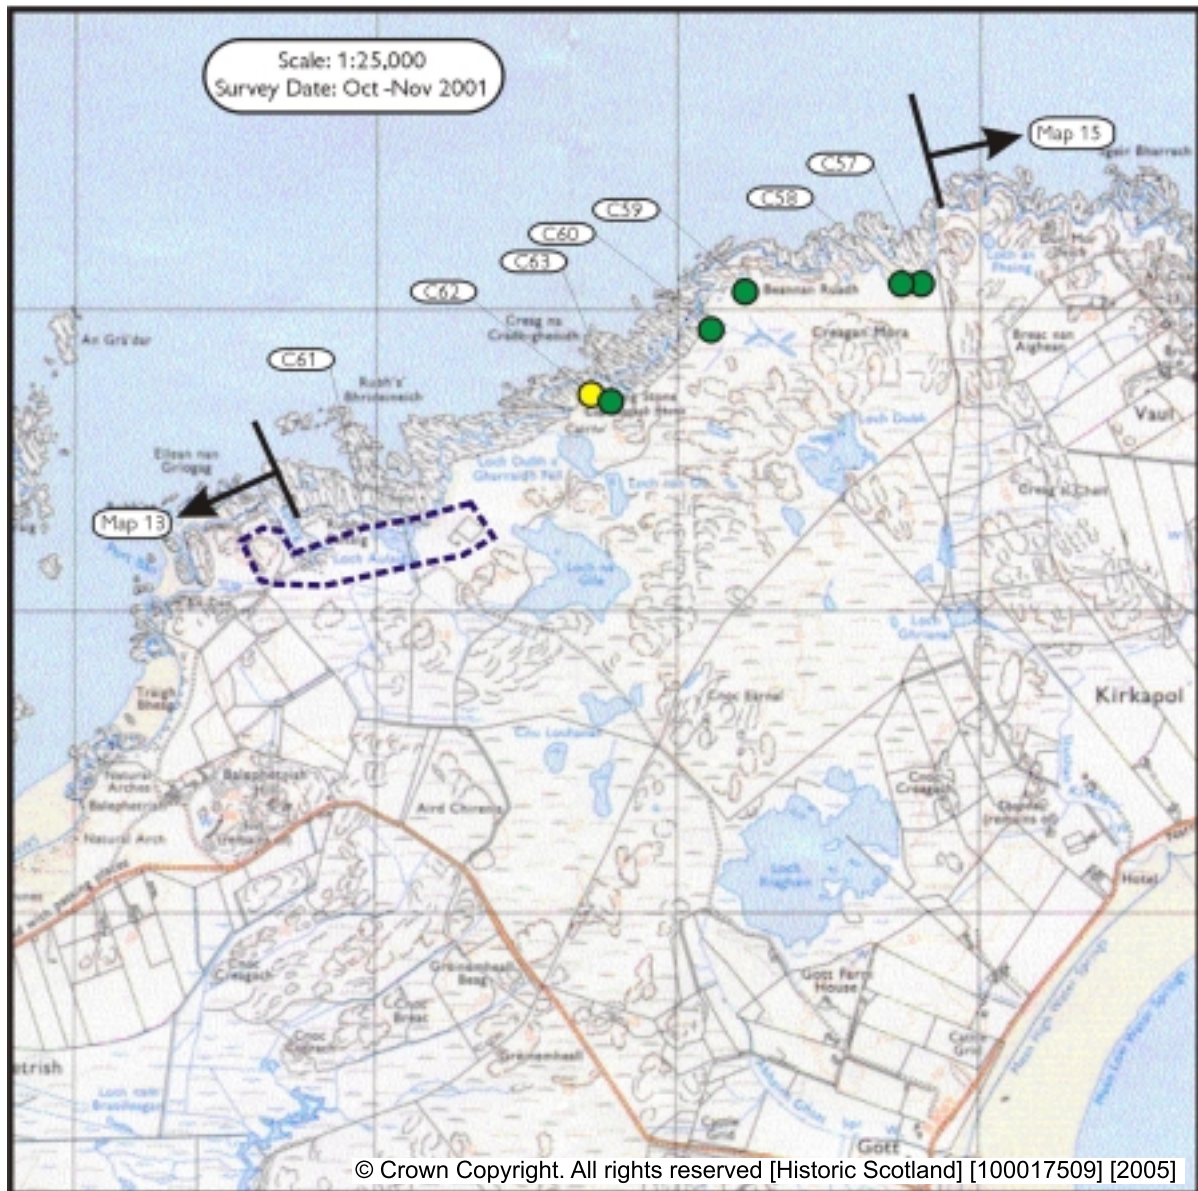
Sites within this area include several remnant field systems and old cultivations, enclosures and land boundaries (T57, 59, 60, 61, 63) and kelp drying walls and kilns (T58, 61). Most of these remains are likely to be of 18-20th C date, although some may be earlier. The very reduced remains of a field system and associated cultivations and a probable house platform to the W of Loch an Fhaing (T57), for example, may be of 14-18th C date. To the NE of Loch Dubh a Gharraidh Fail, the footings of a rectilinear building and associated enclosure may be either a long house, possibly even of Norse origin, or, alternatively, a chapel site (T63). One of the most remarkable sites on Tiree, known as the Ringing Stone, lies on the coast edge within this area (T62). A large cup marked boulder, this glacial erratic is finely balanced on top of the natural bedrock and when struck, produces a clear ringing sound. Over fifty cup marks can be seen; they are located on all sides except the underside of the boulder. It is uncertain if all the markings are of contemporary date but it would appear that many are of some antiquity.

<p>T57 NM 03875 49111 Loch an Fhaing (W of) Field system, cultivations and possible house platform 14-18th C Fair/poor Survey</p>	<p>T61 NM 01687 48114 Loch Aulaig Field system and cultivations, kelp drying walls 18-20th C Fair Survey</p>
<p>T58 NM 03625 49072 Loch an Fhaing (W of) Kelp kiln 18-20th C Fair Nil</p>	<p>T62 (NM04NW6) NM 02696 48679 Ringing Stone Cup-marked boulder, 'The Ringing Stone' Unknown Good Survey</p>
<p>T59 NM 03195 48959 Am Beannan Ruadh Enclosure and cultivation remains 18-20th C Fair Nil</p>	<p>T63 NM 02756 48591 Loch Dubh a Gharraidh Fail (NE of) Structure, enclosure, mound, cultivations, boundary Unknown Fair Survey</p>
<p>T60 NM 03118 48878 Creagan Mora (W of) Enclosure and cultivation remains 18-20th C Fair Nil</p>

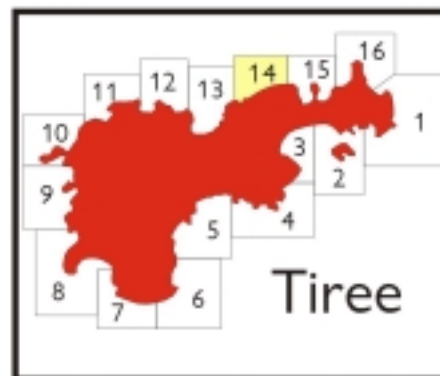
1. Creag na Cradh-gheoidh

Rock platform

Coast edge <5m

Drift/rock interface visible

Rocky shoreline punctuated by small sandy
coves generally <100m long. Hinterland is very
poorly drained in many places. Rough grazing.

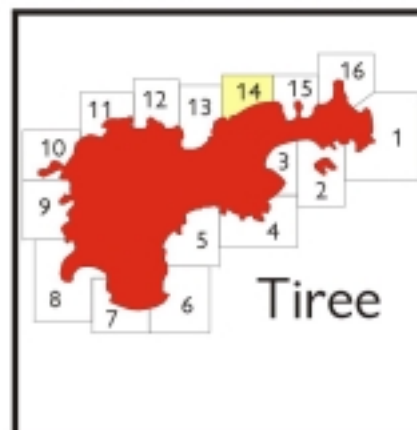
1. Creag na Cradh-gheoidh

Stable

Rocky coast edge with little sign of recent erosion. There is limited erosion within small sandy coves.
