Tiree

Map 2: Millton to Gott Bay

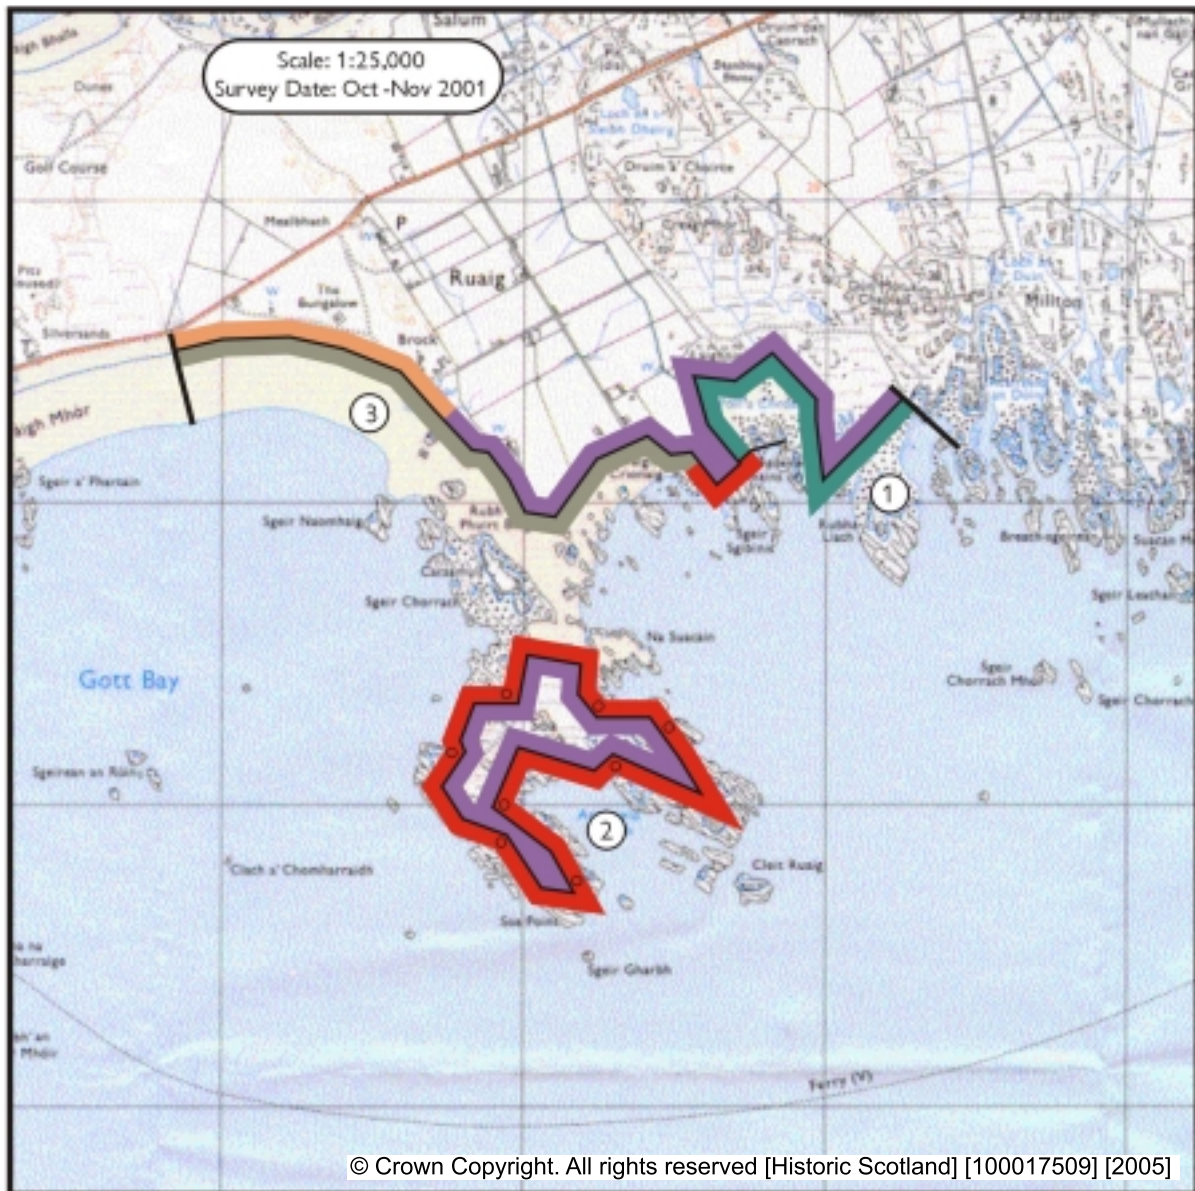
1. Laighnis
NM 079 473
1.6 Km
Salt Marsh
Coast edge <5m
Drift/rock not generally visible
Salt marsh on coast edge. Hinterland is poorly drained rough grazing.

2. Soa
NM 070 462
4.1 Km
Rock platform, some cobble cover
Coast edge <5m
Drift/rock interface occasionally visible
This unit encompasses the small tidal islet of Soa. Coast edge is rocky and slopes steeply to sea. Occasional cobble cover, especially in small coves. Hinterland is rocky and rough. Poorly drained rough pasture.

3. Ruaig
NM 069 470
3.2 Km
Sandy foreshore
Coast edge <5m
Drift/rock interface not visible
This unit includes the eastern end of Gott Bay, a wide sandy bay which slopes gently to the sea. A large expanse of sand is exposed at low tide. Hinterland is blown sand; some dunes close to coast edge.

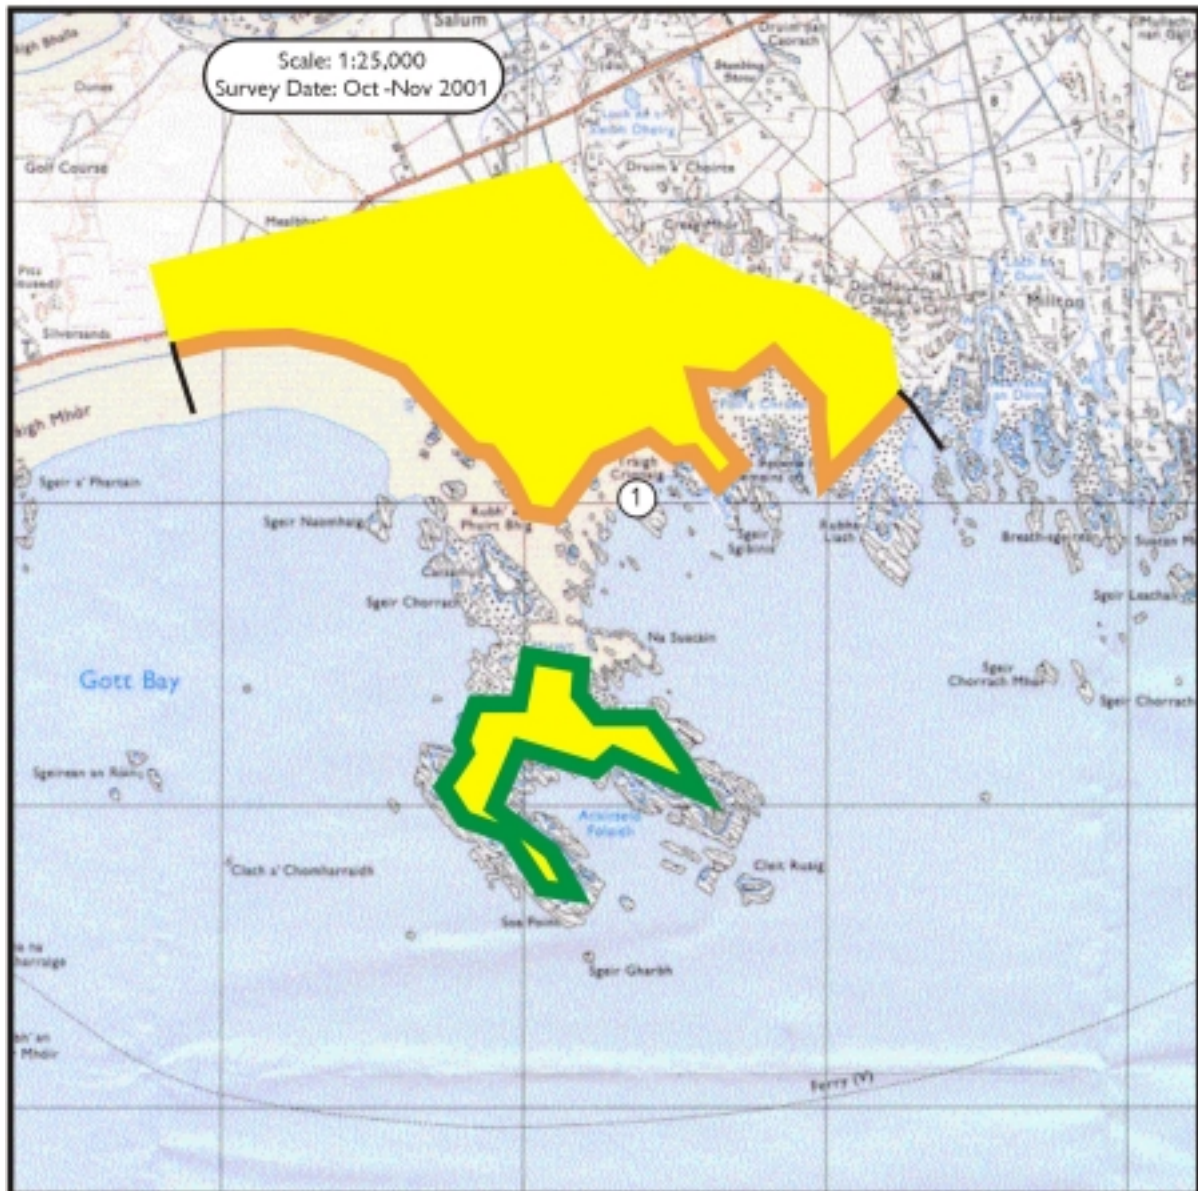
1. Ruaig NM 071 470 4.8 Km Eroding to stable The coast edge for the first c. 1Km is salt marsh, followed by sand. All is classed as eroding to stable. There were slight signs of erosion at the time of visit.	2. Soa NM 070 462 4.1 Km Stable A rocky coast edge with no sign of recent erosion.
--	---
