Tiree

Map 6: Craigaig to Millport House

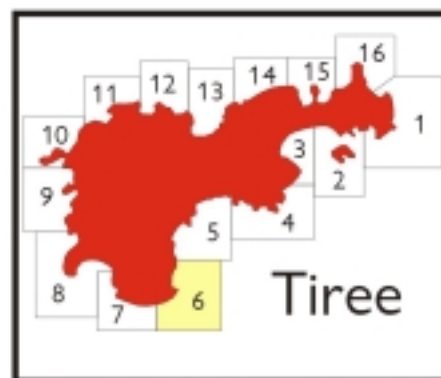
1. Hynish

Rock platform, little cobble cover

Coast edge <5m

Drift/rock interface occasionally visible

A low, rocky shoreline sloping steeply to sea.

Hinterland is poorly drained rough grazing.

There is some dumping of rubble and refuse
along the coast edge in front of Manna.

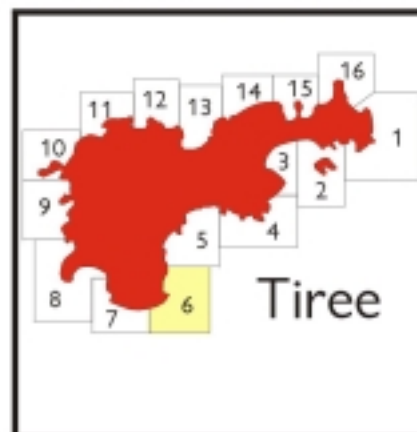
1. Hynish

Stable

Rocky coast edge with no signs of recent erosion.
