# Tiree

## Map 9: Aird Mor to Rubha Hanais

This map section extends from the N end of Traigh nan Gilean, along the W coast of the island, to Traigh Thodhrasdail. The southern part of this section has a low lying rocky coastline behind which the hinterland is formed of stable dunes graduating into enclosed grazing land at Sandaig. From N of Sandaig, past Kilkenneth and to the end of this section, the coast is fringed with sandy beaches, behind which there is a broad strip of unenclosed dunes. There is modern settlement within the coastal zone at Sandaig.

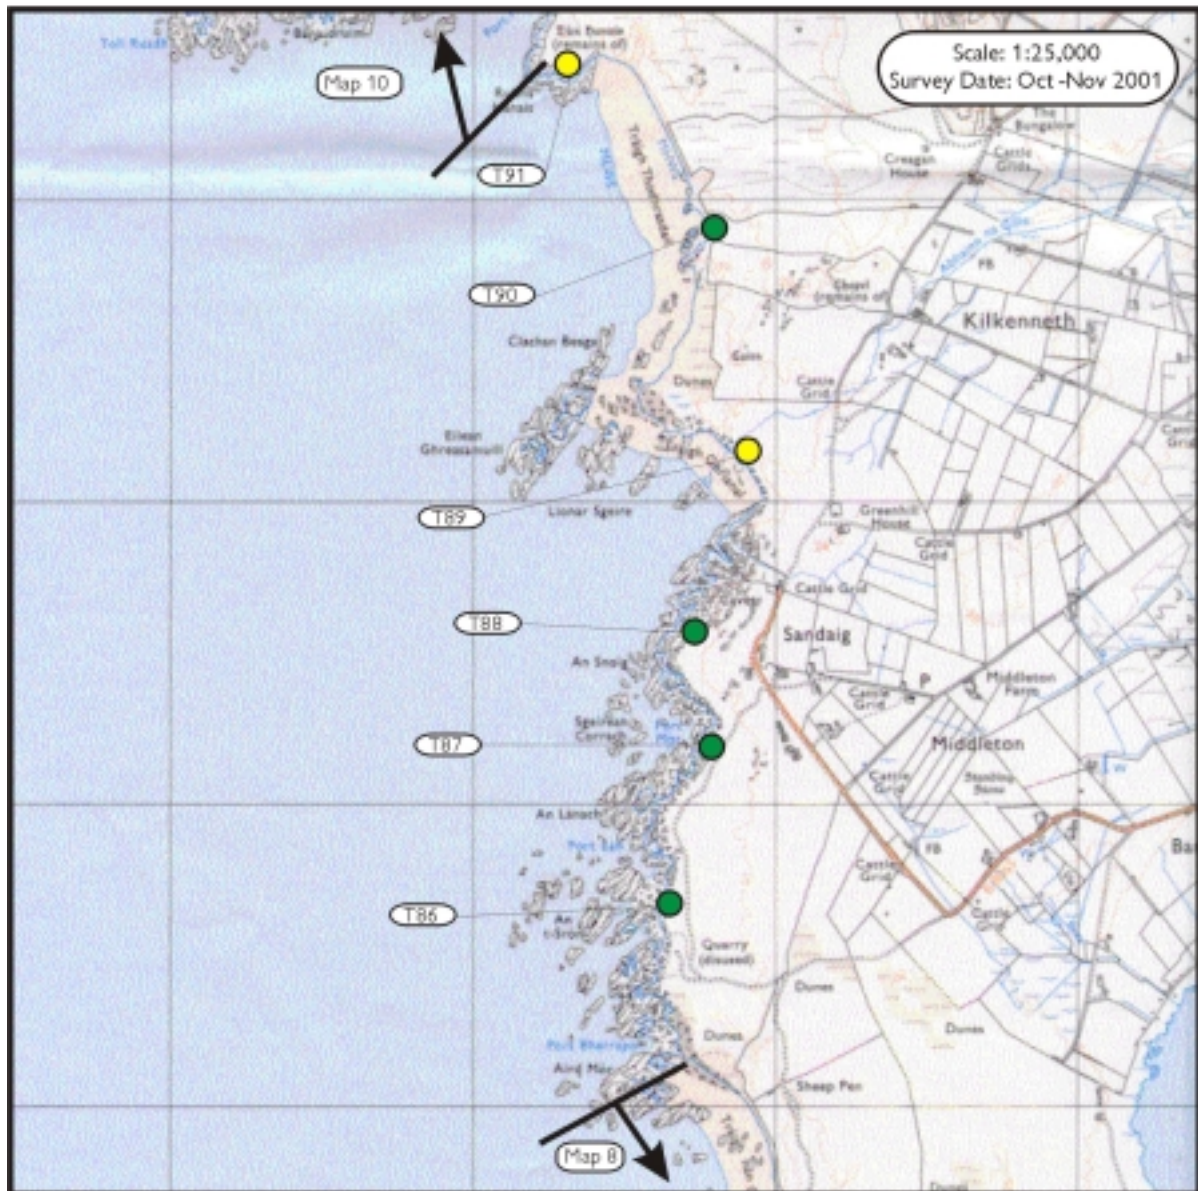
The remains noted in this area include kelp walls of 18-20th C date which lie to the S of Sandaig (T86, 87). An old wall line which appears to have once enclosed a promontory (T88) may indicate a defended site but may alternatively be a stock barrier; the date of this construction could not be determined. To the NW of Greenhill House, between Sandaig and Kilkenneth, a souterrain was discovered and partially excavated in the early 20th C. No trace of this site can now be seen. At Dun Hanais, however, the remains of a substantial house, most likely a broch, lies on a low headland surrounded by outer defensive walls and earthworks which extend across the neck of the promontory. The walls of this building are partially buried and the interior is filled with loose rubble. It is likely that at least part of the interior deposits may survive and the site should be considered as being of high archaeological potential.

<p>T86 NL 93668 42702 Port Ban (S of) Kelp drying walls 18-20th C Fair/poor Nil</p>	<p>T89 (NL94SW5) NL 93893 44176 Greenhill House (NW of) Indeterminate remains, site of souterrain Unknown Poor Nil</p>
<p>T87 NL 93844 43279 Port Mor Kelp drying walls 18-20th C Fair Nil</p>	<p>T90 NL 93811 44881 Traigh Thodhrasdail Cairns, possible clearance material Unknown Fair Monitor</p>
<p>T88 NL 93857 43750 Sandaig (W of) Wall across promontory Unknown Poor Nil</p>	<p>T91 (NL94NW2) NL 93293 45455 Dun Hanais Substantial defended house/ possible broch 1st mill BC-1st mill AD Fair Monitor</p>

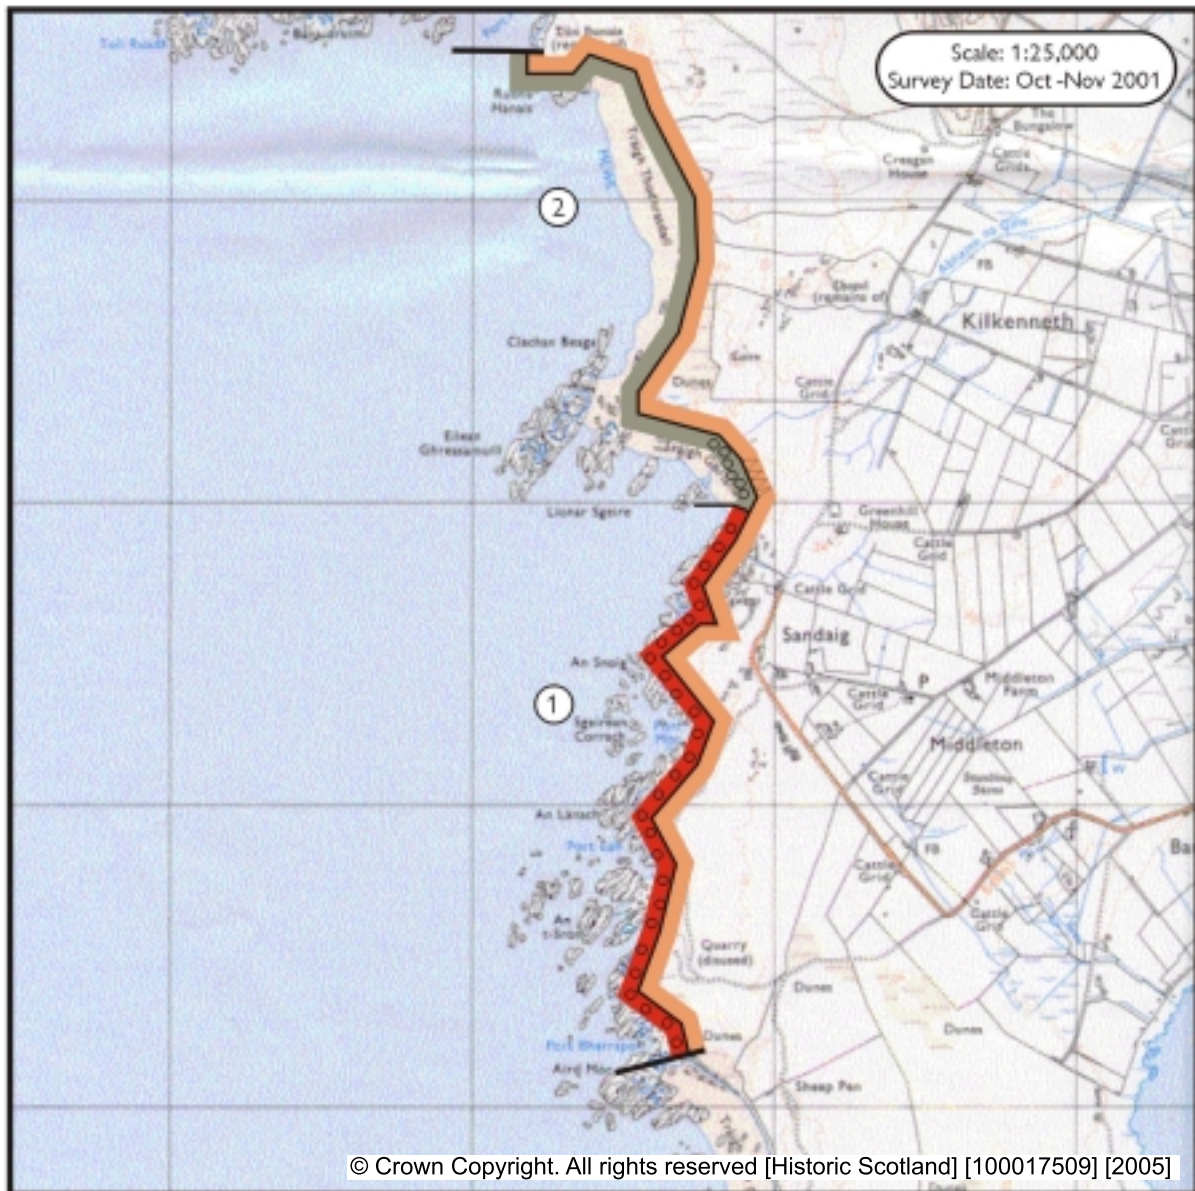
1. Sandaig  
NL 936 430  
2.4 Km  
Rock platform, extensive cobble cover  
Coast edge <5m  
Drift/rock interface not visible  
The coast edge is rock platform with frequent  
cobble cover along upper foreshore. The cobble  
cover is in the form of a storm beach for the  
first c. 500m of the unit. Hinterland is dunes  
and blown sand. Unfenced rough grazing. An  
old quarry at NL 93658 42410 has exploited  
an old storm beach in the hinterland here, partly  
covered by blown sand.

2. Traigh Thodhrasdail  
NL 937 446  
2.6 Km  
Sandy foreshore  
Coast edge <5m  
Drift/rock interface not visible  
Sandy coast edge, cobble cover along upper  
foreshore for first c. 150m of unit. Hinterland  
is dunes, which become higher to the north of  
Eilean Ghreasamuill.

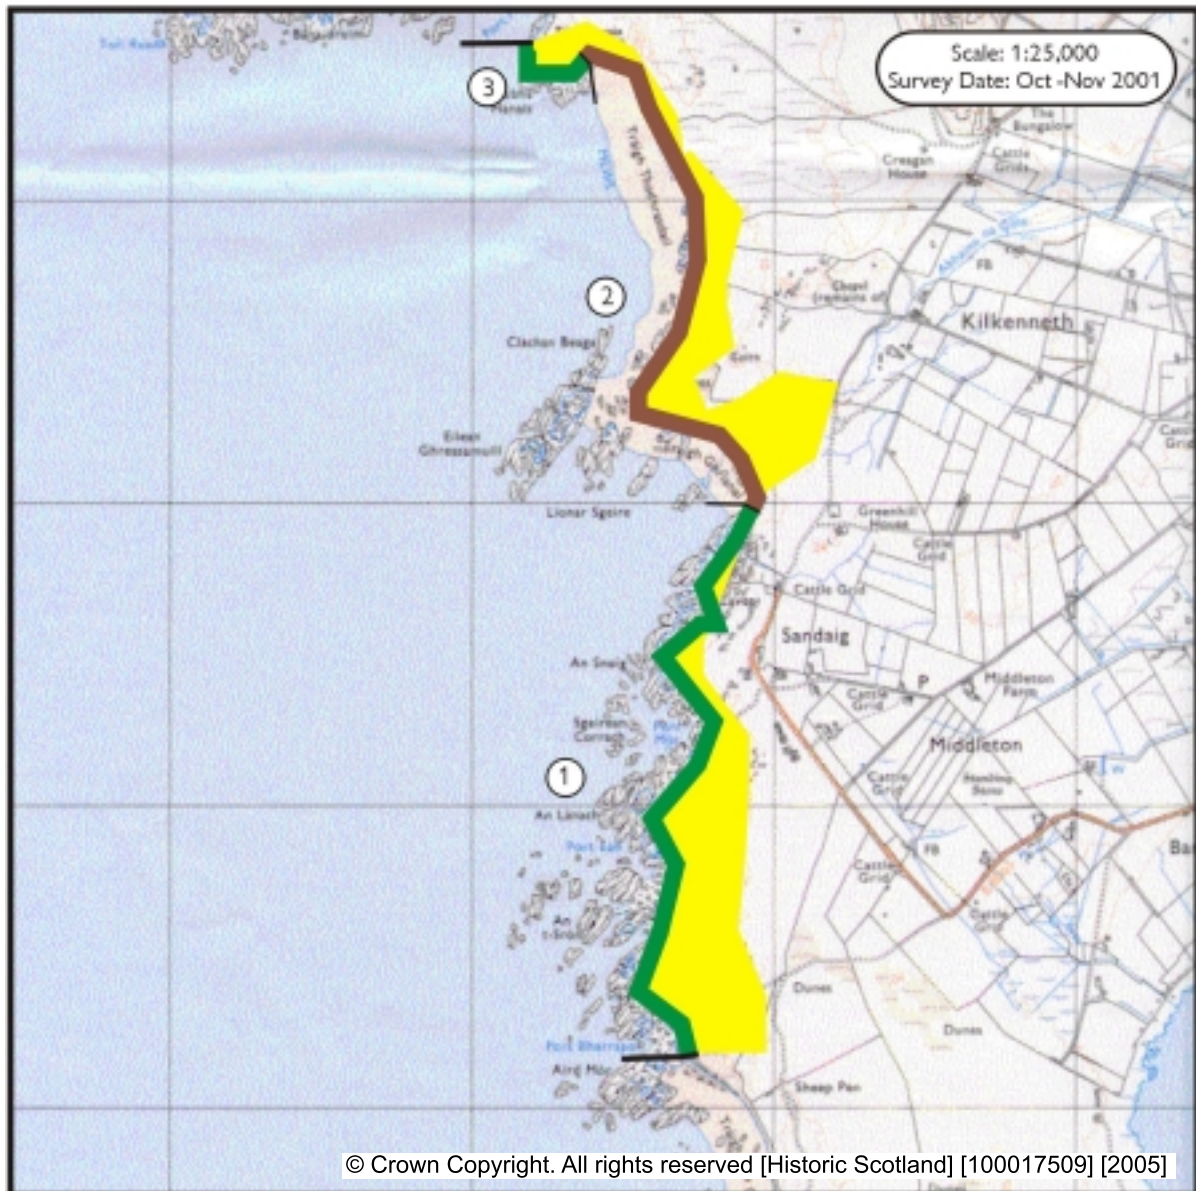
1. Sandaig NL 936 430 2.4 Km Stable The coast edge in this section is rocky and there is only very limited, localised erosion.	3. Rubha Hanais NL 933 454 0.4 Km Stable The coast edge within this section is rocky and stable.
2. Traigh Thodhrasdail NL 937 446 2.2 Km Definitely eroding The coast edge within this section is definitely eroding. An area around a headland opposite Eilean Ghreasamuill is deflating onto an old ground surface, over an area of c. 50m X 100m. The coast edge to the north of the headland are near vertical dunes, which are eroding.
