MAP 10 - KINGHORN LINKS TO LONG CRAIG

- **Hinterland geology and coastal geomorphology; Erosion class** - Apart from the short section of sheltered bay which forms Kinghorn harbour, the foreshore of this sector is exposed to the east and retains little sediment cover except in localised indentations and rock-cuts which act as catchment zones for sand and shingle. Behind the coastal edge, the rock promontory of Kinghorn Ness with its high coastal edge descends after Kinghorn to form a low coastal edge. In the vicinity of Seafield Colliery (Geology units 3-6), there has been substantial human interference in the form of land-fill of colliery waste behind the coastal edge and also in the deployment of short sections of sea-wall to protect the colliery workings.

MAP CLASS: **EROSION**
 (Assessment date: January 1996)
 NT28. Scale 1: 25 000

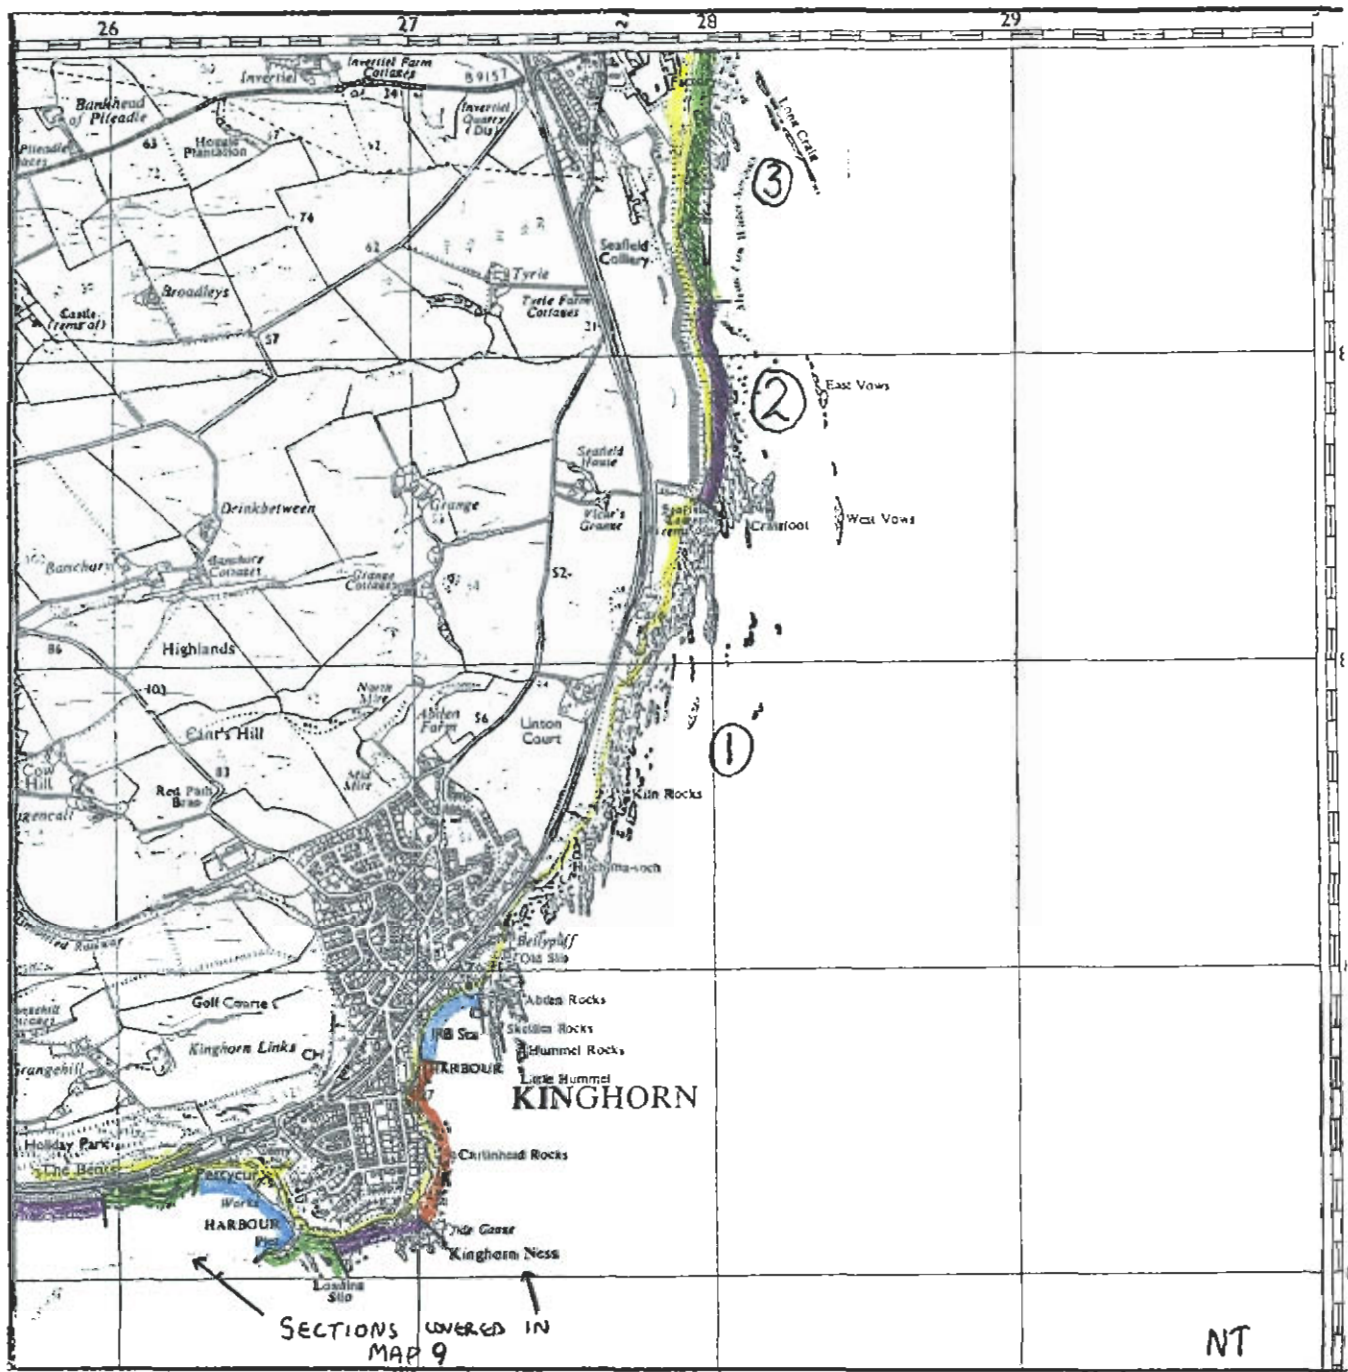
MAP 10: KINGHORN LINKS TO LONG CRAIG

EROSION UNITS

2

Both accreting and eroding

Erosion of low cliff line undermined by wave action and accretion of sediments on some parts of a rocky shoreline.

3

Stable

Rocky shoreline is stable - some sections of coastal defence along shoreline in front of Seafield Colliery.

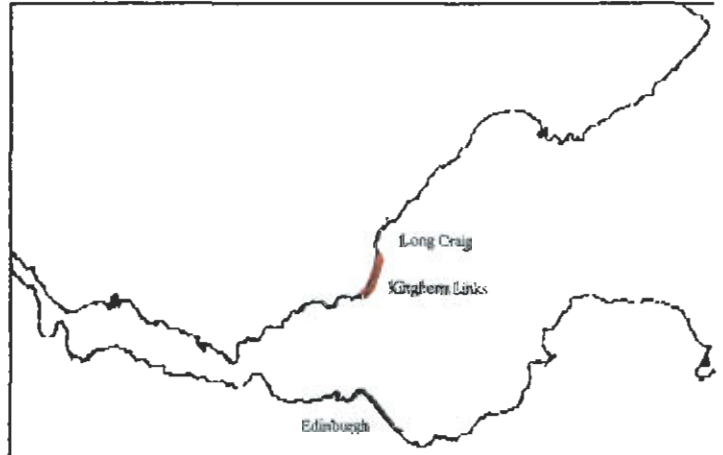
1

NT277877

1.9 km

Not seen

Section not walked.

NT280888

0.7 km

NT279895

0.8 km

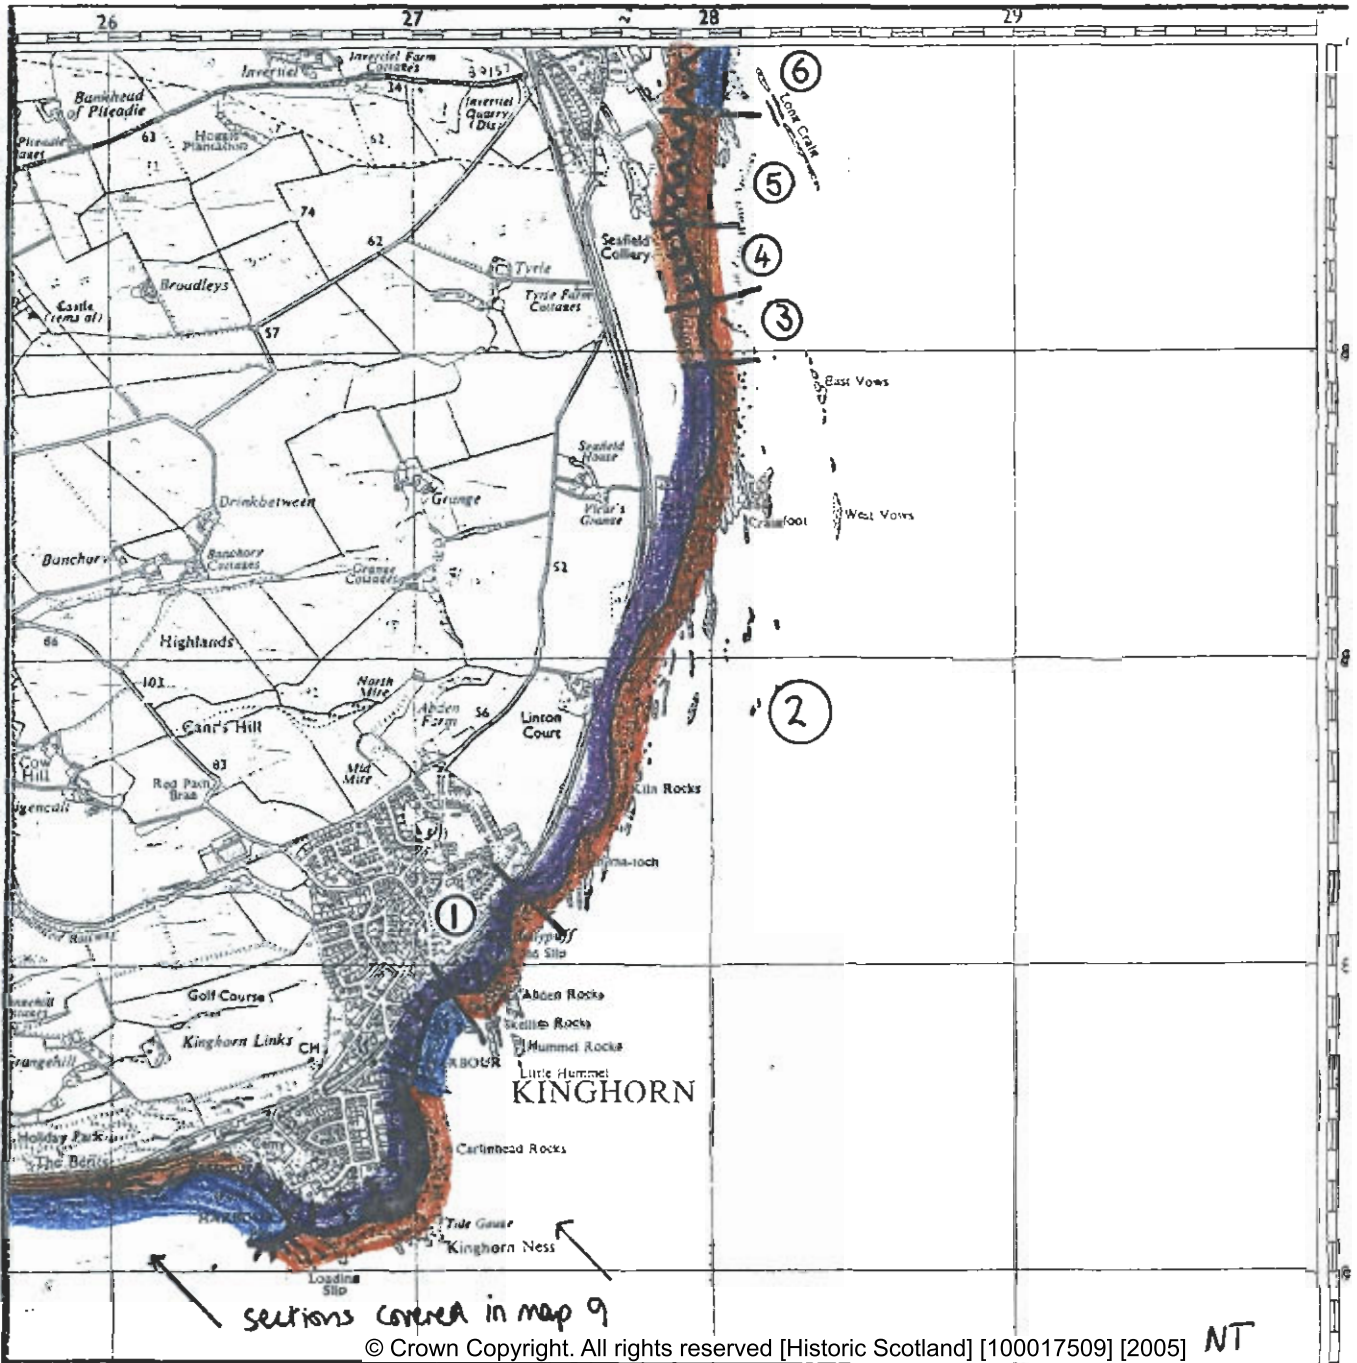
GEOLOGY UNITS

1
NT273870
0.5 km
Mainly rock platform
Man made barrier
Drift, boulder clay over visible rock
Rocky foreshore to the south east and east of Kinghorn by Abden Rocks and Skellies Rocks. Sea-wall along the coastal edge.

2
NT277881
1.7 km
Mainly rock platform
Low edge (< 5 metres)
Drift, boulder clay over visible rock
Although this section was not walked, British Geological Society Drift Maps suggest that the foreshore of this section consists of a rocky platform, with shingle and boulder debris and a low coastal edge behind.

3
NT279891
0.2 km
Mainly rock platform
Low edge (< 5 metres)
Blown sand
Rocky foreshore continues with hinterland geology changing to blown sand.

4
NT279893
0.3 km
Mainly rock platform
Man made barrier
Blown sand
Localised concrete sea-wall to protect Seafield Colliery.

5
NT279896
0.4 km
Mainly rock platform
Human disturbance
Blown sand
Land-fill from Seafield colliery makes up the coastal edge.

6
NT279899
0.2 km
Mainly sand
Human disturbance
Blown sand
The deposition of land-fill along the coastal edge is still evident but sand has accumulated on a rocky foreshore, probably originating from the beach systems further to the north east.

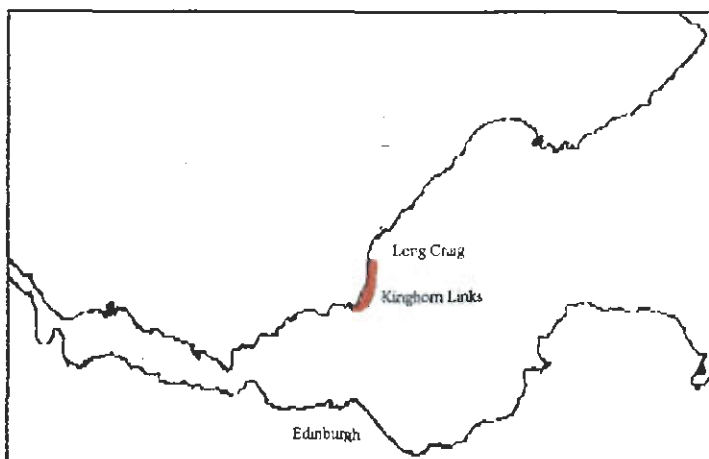
**BUILT HERITAGE AND
ARCHAEOLOGY UNITS**

Sites along the coastal edge

NT27068638

Kinghorn
Pillbox
Mid 20th century
Fair
Survey

KINGHORN; THE PROMENADE
BURIAL
16th Century uncertain
Not seen
Monitor

SEAFIELD TOWER
TOWER, and midden in the eroding face
PROTECTED ANCIENT MONUMENT
Early 16th Century
Poor
Monitor

Seafield
Stone wall and brick foundation in the eroding face
Uncertain
Poor
Nil

Seafield Colliery
Concrete breakwater for the colliery beacon
Modern
Poor
Nil

Seafield Colliery
Sea wall and pier, part of old colliery complex
19th - 20th century
Fair
Nil

Kinghorn
2 concrete tank traps
Mid 20th century
Fair
Nil
