MAP 31: TARBAT NESS

MAP 31: TARBAT NESS
 MORAY FIRTH SURVEY Grid ref: NH 92-96/86-91

**HINTERLAND GEOLOGY
 AND FORESHORE
 GEOMORPHOLOGY**

Assessment date: 24 September 1998

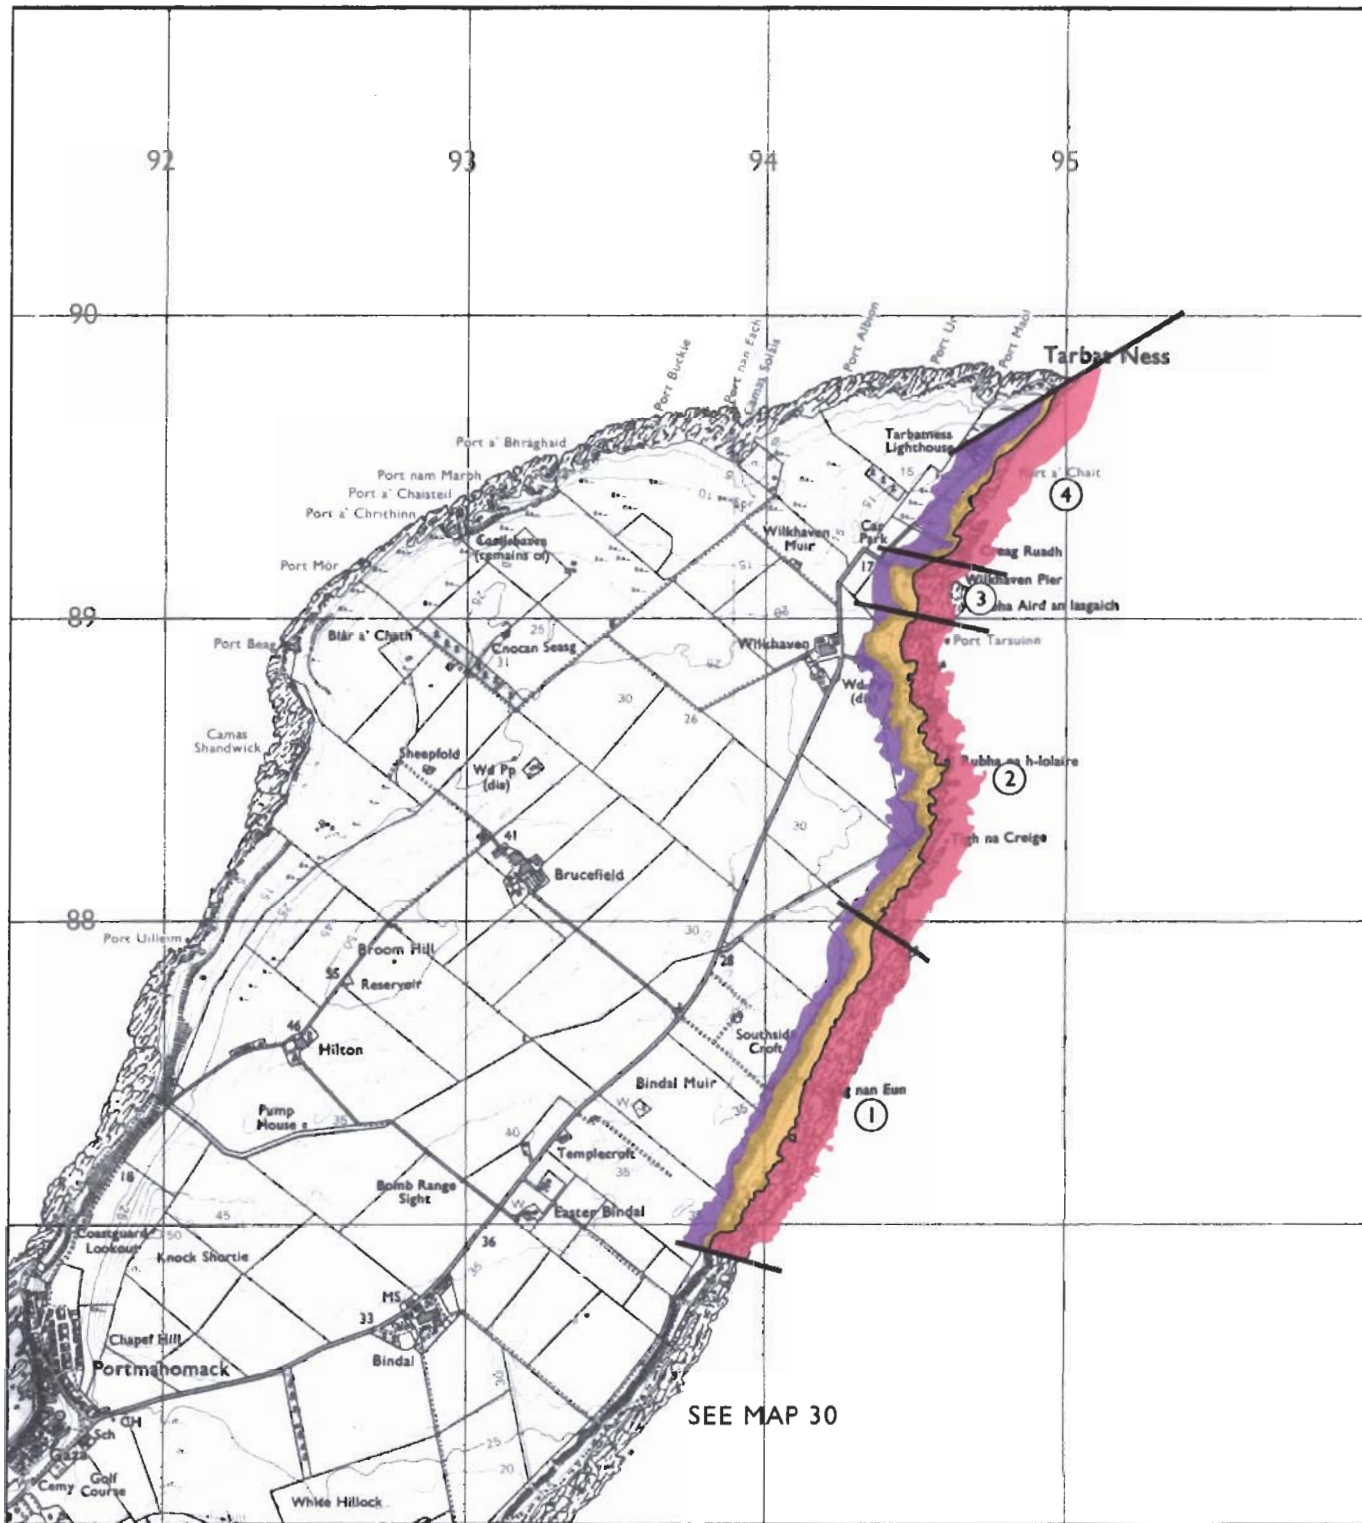
Map 31: Hinterland Geology and Coastal Geomorphology

Wide Post Glacial raised platform mantled by boulder clay. The shoreline consists of rock platform and boulders.

Small cliff girt beach with a sand component comprising fringing beach extending to the foot of the degrading cliff. Boulder clay mantles relict shore platform.

Peninsula with raised beach deposits overlying exposed rock platforms. The foreshore is exposed comprising of rock platform and boulders.

Hinterland Geology and Coastal Geomorphology: The rock bounded coast of Tarbat Ness rests on Old Red Sandstone which is mantled by a cover of boulder clay and morainic drift. Raised beach platform continues to the point of the Ness. At Wilkhaven a small fringing beach near the tip of the rock bounded peninsula is about 10m wide with banking shingle. The till capped cliffs behind the beach are about 20m high and capped by marine deposits.

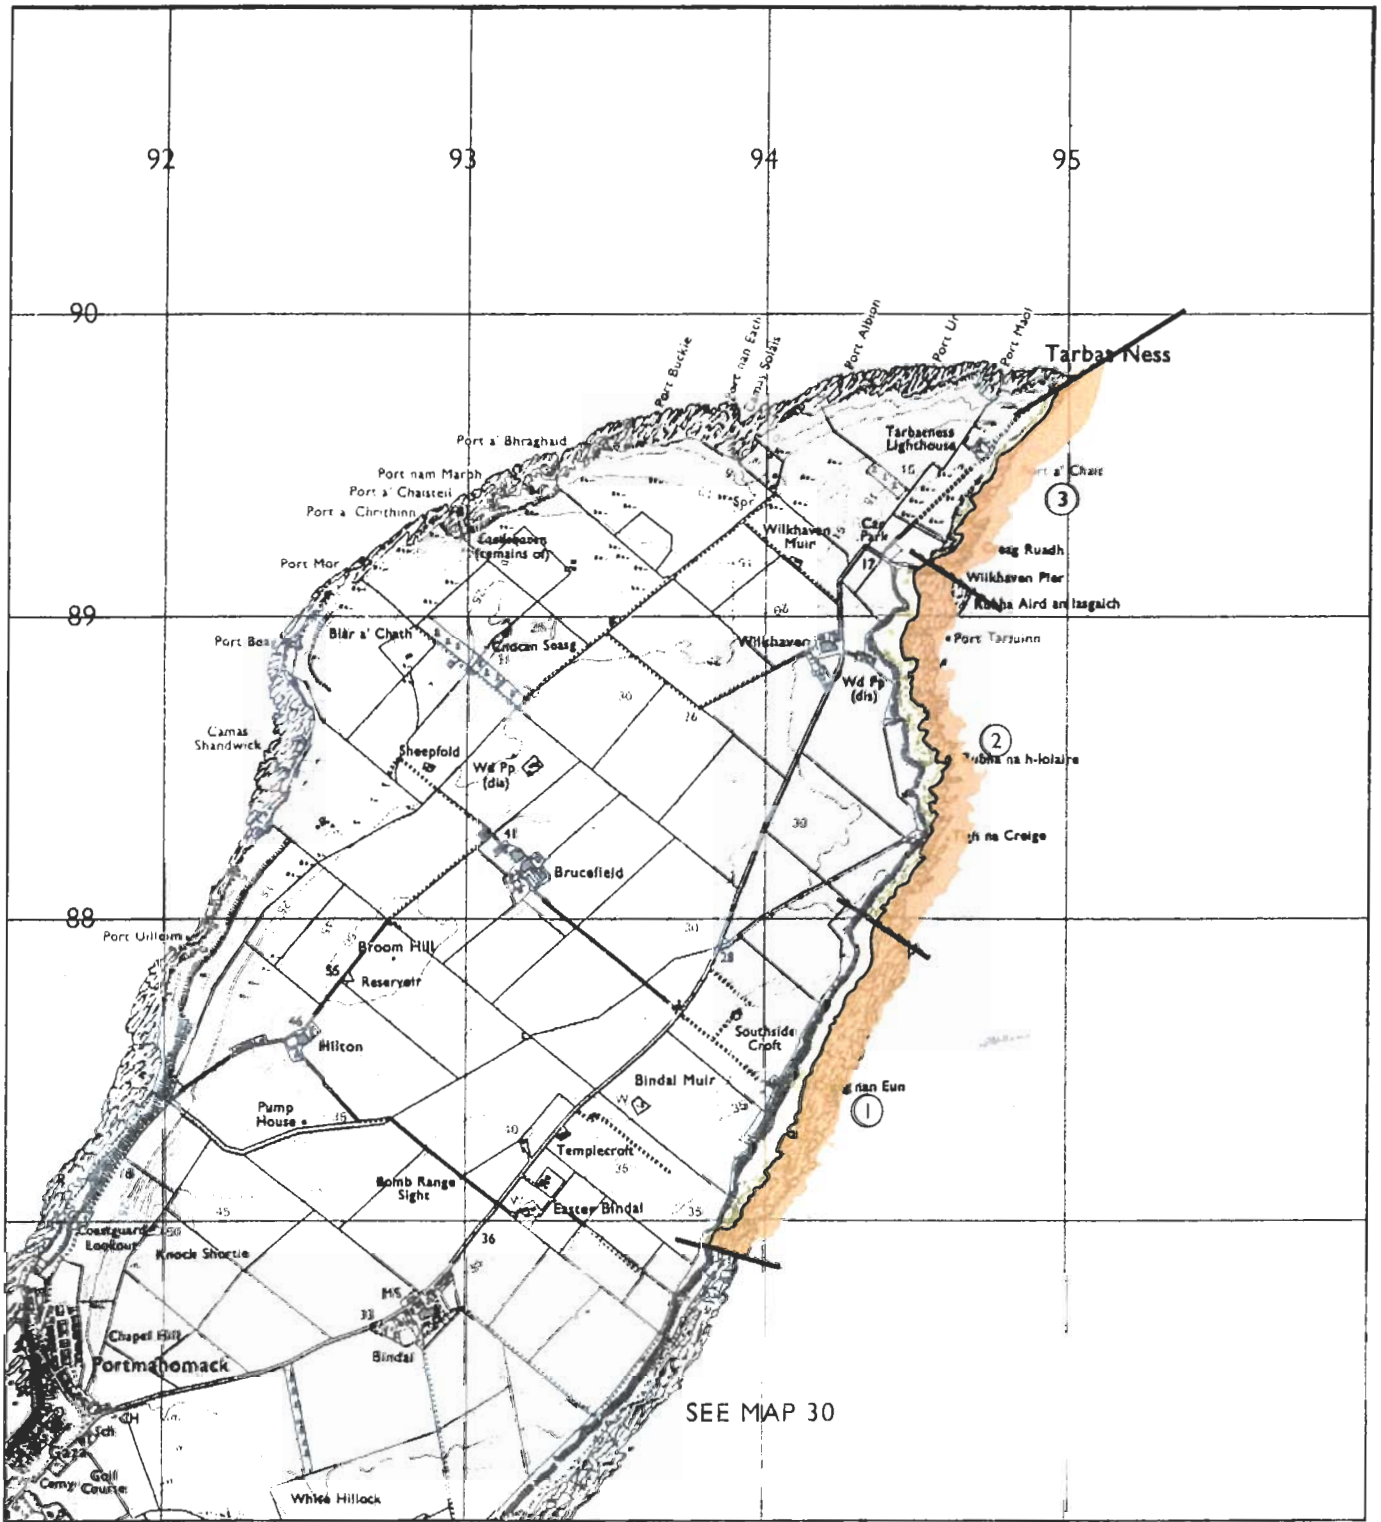
MAP 31: EROSION

Wide wave cut platform overlooking exposed rock platform scoured into a deep gullies scoured by wave action. Attrition at the base of the cliff is constant owing to exposure to easterly gales. Erosion considered to be slow owing to the fairly resilient nature of the Old Red Sandstone.

Irregular coastal edge modified by wave action overlooking gullies and rock platforms. The beach at Wilkhaven is receiving sufficient sand supply and is classified as stable.

Exposed peninsula consisting of irregular cliff face overlooking exposed rock platforms. As described in the previous units the coastal edge is undergoing constant erosion but at a considerably slow rate.

Erosion class: Although the peninsula is exposed to the NE gales the cliff is resilient in terms of erosion and is considered to be stable at the present. Some rubble dumping was noted at the tip of the Ness but this is not connected with sea defence, rather tipping of demolition material.

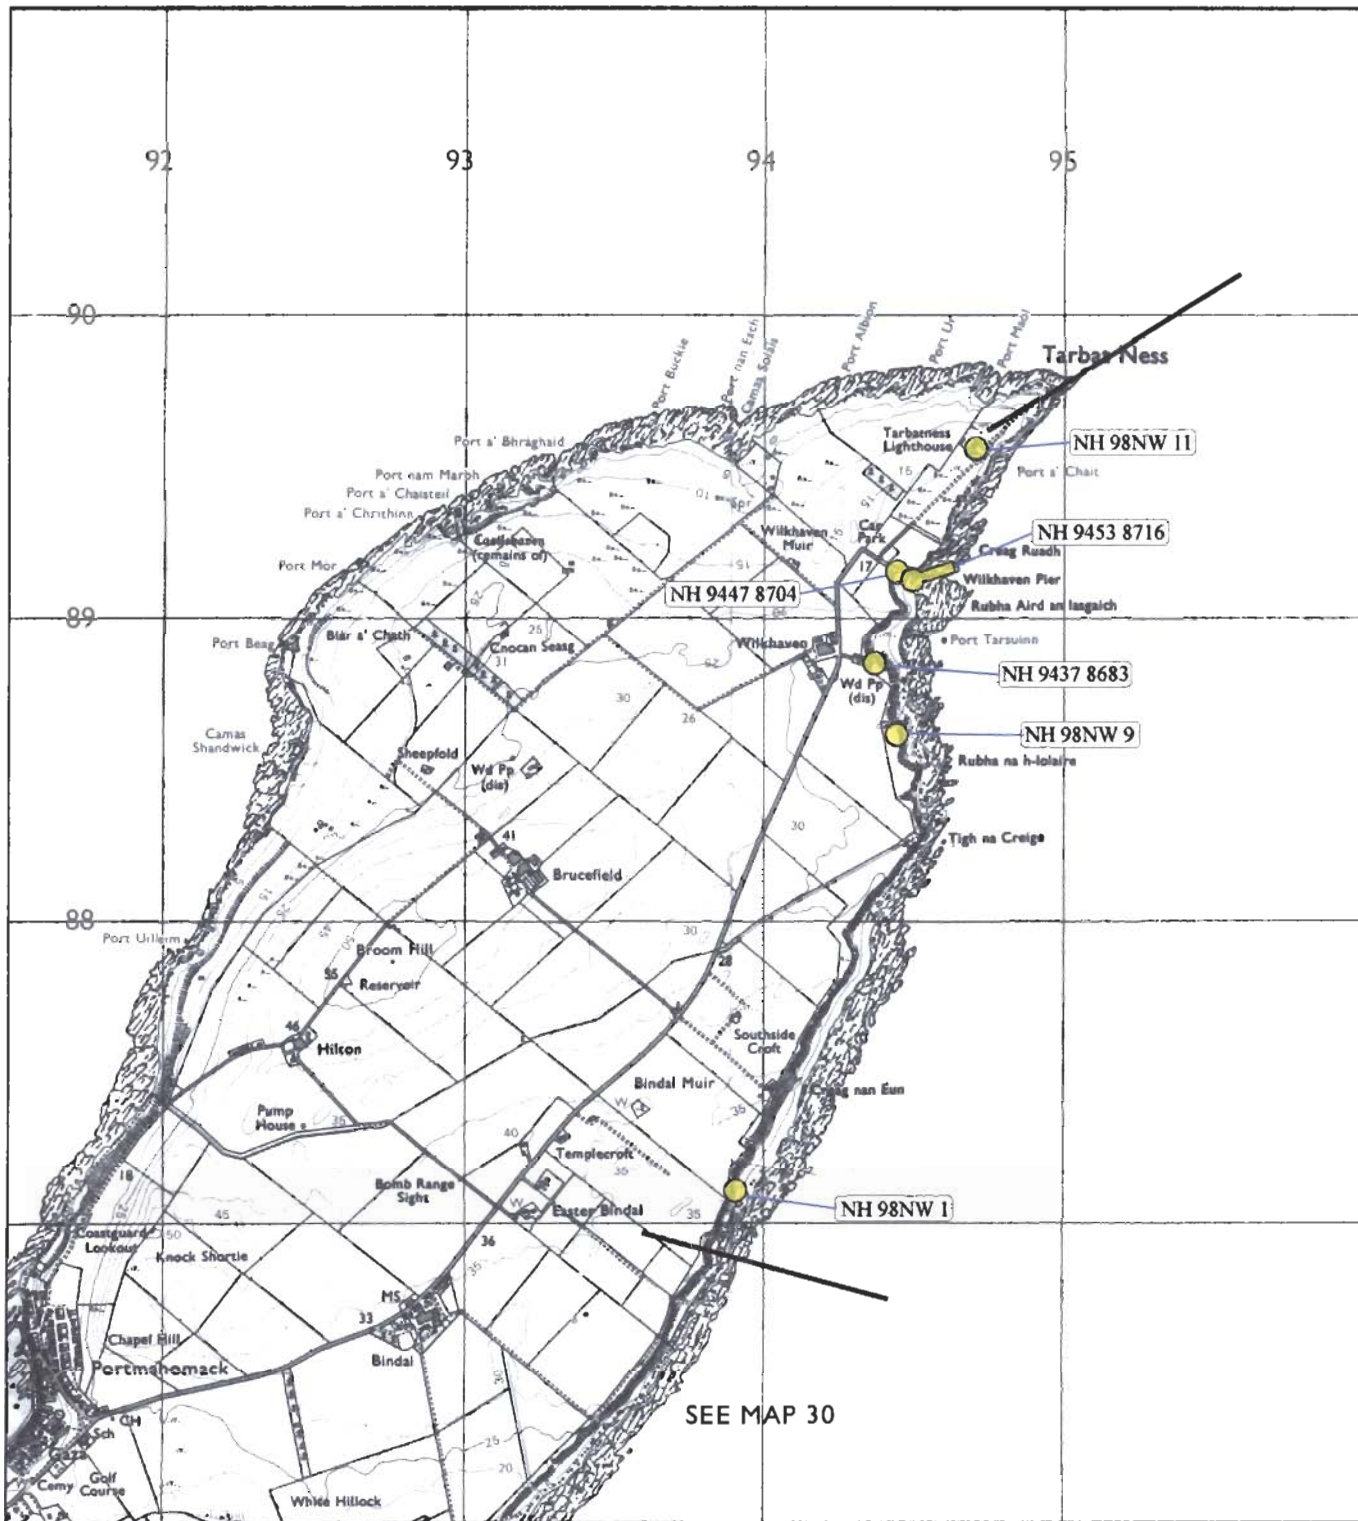
MAP 31: BUILT HERITAGE AND ARCHAEOLOGY

Promontory fort (possible)

Poor

Ruined building

Built Heritage and Archaeology: The hinterland archaeology in the southern part of this area comprises the possible hermitage site at Bindal Muir, consisting of a walled enclosure. In the north, the Tarbat Ness lighthouse, cottages and helipad are the built heritage. The foreshore archaeology in this area includes the possible promontory fort at Wilkhaven, which is a poor state of repair. Other sites include the ruined building and
