## **Introduction to Map 11: Torr a'Muilinn to McArthur's Head**

This map section covers some 3.7km of coastline. It extends northwards along the eastern coast of Islay. The coastline in this area lies little more than 10m OD and is rough and rocky. The coast edge within this map section has been classified as stable. There is no modern settlement and much of the hinterland comprises of rough grazing and moorland. There are no roads within this area, although short sections of a rough track extend close to the coast to McArthur's Head.

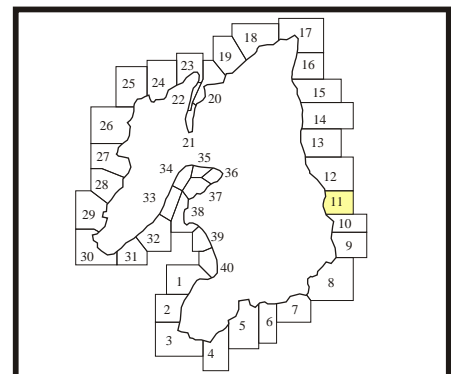
**1. Carraig an Ratha**

NR 461 587

3.7 Km

Rock platform

Coast edge mostly <5m

Raised beach etc./ Drift on visible rock.

The coast edge is rock platform covered by a mix of boulder and cobble, broken by the occasional rock outcrop. At the southern portion of this unit the immediate hinterland is flat and low lying in front of cliffs c. 20m high. The cliffs approach the coast edge towards the north, where they are separated from the coast edge by a steeply sloping area 20m - 60m wide. The hinterland is poorly drained and overgrown, with scrub in places.

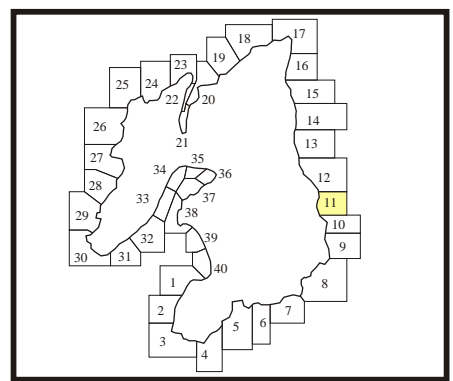
**1. Carraig an Ratha**

NR 461 587

3.7 Km

Stable

The coast edge in this unit is rocky and stable. No signs of erosion.
